AVIATION OCCURRENCE REPORT

GEAR-UP LANDING

COUGAR HELICOPTERS INC.
EUROCOPTER AS332L
SUPER PUMA (HELICOPTER) C-GQCH
ST. JOHN'S, NEWFOUNDLAND
01 JULY 1997

REPORT NUMBER A97A0136

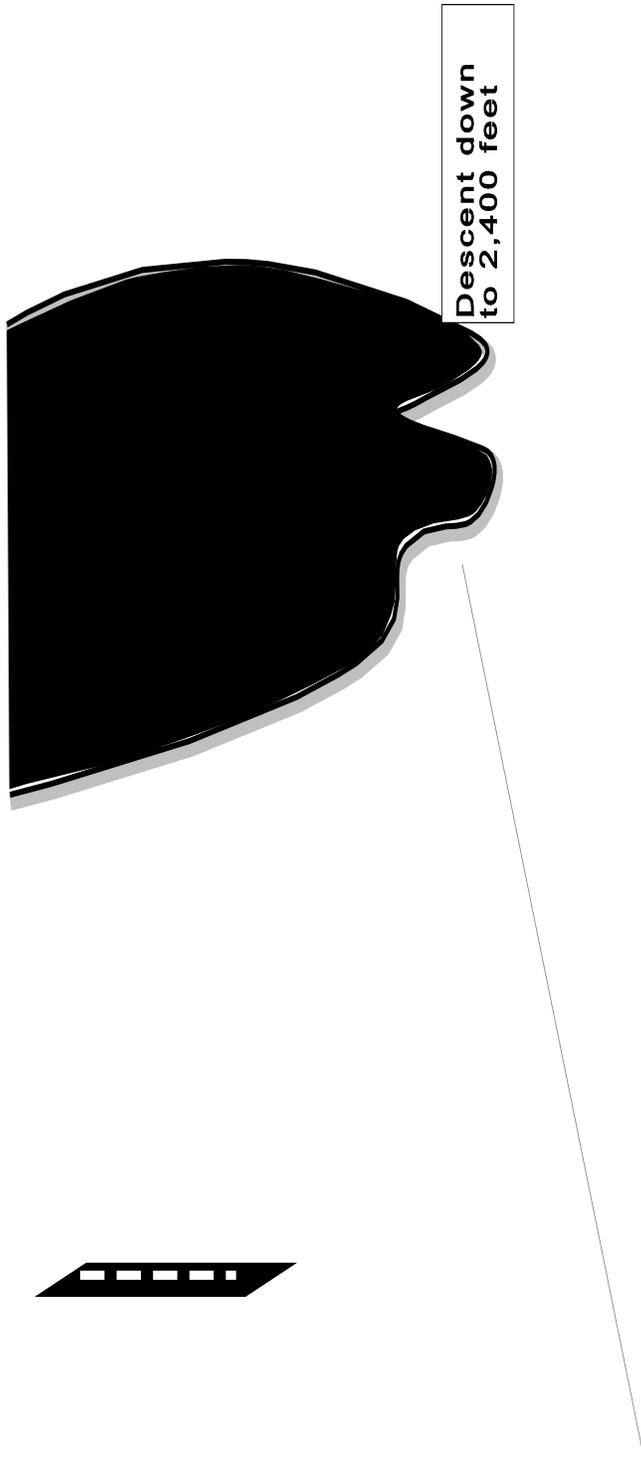
Flight Profile

Correlation of radio communication records and air traffic control radar data revealed the sequence of events during the flight. At 1926, about 40 minutes prior to landing and approximately 95 miles east of St. John's, the crew, operating under the callsign Cougar 33, contacted Gander Area Control Centre (ACC) by radio and requested clearance to the St. John's airport. Cougar 33 received clearance direct to the airport at an altitude of 4 000 feet asl and was advised that Runway 29 had the best visibility for landing with runway visual range (RVR) readings of 1 800 feet, but that visibilities were fluctuating up and down. When Cougar 33 was about 12 minutes and 28 miles back from landing, Gander centre issued a clearance for Cougar 33 to descend to 3 000 feet asl and 3 minutes later issued a further clearance for Cougar 33 to descend to 2 400 feet asl. Two minutes later, while Cougar 33 was 16 miles east-southeast of the airport, Gander Centre cleared the flight to the St. John's airport for a straight-in ILS approach to Runway 29 via the TESOX approach fix (see Appendix A).

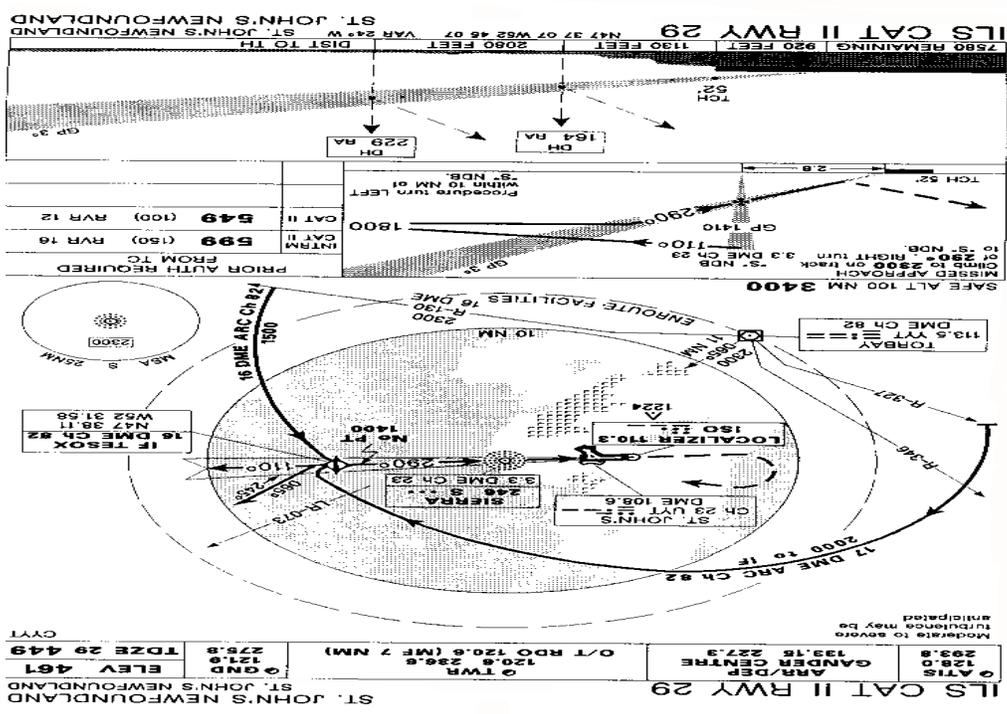
Appendix B - Instrument Approach Procedure Charts

While it is not the case with all ILS approach equipped runways, Runway 29 at the St. John's airport was equipped for Category 2 operations. Category 2 approach operations enable suitably equipped and authorized crews and aircraft to conduct an ILS approach to a 100 foot decision height. The published approach procedure for the Category 2 ILS approach to Runway 29 (see Appendix B) indicates that the decision height at 100 feet above touchdown zone elevation corresponds to a barometric altimeter reading of 549 feet asl, and a radar altimeter reading of 164 feet above ground. The instrument approach procedure chart for the Category 2 approach to Runway 29 includes a graphic representation that shows the upslope of the ground towards the threshold of Runway 29 at the St. John's airport.

5. As there was no radar altimeter reference heights on the Category 1 ILS instrument approach procedure chart, the crew used the HAT of 100 feet and set the radar altimeter altitude alert preset accordingly.

6. The published approach procedure for the Category 2 ILS approach to Runway 29 at St. John's indicates that a decision height of 100 feet HAT corresponds to a barometric altimeter reading of 549 feet above sea level, and a radar altimeter reading of 164 feet above ground.
