AVIATION INVESTIGATION REPORT
A01W0160

RISK OF COLLISION

NAV CANADA
EDMONTON AREA CONTROL CENTRE - ALSASK SECTOR
EMPRESS VOR, ALBERTA, 40 nm W
04 JULY 2001

Report Number A01W0160

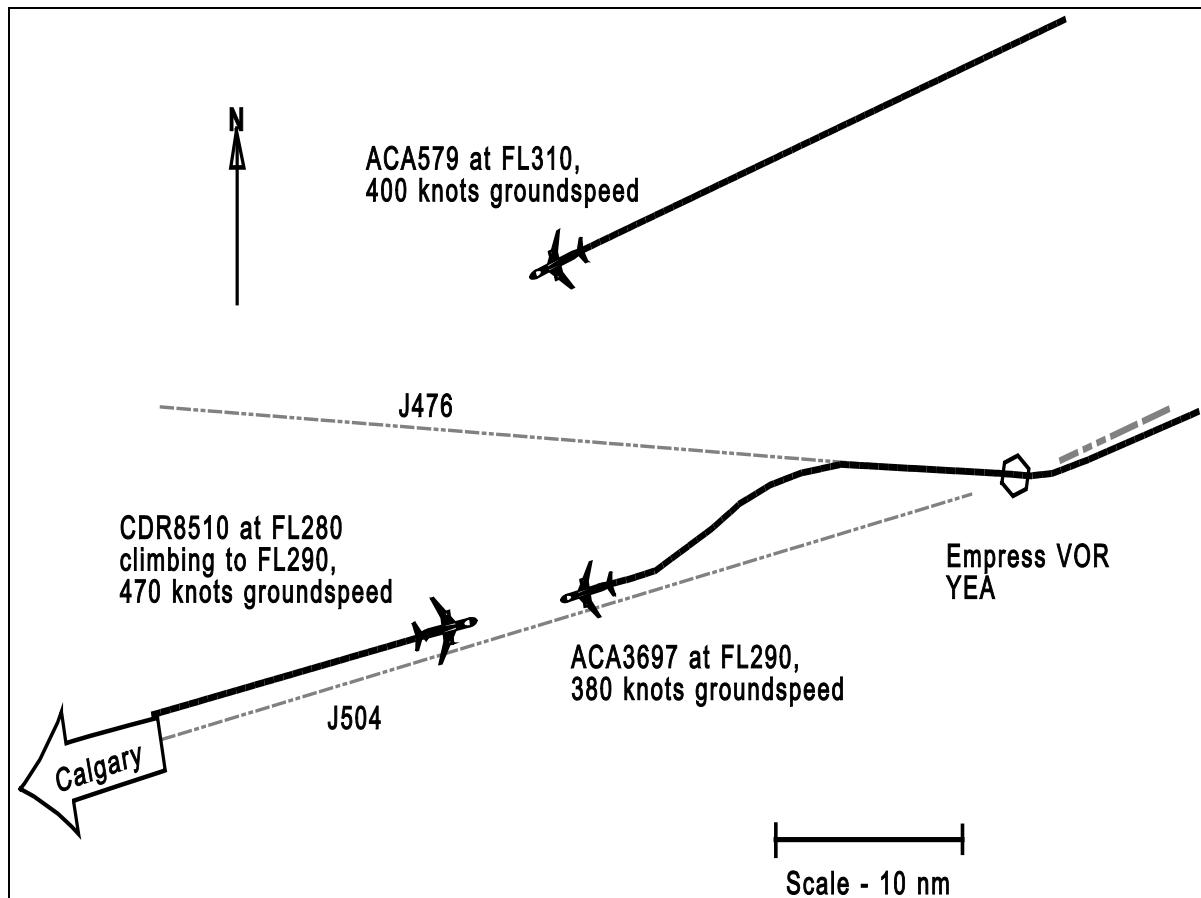
ACA3697 was cleared to proceed westbound at FL350 on Airway J504 to the Empress VOR (VHF omnidirectional radio range) (YEA), Airway J476 to the ALOMO intersection, and then to the Calgary airport via a published STAR. When ACA3697 was about 25 nautical miles (nm) east of YEA, the Alsask controller cleared the aircraft to descend to FL290 in preparation for handing control of the flight over to the Calgary terminal sector of Edmonton ACC. After crossing YEA, ACA3697 turned right on J476 in accordance with the clearance. (See Figure 1.)

When ACA3697 was issued descent clearance, an Airbus A320 (ACA579) was westbound on a track of 252° at FL310 about 11 nm north of YEA. After determining ACA579's heading, the Alsask controller instructed ACA3697 to turn left to a heading of 250°, followed shortly by instructions to turn right to a heading of 270°. This manoeuvring assured separation between ACA3697 and ACA579, but placed ACA3697 on a track nearly reciprocal to CDR8510. ACA3697 leveled at FL290 approximately 5.9 nm in front of CDR8510, which was climbing through FL280 for FL290.

While climbing through FL280, CDR8510 received a traffic alert and collision-avoidance system (TCAS) resolution advisory (RA) to descend for traffic avoidance. Within 30 seconds, CDR8510 had descended to FL277, passing under ACA3697 at FL290. ACA3697 received a TCAS traffic advisory—information to assist the flight crew visually acquire conflicting traffic and to alert pilots of the possibility of an RA; the pilot took no evasive action. The sky was clear with unlimited visibility, and both flight crews had visual contact with the other aircraft when they passed. Aircraft flying in Canada are not required to be fitted with an on-board collision-avoidance system.
