AVIATION INVESTIGATION REPORT

A03Q0092

COLLISION WITH WATER

BELL 206 JET RANGER (HELICOPTER) C-GNPI

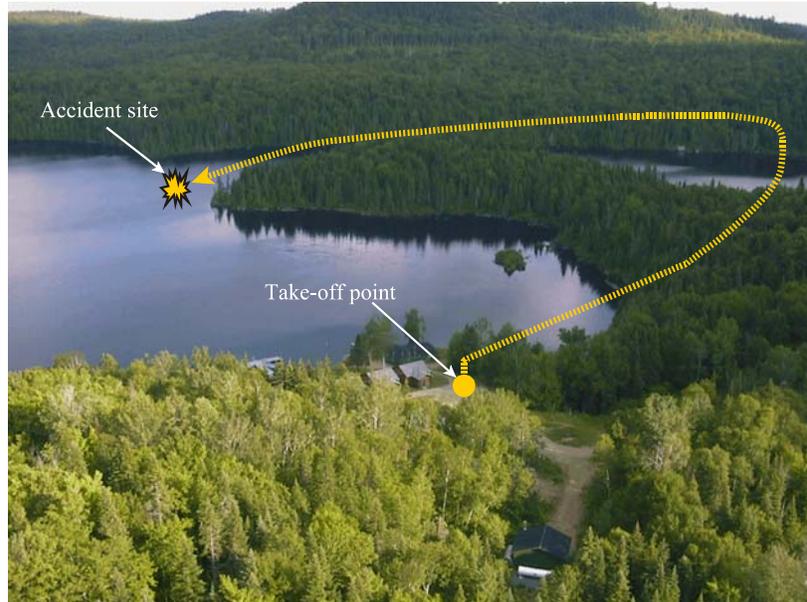
Photo 1. Estimated track of helicopter

still decreasing. However, he did not hear the low rpm warning alarm. To reduce power demand and increase rotor rpm, the pilot lowered the collective and at the same time lowered the nose to accelerate. A short time later, the N_2 indicator showed 85 per cent. The pilot, who was then over trees, steered the aircraft toward Boucher Lake, which was on his left. The aircraft descended over the lake and curved around a peninsula. After flying a distance of about one kilometre, a few feet above the lake, the pilot observed an increase in engine rpm in the normal operating range. However, he concluded that, because of the attitude, speed and altitude of the aircraft, the accident was unavoidable. The pilot raised the nose of the aircraft just before striking the surface of the water. Some of the outfitter's residents rescued the pilot a few minutes after the accident.

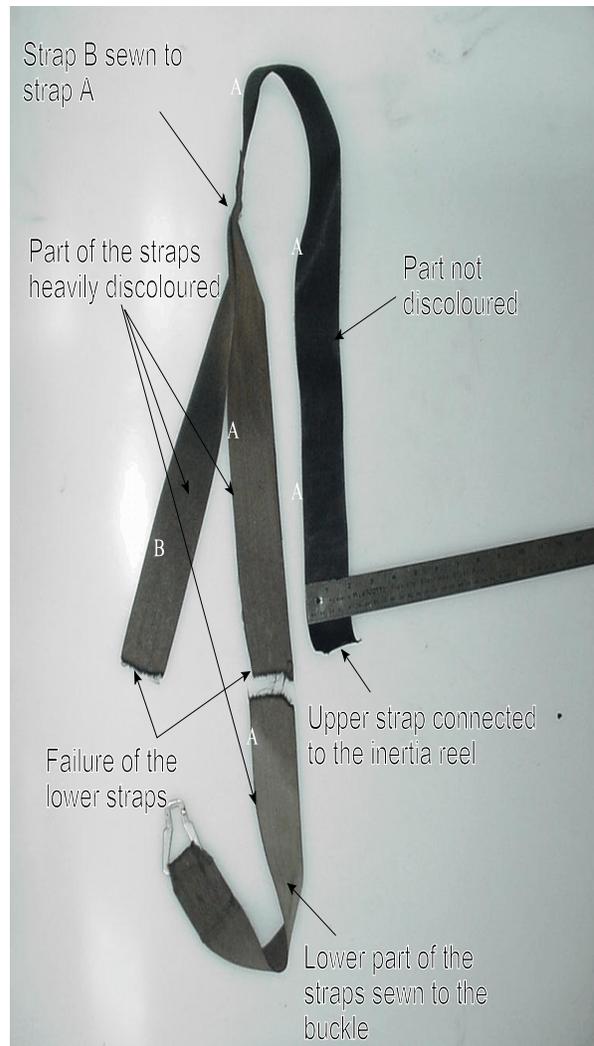
The pilot was wearing his seat belt, which consisted of a lap belt and shoulder straps connected to an inertia reel mounted on the back panel of the pilot's seat. As a result of the impact, the shoulder straps failed in overload. However, the lap belt remained intact. The pilot unfastened his seat belt before evacuating the helicopter. Although he was wearing a helmet, the pilot sustained substantial head injuries. Examination of the seat belt by the TSB Engineering Laboratory revealed that the shoulder straps were substantially discoloured. There were no signs of rubbing wear or tension. The thickness of the straps was relatively uniform. No date of manufacture was indicated on the shoulder straps; a label on the lap belt indicated that it was manufactured in December 1976. Strength testing established that the upper part of the strap failed under 1500 pounds of tension and the lower parts failed under 600 pounds. The applicable standard, Federal Aviation Administration (FAA) TSO C22, states that a strap two inches in width has a nominal strength of 1500 pounds and should not fail below 2250 pounds of tension. Seat belts are replaced when they are deemed to be in bad condition. Discolouration is not a criterion for belt replacement. According to the Bell Helicopter's company maintenance manual, proper operation, anchor security and the state of deterioration of belts should be checked on the 100-hour inspection.

Photo 2. Pilot's shoulder harness straps

The whitening of the lower shoulder straps was caused by ultraviolet rays from the sun. The upper part of the shoulder straps, which was less exposed to sunlight because it was rolled up on the inertia reel, was practically not faded. Since the lower parts of the straps failed at 600 pounds of tension and the upper portion failed at 1500 pounds, it is reasonable to conclude that the degree of weakening of the straps corresponded to the duration of their exposure to sunlight. Moreover, since the upper portion of the strap, although less exposed to sunlight, failed at 66 per cent of the limit required by standard TSO C22, it is reasonable to conclude that even a strap exhibiting no signs of discolouration may have sustained some ultraviolet degradation. Since their mechanical strength was reduced to about 26 per cent of their original strength, the lower shoulder straps failed before reaching the prescribed limit. Consequently, the pilot was subjected to greater deceleration forces than he should have sustained in the accident. The degree of discolouration of the lower shoulder straps was indicative of a degradation of

their strength. However, since no signs of physical wear were found, the belts were considered to be in good condition on the aircraft maintenance and TC inspections. It appears therefore that the absence of specific evaluation criteria with regard to the ultraviolet degradation of the belts contributed to the return to service of seat belts that no longer met regulatory requirements.

1. The pilot's seat belt shoulder straps failed at a tension level below regulatory requirements. The failure occurred as a result of degradation of the straps caused by prolonged exposure to sunlight.
