AVIATION INVESTIGATION REPORT

A05P0154

POWER LOSS

ROBINSON R22 BETA HELICOPTER C-FQDQ

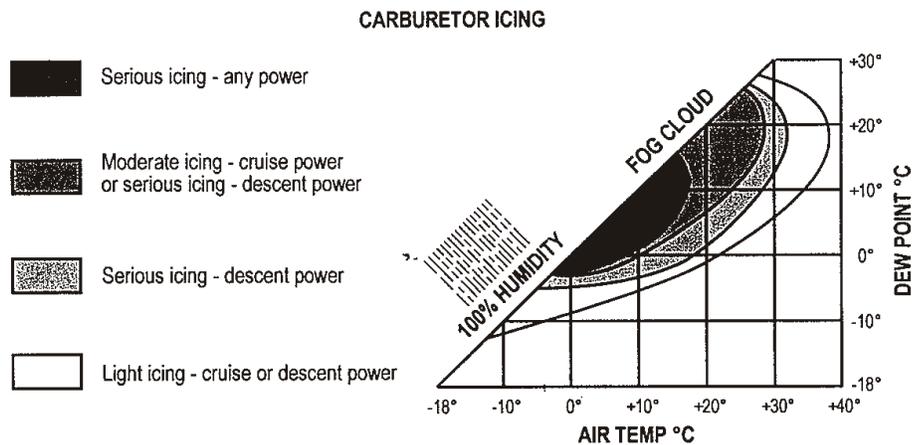
Appendix A – Carburetor Icing

According to the carburetor icing chart in *Aeronautical Information Publication* (A.I.P. Canada), Section AIR 2.3, an air temperature of 19°C and a dew point of 12°C fall in the "moderate icing at cruise power" or "serious icing at descent power" sector (see Appendix A). Indicators of carburetor ice would normally be a drop in manifold pressure and engine rpm. Severe icing will result in engine stoppage. The Robinson Helicopter Company Pilot's Operating Handbook states, "The pilot may be unaware of carburetor ice formation as the governor will automatically increase throttle and maintain constant manifold pressure and rpm."

The weather conditions at the time of the occurrence were conducive to carburetor icing. However, if the pilot did not closely monitor the engine instruments, the formation of carburetor ice would initially be hidden while the governor was maintaining a constant manifold pressure and engine rpm. Therefore, whenever icing conditions are suspected, the pilot must apply carburetor heat as required. The pilot did not recall applying carburetor heat prior to departure or during take-off. There was nothing found to indicate that a mechanical
