**AVIATION INVESTIGATION REPORT
A06O0186**

COLLISION WITH TERRAIN

**CESSNA 180H N720CS
CORDINGLEY LAKE, ONTARIO
19 JULY 2006**

Report Number A06O0186

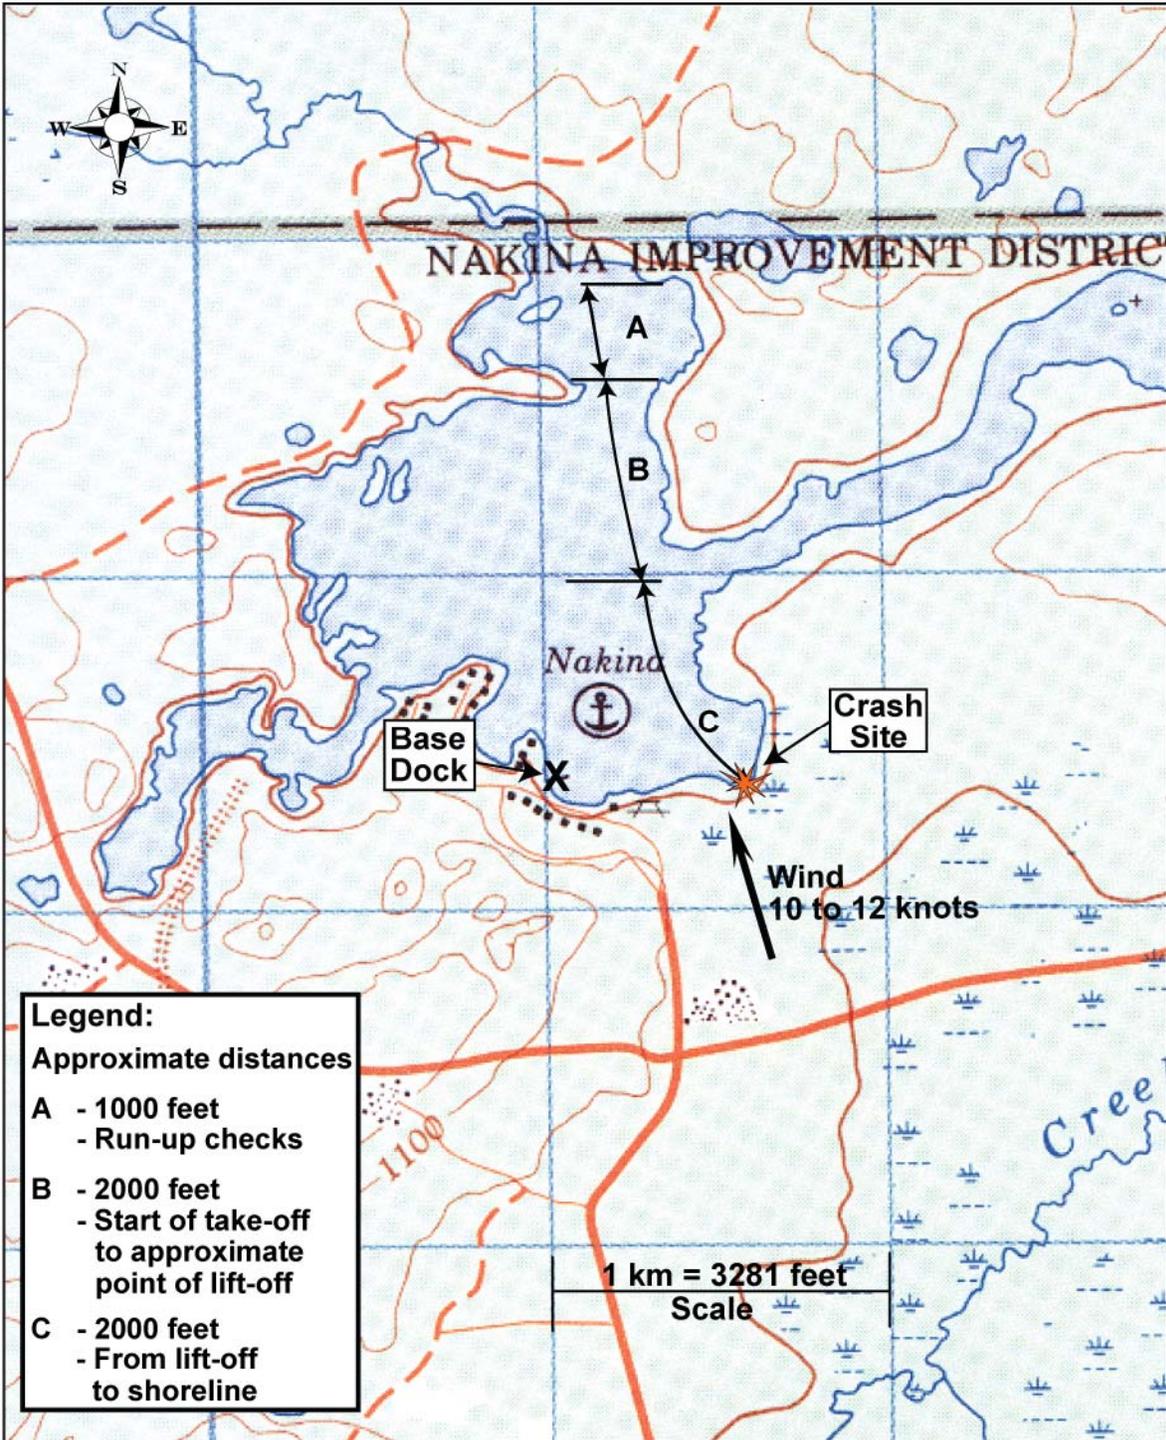
Appendix A – Aircraft Take-off Path

The aircraft's floats were pumped out as part of the pre-flight checks. The aircraft was taxied to the north end of the lake and turned into wind for run-up checks of magneto and propeller operations. The aircraft travelled approximately 1000 feet during these checks. At 0905 eastern daylight time ¹, it began its take-off run with approximately 4000 feet remaining to the shoreline (see Appendix A - Aircraft Take-off Path). Flap setting was 20°. The aircraft came up on the step normally. The right float was rolled off the water; then it settled back. The right float was rolled off again and the aircraft became airborne at a speed of approximately 60 mph. The actual water run was approximately 2000 feet.

After the aircraft was airborne, it accelerated to about 65 mph and climbed to about tree-top height. It then stopped accelerating or climbing and the airspeed decreased to about 60 mph. The aircraft was turned 20° to 30° to the left to take advantage of lower terrain in that direction. The distance remaining to the shoreline was considered to be too short to permit a safe landing straight ahead. As the aircraft crossed the shoreline and made initial contact with the tops of trees, full flap (40°) was lowered and the controls were pulled aft in an attempt to slow the aircraft and cushion the impact by striking with the bottom of the floats first. The engine remained at full power.
