**AVIATION INVESTIGATION REPORT
A07W0005**

LANDING SHORT OF RUNWAY

**PEACE AIR LTD.
BRITISH AEROSPACE JETSTREAM 3112 C-FBIP
FORT ST. JOHN, BRITISH COLUMBIA
09 JANUARY 2007**

Report Number A07W0005

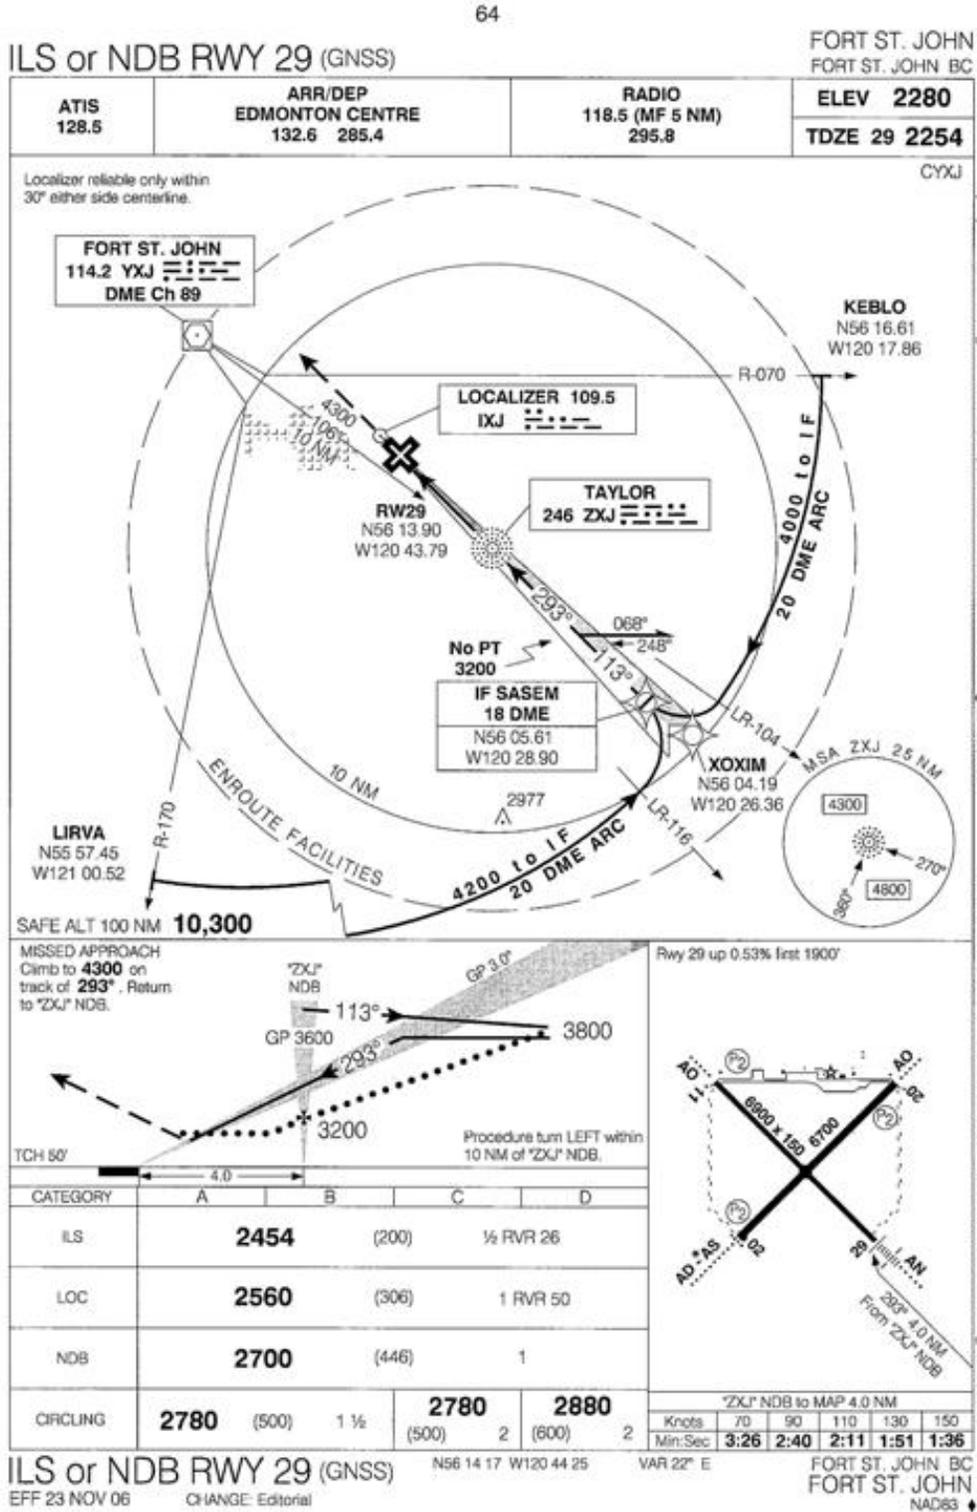
Appendix A – Instrument Approach for Fort St. John

The runway is served by an ILS with a glide slope angle of 3.0°, which places an aircraft at a height of 50 feet when crossing the threshold. DH for the ILS approach is 2454 feet asl, or 200 feet agl. The published landing visibility⁷ is ½ sm or RVR 2600 feet (see Appendix A). Required visual reference is defined as the section of the approach area of the runway or visual aids including approach lights that, when viewed by the pilot of the aircraft, enables the pilot to make an assessment of the aircraft position and the rate of change of position relative to the nominal flight path.
