**AVIATION INVESTIGATION REPORT  
A08O0029**

**CONTROLLED FLIGHT INTO TERRAIN**

**CANADIAN HELICOPTERS LIMITED  
SIKORSKY S-76A (HELICOPTER), C-GIMR  
TEMAGAMI, ONTARIO  
08 FEBRUARY 2008**

Report Number A08O0029

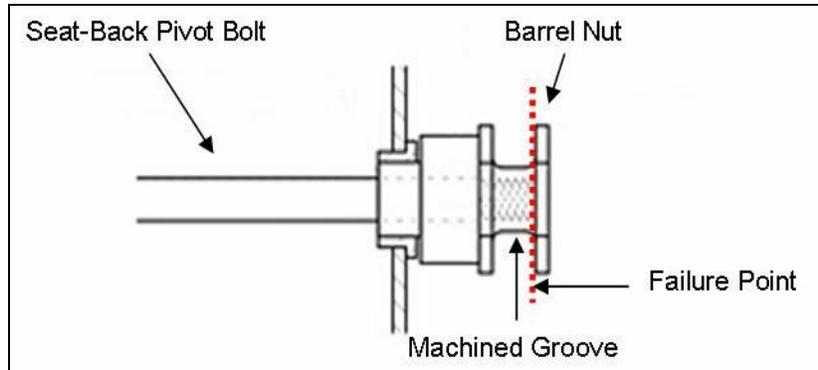
Figure 1. Lap belt attachment point

barrel nut, which is threaded onto the seat-back pivot bolts. The seat-back pivot bolt is designed to pass through the barrel nut to the end of the machined groove. The barrel nut failed where the bolt ended (see Figure 1). There was thinning of the material in the groove of the barrel nut due to wear from the stainless steel lap belt attachment.

The lap belt barrel nut attachment failed due to several factors. First, the barrel nut was weakened due to wear from the stainless steel lap belt attachment. Second, the seat-back attachment bolt did not pass completely through the barrel nut, but instead passed only part of the way through to the end of the machined groove. This created a weak point on the assembly at the outside edge of the barrel nut. Under normal loads, such as forward and aft g-forces, this

would not be an issue because the main load would be over the machined groove and seat-back attachment bolts. However, with a side impact, the main loads are in a sideways direction on the end barrel nut. This placed an abnormal load on the end of the barrel nut, which caused it to fail at the weakest point.

1. The right rear aft-facing paramedic seat lap belt attachment barrel nut was worn in the groove where the seat belt attaches, weakening the barrel nut's structural integrity, thereby increasing the risk of failure.
2. The helicopter crashed on its side, placing an abnormal side load on the right rear aft-facing paramedic seat lap belt attachment barrel nut, thereby causing it to fail.

Following the occurrence, JCM Aerodesign Limited, the supplemental type certificate (STC) holder for the emergency medical services (EMS) interior utilized in the S-76, issued Service Bulletin No. SB-EMS76-1. This service bulletin identified the affected helicopters and called for the replacement of the existing barrel nut lap belt attachment with a steel shackle. All affected helicopters have complied with the service bulletin.

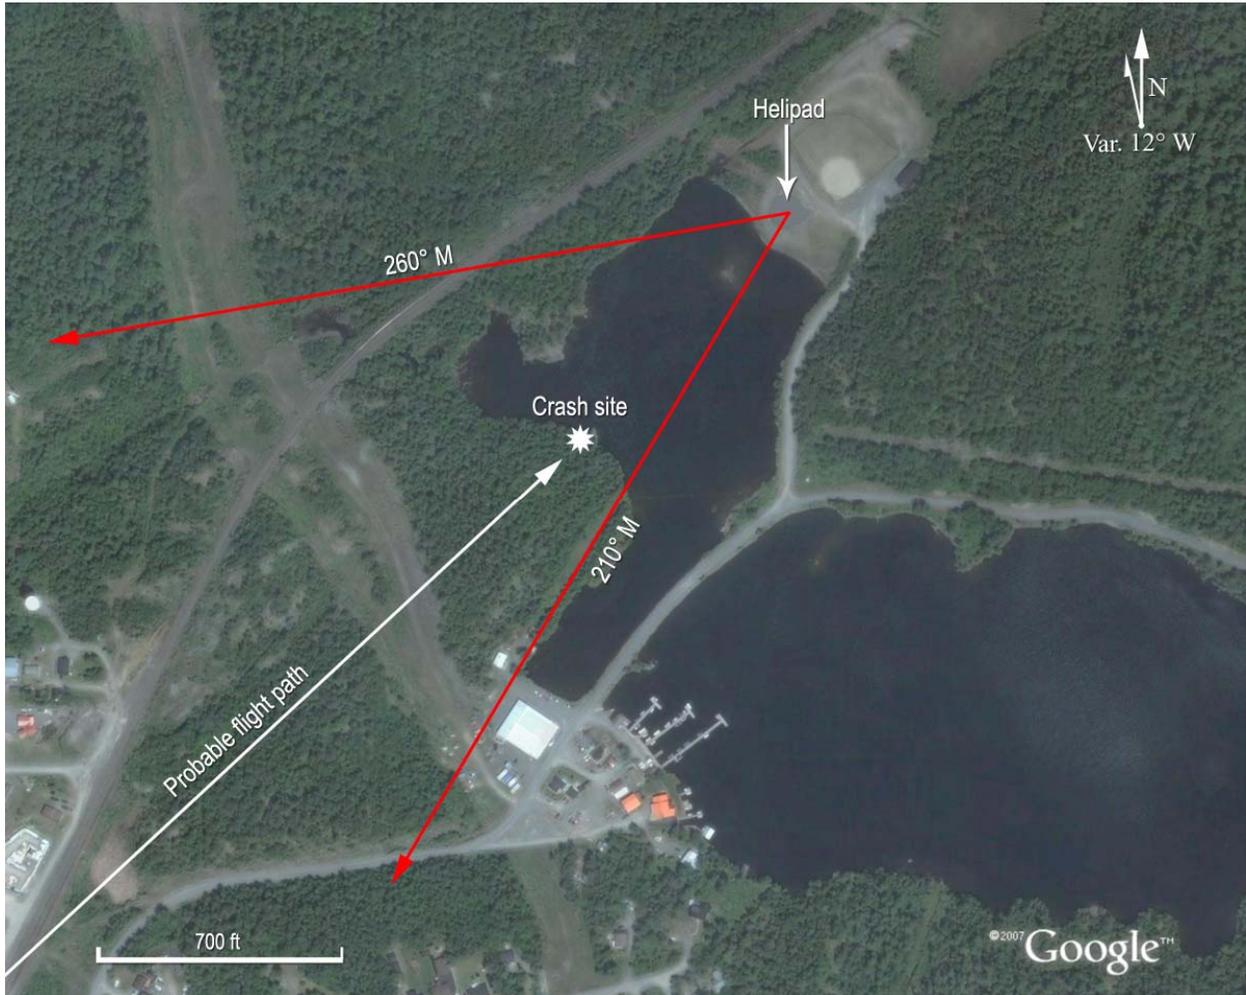
*Appendix B – Snake Lake Helipad*

The helicopter approached the helipad from the southwest on a heading of approximately 048°M and entered the trees near the edge of the lake approximately 814 feet horizontally from the helipad (see Appendix B - Snake Lake Helipad).
