AVIATION INVESTIGATION REPORT

A09O0117

ERRONEOUS INSTRUMENT INDICATIONS RESULTING IN AIRSPEED AND ALTITUDE DEVIATIONS

BOEING 767-300 SP-LPA

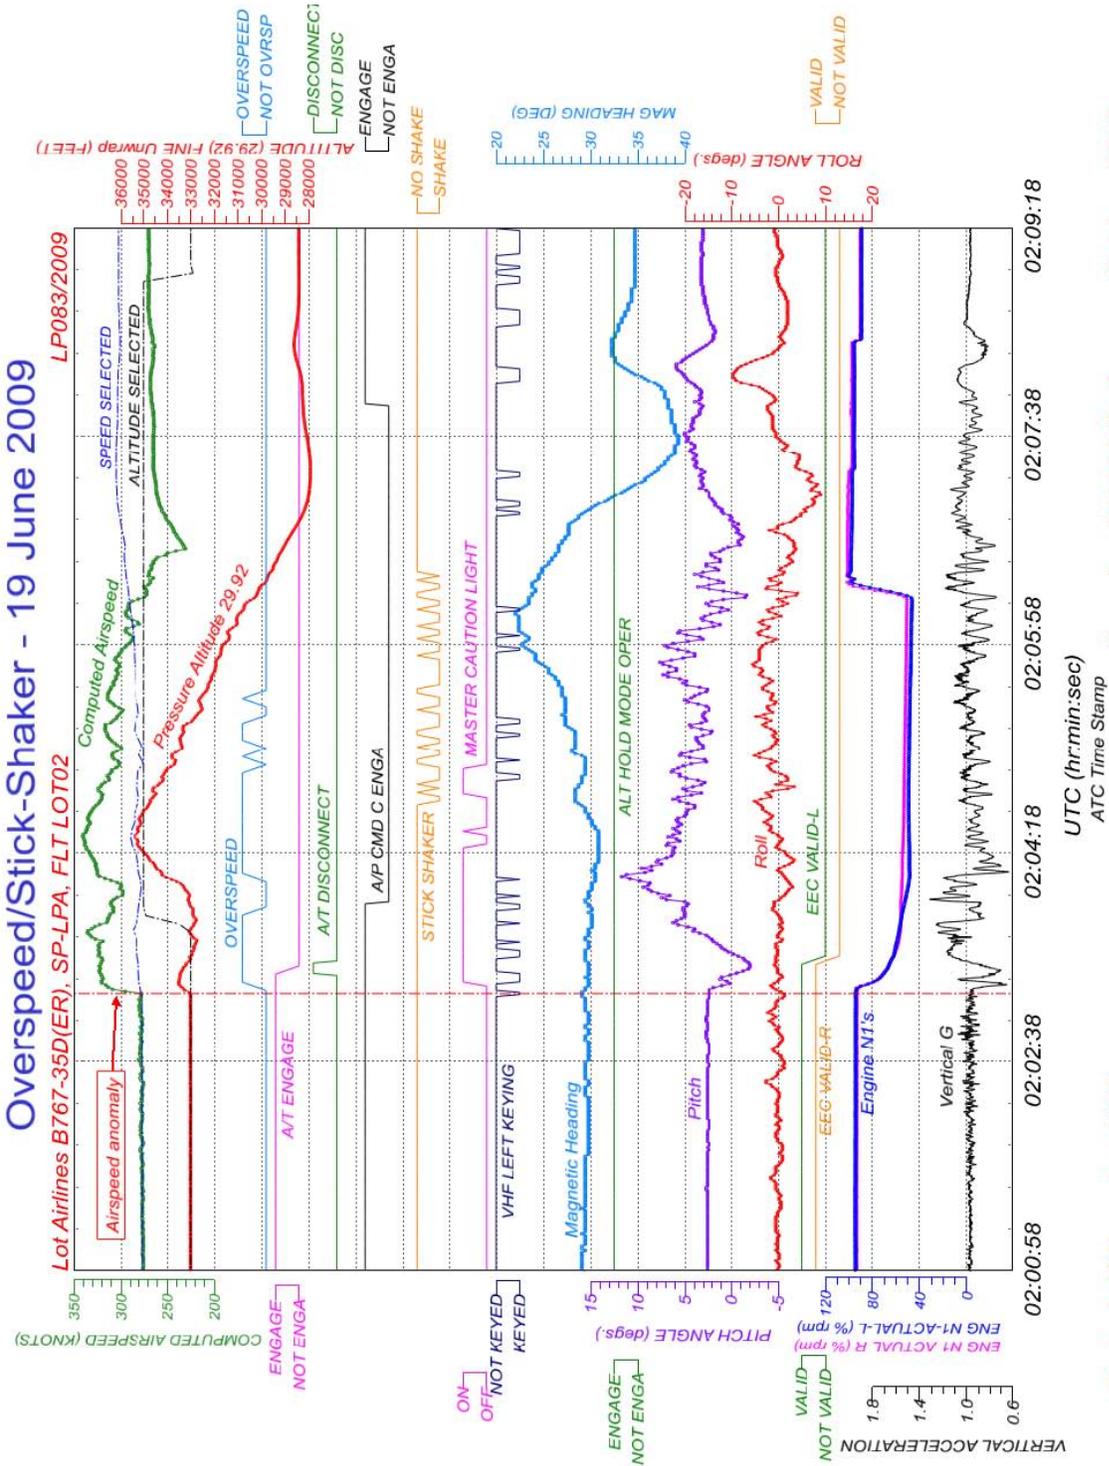
Appendix A - FDR PLOTS

The flight data recorder (FDR) installed on the aircraft was manufactured by Honeywell. The FDR contained approximately 52.5 hours of data which included the occurrence and 5 previous flights. The overspeed event and the subsequent stick shaker activations are plotted in Appendix A.
