AVIATION INVESTIGATION REPORT

A09W0146

LOSS OF CONTROL - TAIL STRIKE

ROBINSON R44 RAVEN II (HELICOPTER) C-GNYT
NAHANNI BUTTE, NORTHWEST TERRITORIES, 17 nm W

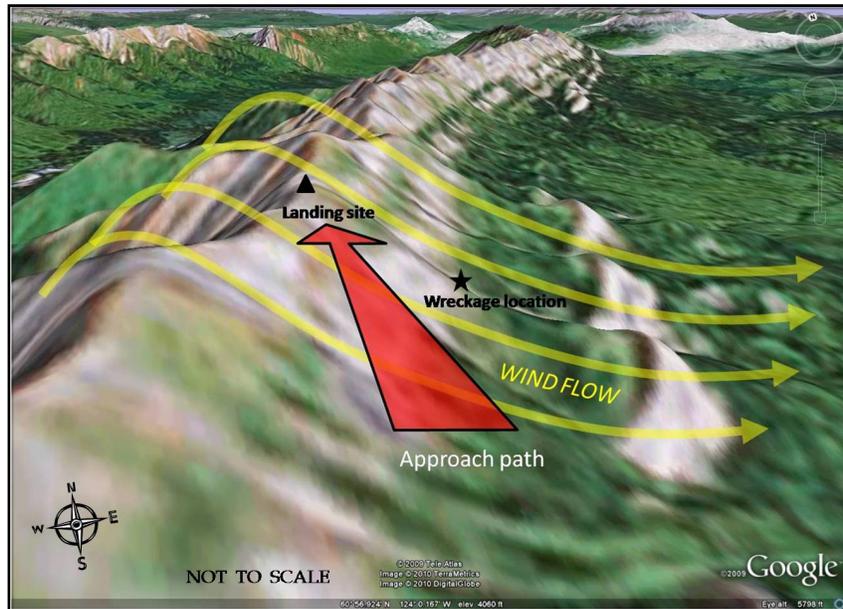
Figure 1. Flight path and wind flow

A light wind striking perpendicular to a ridge line will flow smoothly upslope to the top of the ridge and, after passing the peak, will begin to descend, flowing down the lee slope (see Figure 1). Turbulence can be associated with the transition over the peak. Pilots of aircraft entering the region downwind near a ridge line can expect to use higher engine power settings to maintain altitude in the descending air. It is possible that the power necessary to maintain altitude will exceed that available. Attempts to maintain altitude by increasing rotor pitch can demand engine power beyond the aircraft's capability, resulting in a loss of rotor speed.

Conducting a shallow perpendicular approach on the downwind side of a ridge line exposes a helicopter to subsiding air. This substantially reduces the option of entering a safe drop-off zone in up-flowing air, thus avoiding the need for high engine power.

After overflying the ridge en route to the destination, the helicopter turned for a shallow approach, 60 degrees to the ridge. The shallow approach was part of the recommended technique. The approach path downwind of the ridge, however, would have exposed the helicopter to subsiding air near the ridge. As the helicopter slowed through the speed where effective translational lift was lost before it entered the ground effect on the narrow ridge top, rotor pitch had to be increased substantially, accompanied by an increase in engine power. Since the helicopter's ability to hover out of ground effect was marginal under ideal wind conditions, its ability to do so in subsiding air was substantially reduced.

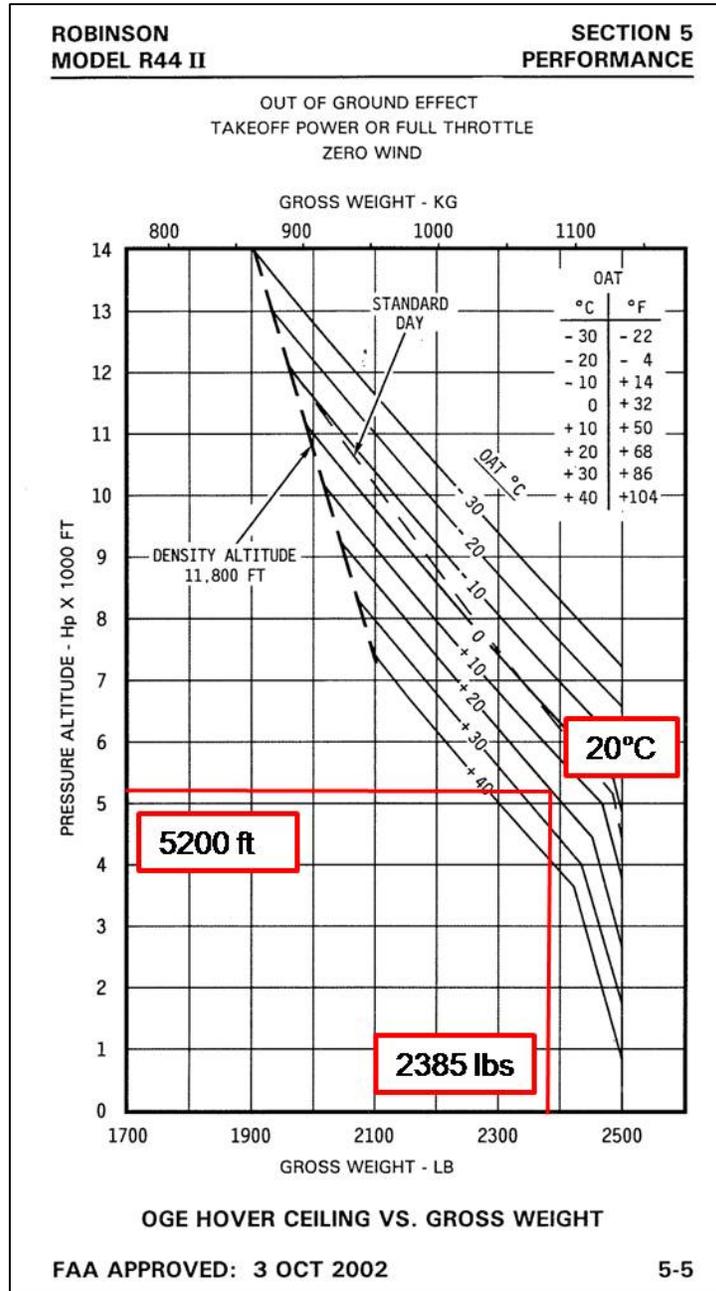
Appendix A – Hover Out of Ground Effect – Robinson R44 Raven II

The engine was developing full available power and no mechanical flight control difficulties were encountered during the occurrence. Performance charts in the pilot's operating handbook indicate that, at 2385 pounds, at 20°C, zero wind and 100 per cent main rotor rpm, the maximum pressure altitude for hover out of ground effect is 5200 feet (see Appendix A). The maximum pressure altitude for hover in ground effect under the same conditions is 8760 feet, which indicates a large difference in power requirements between hover in and out of ground effect. The pressure altitude at the attempted landing site was 5100 feet, where the helicopter would be operating with an out of ground effect margin of 100 feet.
