**AVIATION INVESTIGATION REPORT
A10A0032**

RUNWAY EXCURSION

**CARGOJET AIRWAYS LTD.
BOEING 727-225, C-GCJZ
MONCTON, NEW BRUNSWICK
24 MARCH 2010**

Report Number A10A0032

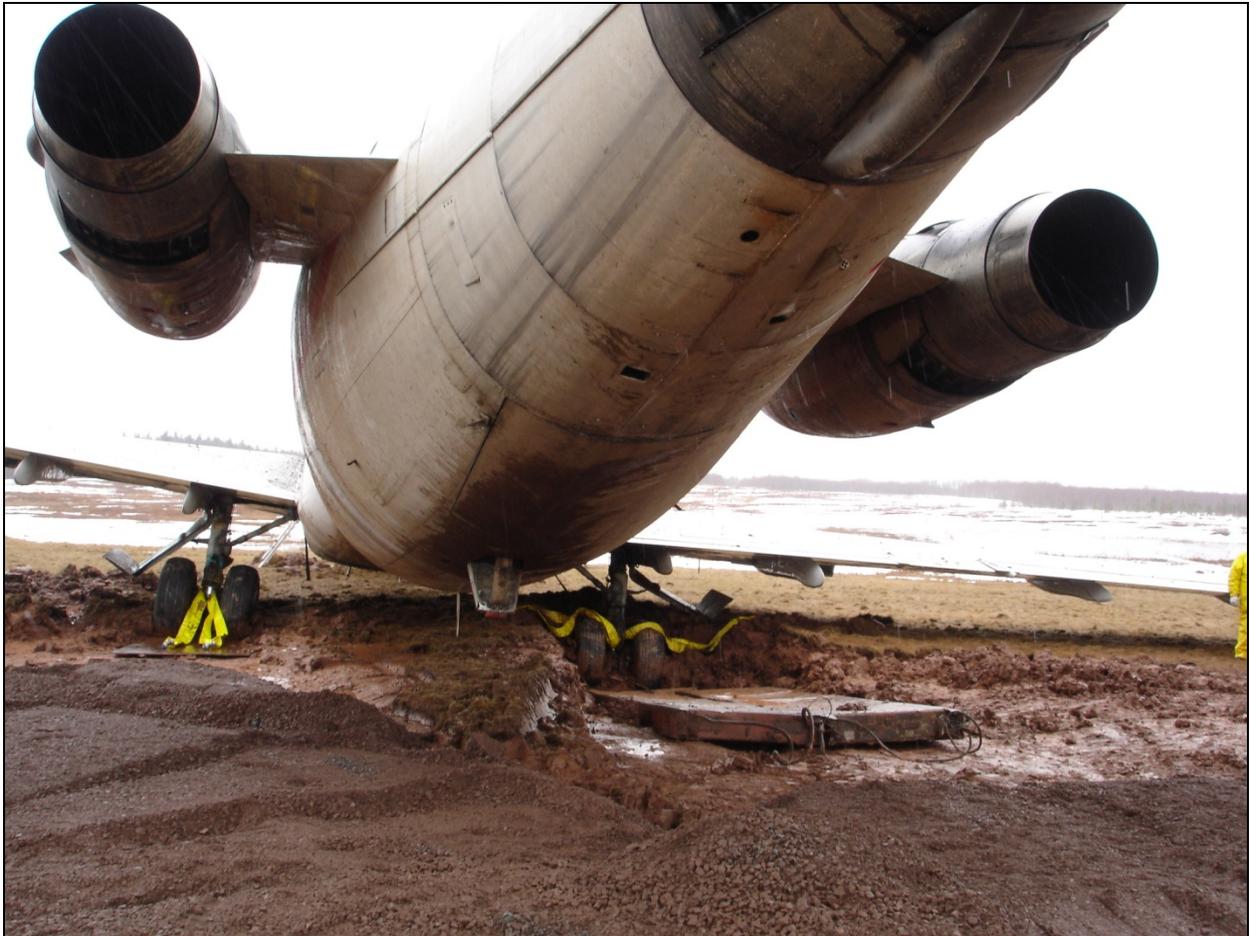
paved surface with an indicated airspeed of approximately 50 knots. The aircraft came to a stop in deep mud approximately 27 seconds after touching down on Runway 06 (see Photo 1). Maximum manual wheel braking was applied shortly after touchdown, and maintained by the flight crew throughout the entire landing roll.

Photo 1. Occurrence Aircraft Stuck in Mud (Photo taken during recovery)

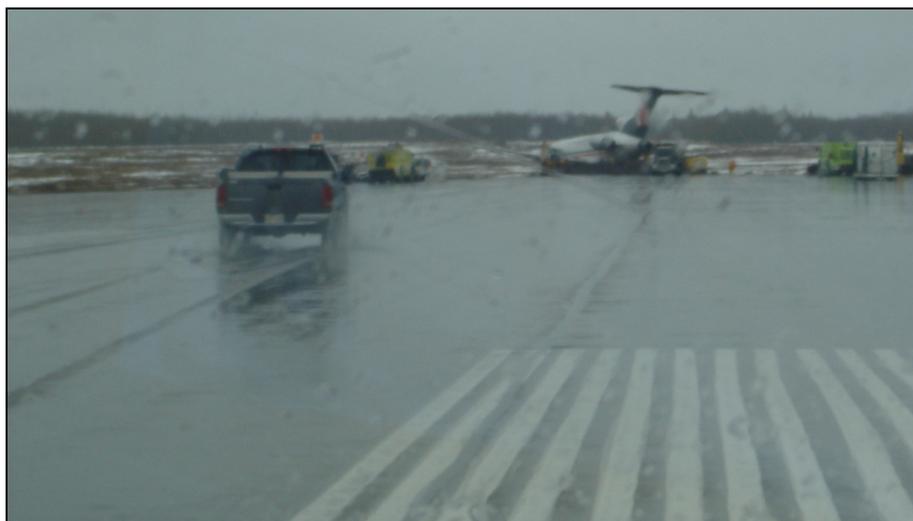
After the aircraft had been shut down, and firefighters were on-scene, standing water ² was observed on Runway 06 (see Photo 2). There was no indication of ice or slush present on the runway surface.

Photo 2. Water visible on Runway 06 (photo taken a few hours after occurrence)

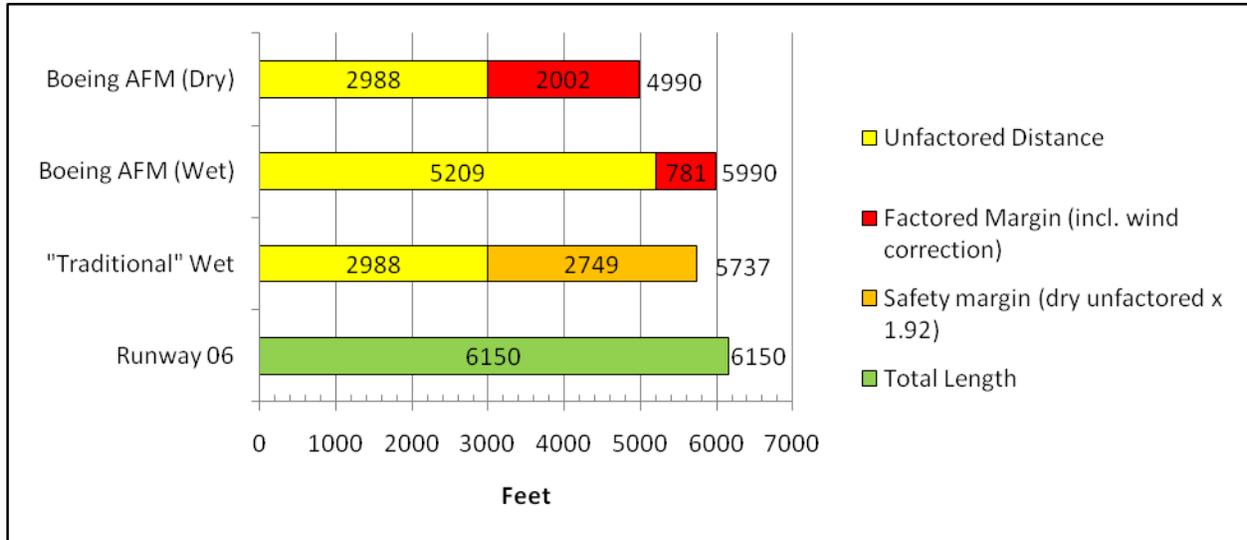
Figure 1. Comparison of AFM Dry/Wet Landing Distances versus Usable Runway (LDA)

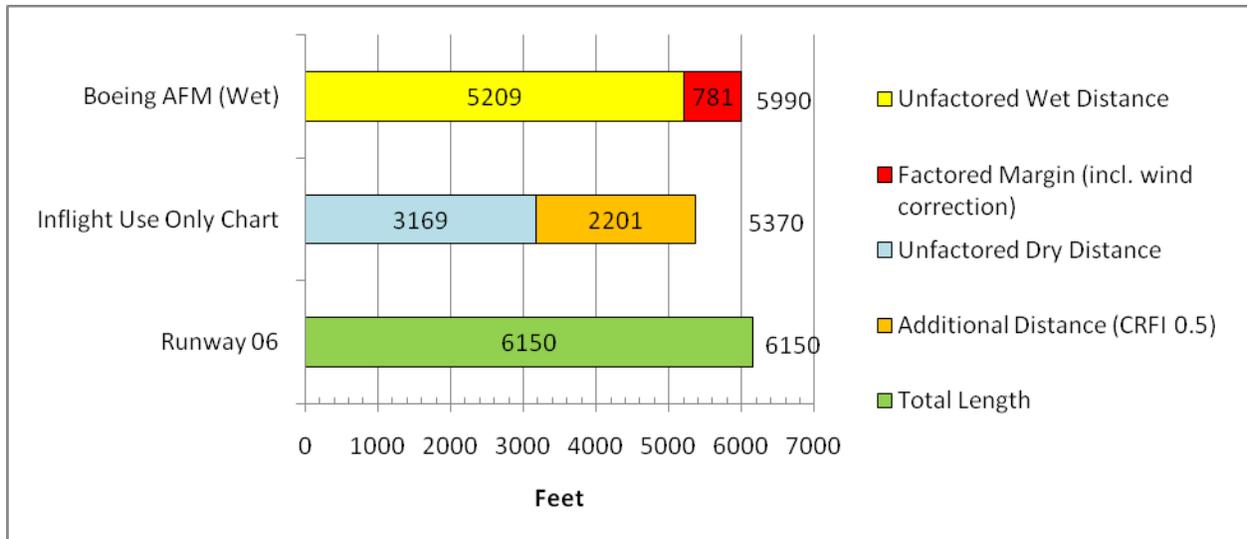
Figure 3. Comparison of AFM versus Cargojet "Landing Distance - Inflight Use Only" chart

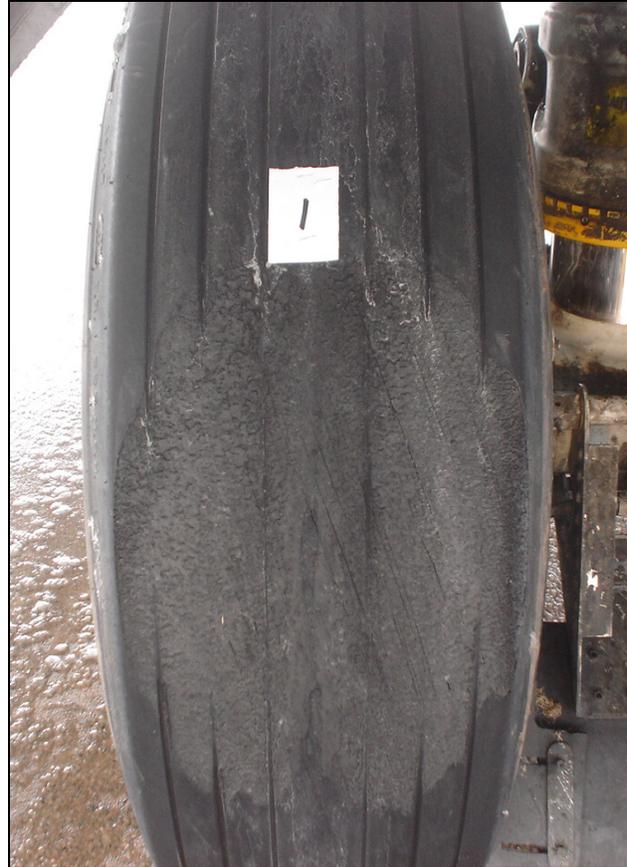
One type of hydroplaning is called reverted rubber hydroplaning, which occurs with a non-rotating or skidding tire on a surface covered with a thin water layer up to and including standing water. The heat generated by this type of hydroplaning can leave steam-cleaned marks on the runway surface and can cause rubber to revert to its original uncured state.

In this occurrence, steam cleaned marks were not detected on the runway after the incident. However, all 4 of the B727's main landing gear tires exhibited damage consistent with reverted rubber hydroplaning (see Photo 3).

Photo 3. Reverted Rubber Occurrence Aircraft Tire

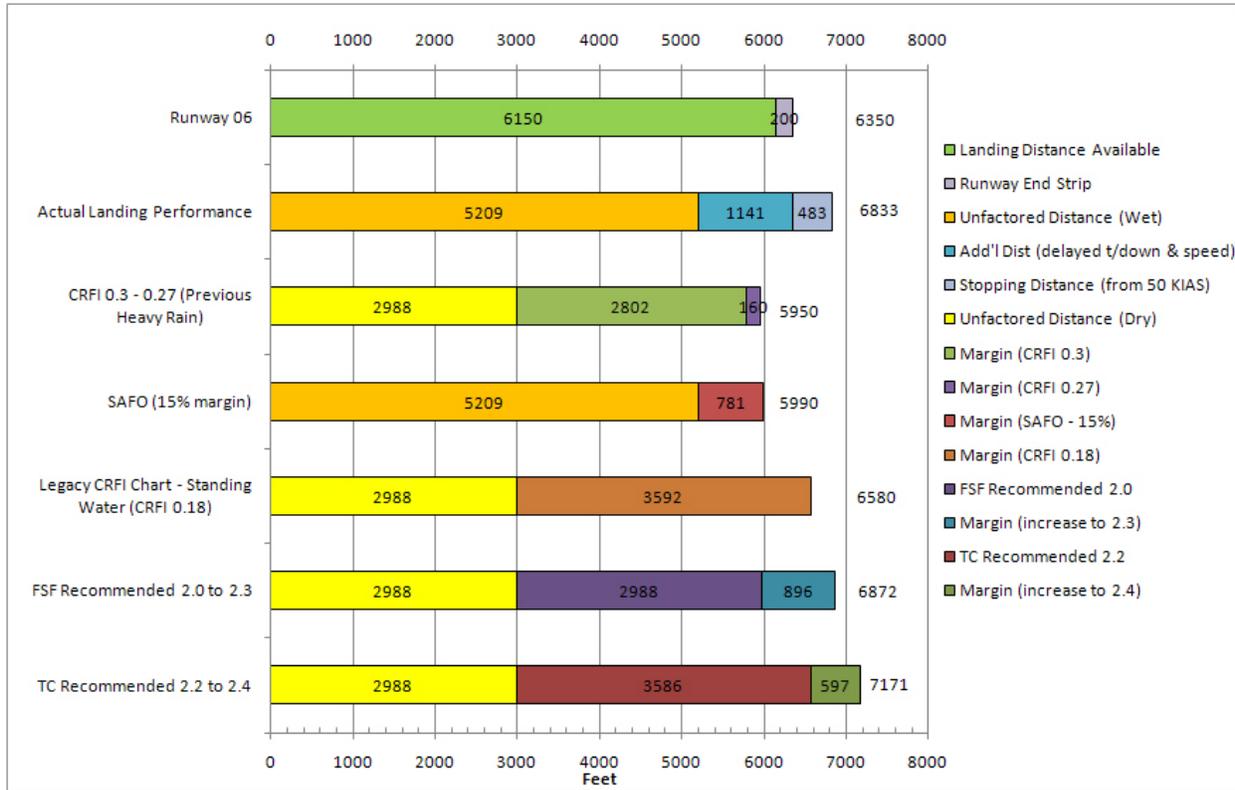
Figure 4 below provides a comparison of the actual landing performance⁶² of the aircraft in this occurrence compared to the calculated landing distances based on the various recommended safety margins suggested by SAFO 06012, the Flight Safety Foundation, Transport Canada, and previous CRFI equivalent values for heavy rain and standing water.

Figure 4. Comparison of Recommended Wet Adjustments to Landing Distance
