**AVIATION INVESTIGATION REPORT
A14O0178**

GEAR-UP LANDING

**AIR CREEBEC INC.
BEEHCRAFT KING AIR A100, C-FEYT
TIMMINS VICTOR M. POWER AIRPORT
TIMMINS, ONTARIO
26 SEPTEMBER 2014**

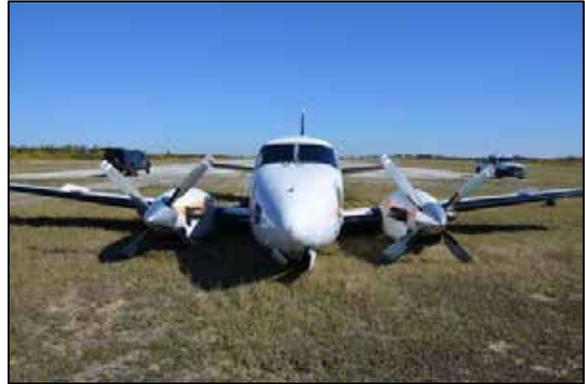
beyond the threshold. It continued down the runway, then slid off the end of the runway, continuing for approximately 40 feet before coming to rest (Photo 1). All of the occupants exited the aircraft through the main cabin door and were met by emergency services. The accident occurred at 1740.¹

Photo 1. Front view of the occurrence aircraft off the runway

The following aircraft components were substantially damaged during the landing:

- Propeller blades
- Engines
- Main and nose landing gear doors
- Flaps
- Underbelly skin and antennas.

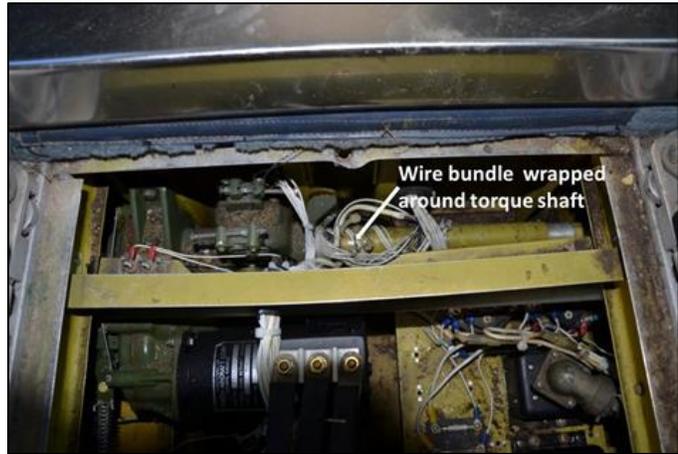
Before the aircraft was removed from the scene, investigators took off the cabin floor panel, which covers the landing-gear motor and transmission. A wire bundle that was routed through the area of the landing-gear motor and transmission had caught on the rotating torque shaft that drives the landing-gear screw jacks to extend or retract the landing gear (Photo 2). As the bundle had wrapped itself around the shaft, it had pulled wires connected to the 2 generator voltage regulators, disconnecting the generator control circuits. One of the voltage regulators had been pulled from its floor mount.

Photo 2. Wire bundle wrapped around the landing-gear torque shaft

During the landing-gear extension, the rotating torque shaft that drives the screw jack actuators to lower the landing gear caught on a wire bundle that is routed through this area. The bundle likely snagged on the torque shaft bolts. As the shaft rotated after “landing gear down” was selected, the wire bundle became entangled around the torque shaft and prevented further rotation of the shaft, which consequently halted the landing-gear extension. The alternate gear extension system uses the same torque shaft system to extend the landing gear, and so it was disabled as well. The crew was therefore required to conduct a landing with only the nose gear partially extended and the main landing-gear doors open.

The wire bundle included wiring for the generator control units. This wiring was sufficiently damaged to disconnect the generator control circuits and illuminate the generator lights on the annunciator panel.

It could not be determined when or how the wire bundle shifted sufficiently to catch on the rotating shaft during the landing-gear extension. Maintenance had been performed previously in this area when the landing-gear retraction motor was replaced, and the wire bundle may have been inadvertently shifted. However, numerous flights and landing-gear cycles had been performed without incident since this maintenance.

1. During the extension of the landing gear, a wire bundle became entangled around the landing-gear rotating torque shaft, preventing full extension of the landing gear.
2. The entanglement by the wire bundle also prevented the alternate landing-gear extension system from working. The crew was required to conduct a landing with only the nose gear partially extended.

After the occurrence, Air Creebec performed its own safety management system investigation, and all findings, and actions taken as a result of findings, were provided to the TSB. As part of its investigation, Air Creebec immediately performed an inspection of its 2 other Beechcraft King Air A100 aircraft, and found no faults. As a precaution, the wiring harnesses surrounding the landing-gear drive shaft were resecured to ensure that there would be no possibility of contact in future operations. The operator also submitted a safety deficiency report to TC and issued an in-house maintenance advisory to its staff to check for proximity of wiring harnesses to surrounding rotating parts. It reviewed all pertinent airworthiness directives, service bulletins and safety communiques, but did not find any information that related to this type of event.

In addition, Air Creebec contacted other operators using the same type of aircraft and made them aware of the potential for this type of event.
