MARINE INVESTIGATION REPORT

M00C0069

BULK SELF-UNLOADER "ATLANTIC HURON"

CANADIAN COAST GUARD SHIP "GRIFFON"

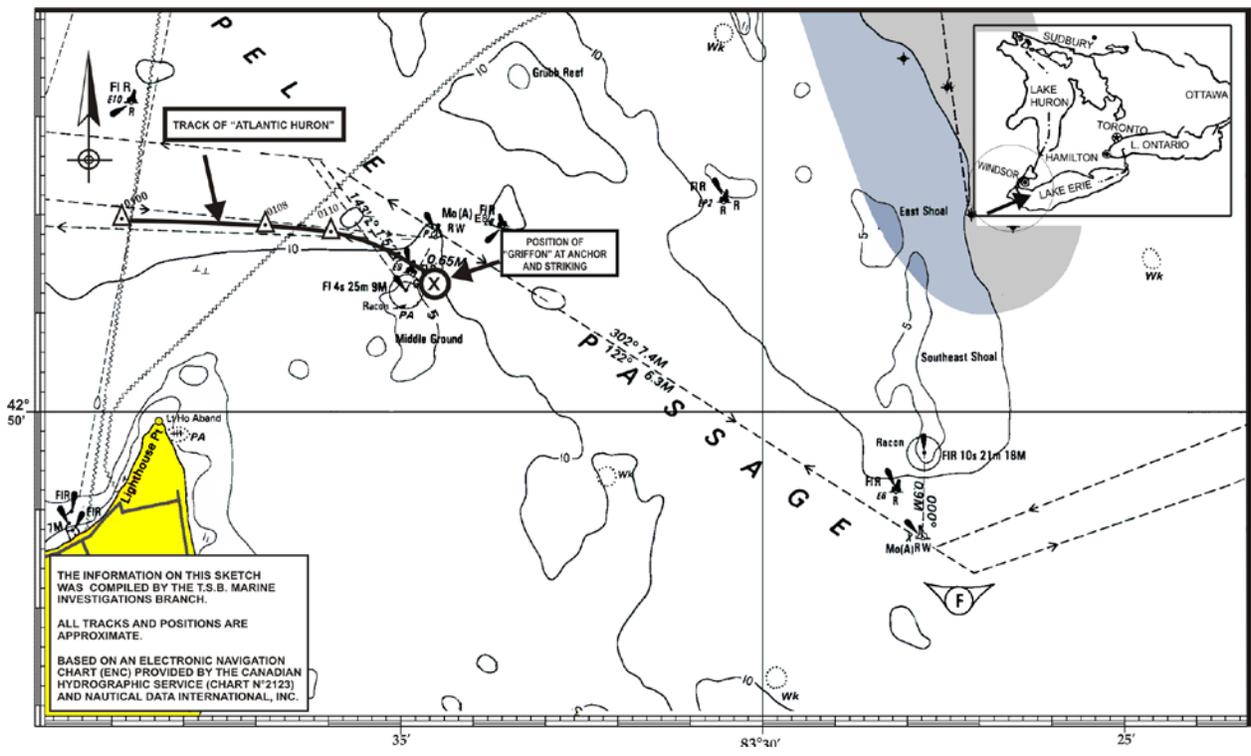
Pelee Passage is the main shipping channel for commercial vessels crossing western Lake Erie (see Figure 1). The fixed light is situated on a pier south of the light buoys at the north end of Middle Ground Shoal and is shown from a circular tower which extends up from a 14-m square helipad. A radar beacon (RACON) is fitted above the light.
