MARINE INVESTIGATION REPORT
M00W0230

FATAL ACCIDENT

FISHING VESSEL – TRAWLER “STAR QUEEN”
FRASER RIVER, BRITISH COLUMBIA
6 SEPTEMBER 2000

Report Number M00W0230

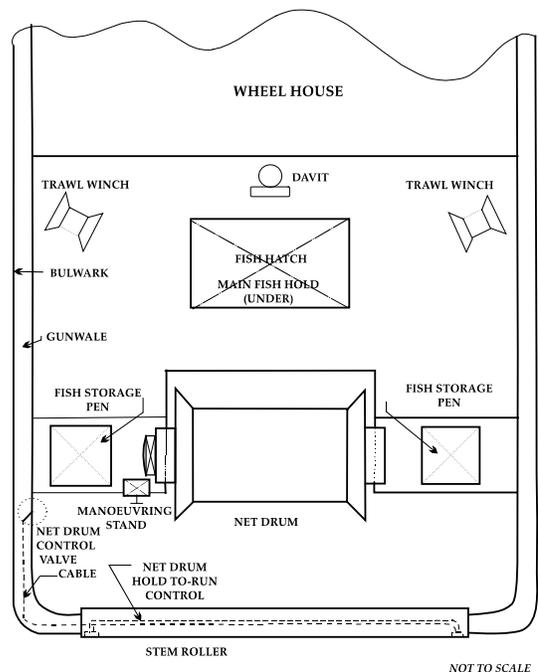
The working deck extends aft from the wheelhouse structure, to the stern of the trawler (see Figure 1). An hydraulically-operated boom is located abaft the wheelhouse, together with two hydraulic trawl winches, one on the port side and the other on starboard. A hatch for access to the main fish (cargo) hold, is located on the centre line, aft of the boom, and an open working space is aft of the hatch. The after deck area, part of which forms a well, is located under the drum of the main net storage winch. A second set of engine and rudder controls, used during fishing operations, are arranged on the port side, outboard of the winch. The control valve and handle to govern the speed and direction of rotation of the main winch motor is arranged under the bulwark on the port quarter.

A remote start/stop device (hold-to-run control) to the hydraulic winch motor is fitted under the bulwark around the stern. All the controls are arranged ergonomically around the operator's stand.
