MARINE INVESTIGATION REPORT

M01W0116

NEAR SINKING

CATAMARAN PASSENGER VESSEL *WASCA II*
WASCANA LAKE, REGINA, SASKATCHEWAN

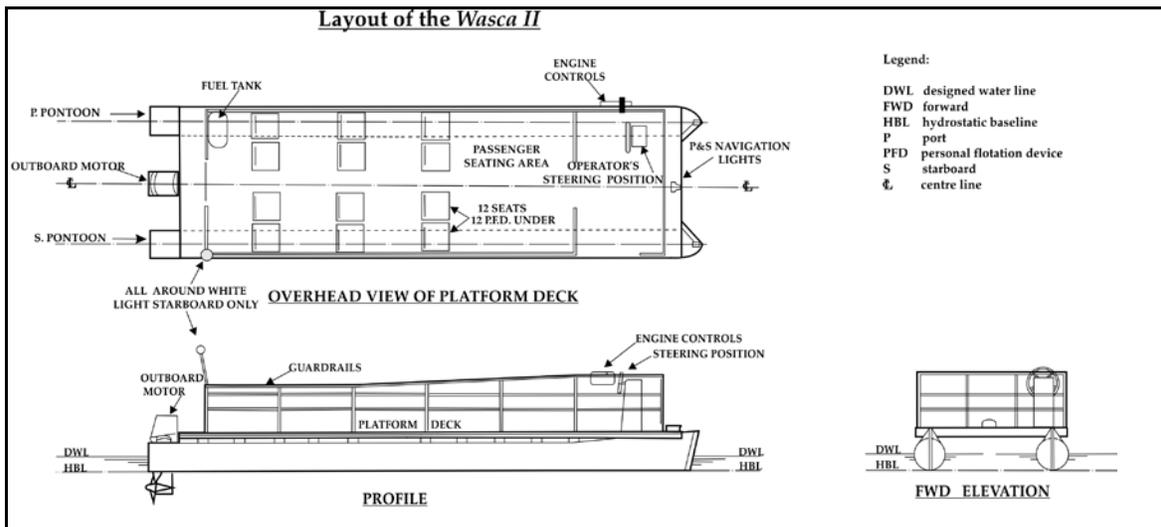
The basic layout of the *Wasca II* vessel is shown in Figure 1.
