MARINE INVESTIGATION REPORT

M03L0124

DOWNFLOODING AND GROUNDING

FISHING VESSEL *EVAN RICHARD*
OFF ANTICOSTI ISLAND, QUEBEC
29 SEPTEMBER 2003

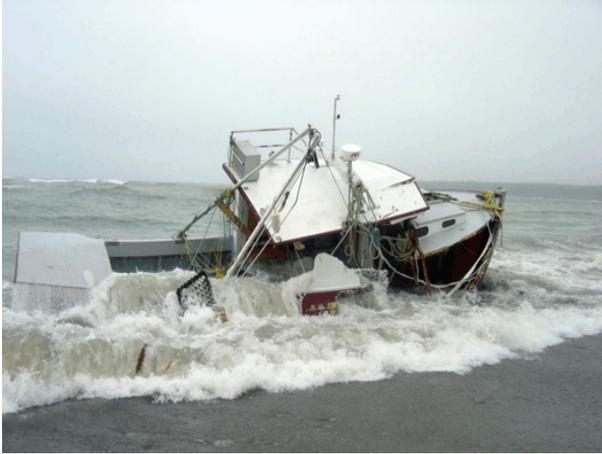
The *Evan Richard* was damaged when it went aground on shore about 3 nautical miles from the position where the Mayday was broadcast. It was completely destroyed by the waves and is now considered a total loss.

Photo 3. The *Evan Richard* on an Anticosti Island beach a few hours after sinking

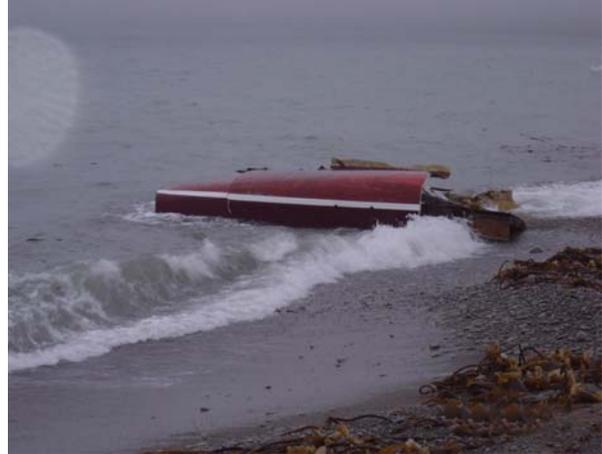
Photo 4. The wreckage of the *Evan Richard* on an Anticosti Island beach on 03 October 2003

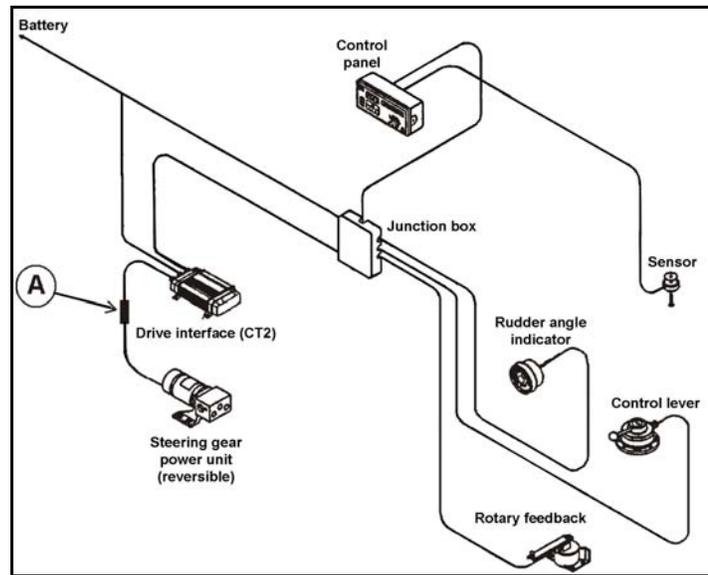
Figure 2. Schematic of power assist electrical circuit on the *Evan Richard*

During the installation, a 20 A fuse was added between the drive interface and the power unit (see "A" in Figure 2). Experience showed that the power unit of the steering gear tended to fail at sea. The fuse was added to limit maintenance and the need to replace this part.

On the sea trials during the days preceding the departure, the master told the technician that the fuse blew several times. Evaluation indicated that the fuse blew when the wheel was held hard right or hard left; the system was not equipped with a limit switch. This caused an overload in the circuit and blew the 20 A fuse. To solve this problem, it was suggested that a different type of power assist be installed, but the master decided to keep the system already installed due to the additional replacement cost.

According to the information received, the steering gear failed when the power assist was used to heave to. Inspection of the power assist circuits revealed that a fuse connected in series between the steering gear power unit and the drive interface had blown.

To protect the power unit of the steering gear from current variations when the system is operating normally, the manufacturer provided 30 A thermal protection inside the drive interface. According to the manufacturer, adding a 20 A fuse (see "A" in Figure 2) does not increase system safety and can even prevent it from operating properly.

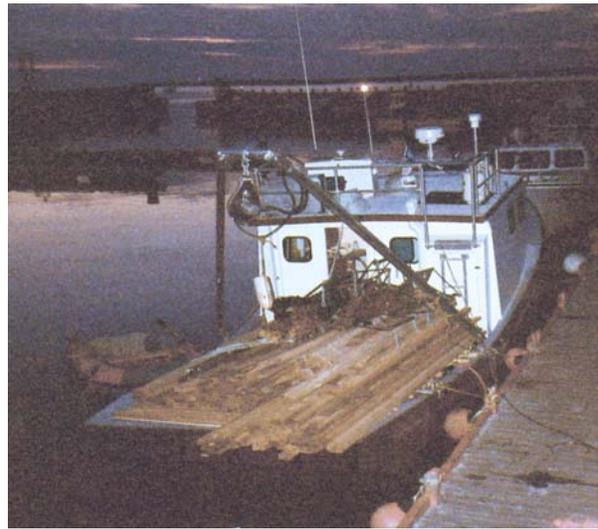
There were no freeboard marks or load lines on the *Evan Richard*. When the boat was loaded, the distance between the surface of the water and the top of the bulwark was some 45 cm (see Appendix A). The scuppers had been blocked with wooden plugs, but since they were not watertight, an electric pump was installed to discharge water from the after deck.

Photo 5. Aft view of the *Evan Richard* with its load prior to departure from Bas Caraquet

The *Evan Richard* had a cargo of some 6570 kg, which was about twice the usual cargo weight at the time. With this cargo, the after deck was approximately 20 cm below the waterline and the plugged scuppers were not watertight (see Appendix A). The electric pump used to discharge water from the after deck had to operate throughout the whole voyage to keep the crew safe.

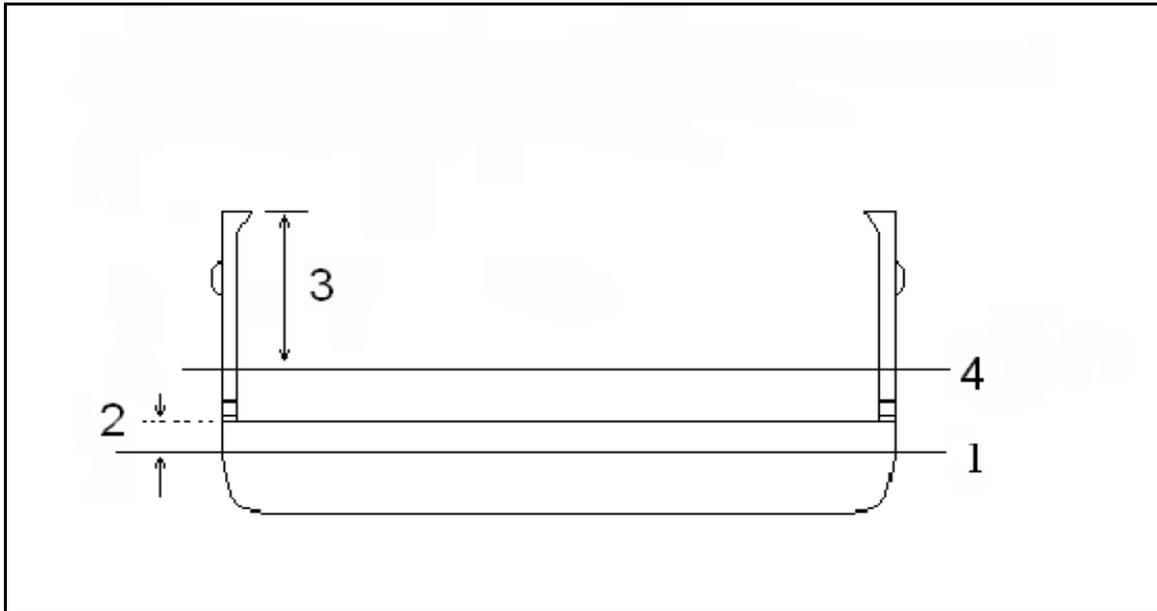
Appendix A – Cross-Section of the *Evan Richard*

Cross-section (not to scale) of the *Evan Richard* aft of the accommodation

1. Waterline in light condition.
2. Distance between waterline and watertight after deck: approximately 10 cm in light condition (not to scale).
3. Distance between surface of water and top of bulwark: approximately 45 cm.
4. Waterline when loaded on departure from Bas Caraquet.
