## MARINE INVESTIGATION REPORT

M04M0013

### FURNACE EXPLOSION - STARBOARD AUXILIARY BOILER

RO-RO PASSENGER FERRY *CARIBOU*

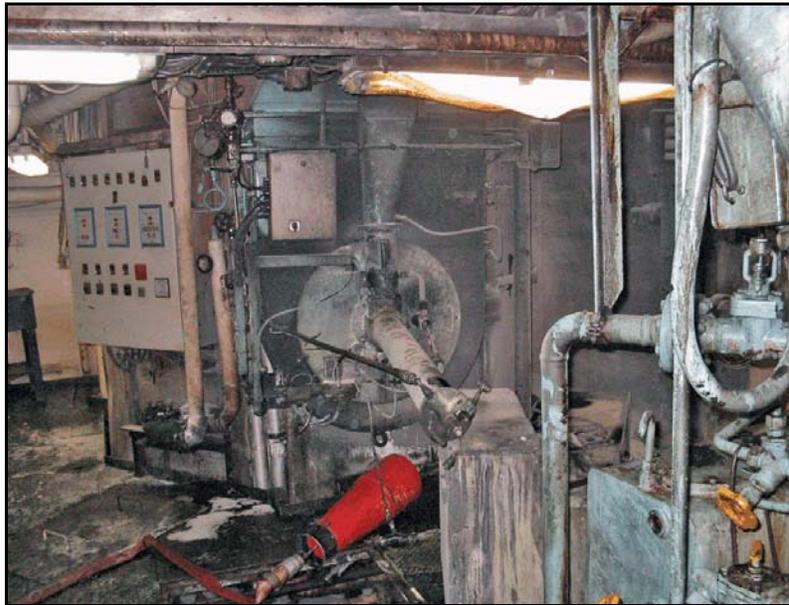
**Photo 2.** Starboard auxiliary boiler

Damage was confined to the starboard auxiliary boiler. The four securing dogs on the boiler burner assembly door were sheared off. The main and pilot burner tubes, as well as the tertiary air register, were dislodged. The linkage to the main burner air regulator was severed, and the fire bricks lining the floor of the boiler were severely disturbed. Electrical wiring aft of the starboard boiler suffered fire and heat damage.

- The starboard auxiliary boiler was fitted with a new burner unit under the supervision of a factory service engineer.
- The port auxiliary boiler was adjusted to the manufacturer's specification by a factory service engineer.

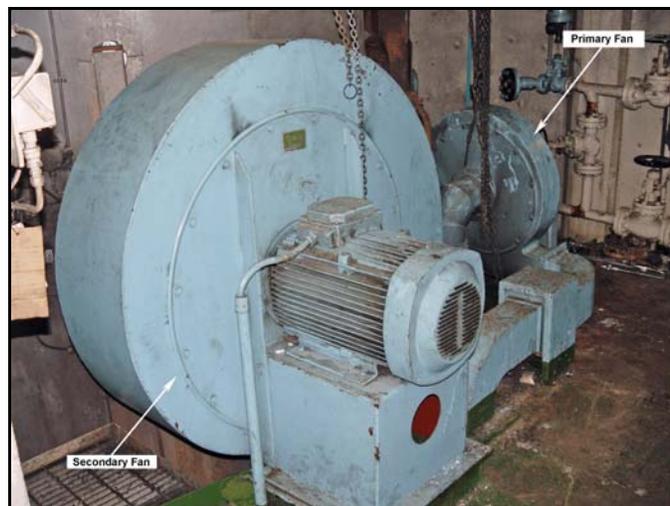
**Photo 3.** Primary and secondary fans

air fan that further raises the pressure of the air so that it will provide sufficient energy to atomize the fuel oil.<sup>7</sup> The primary fan also supplies combustion air to the pilot burner assembly (see Photo 3).

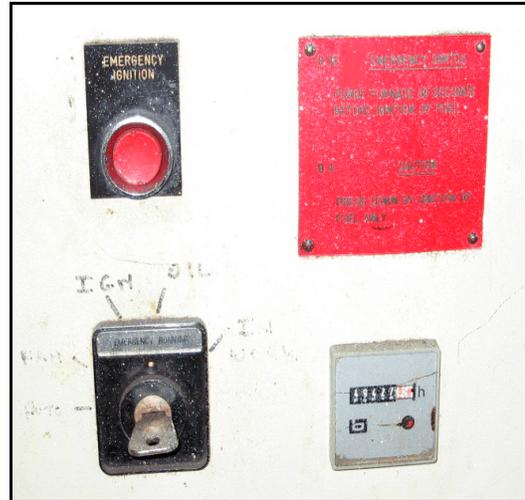
In the event that the automatic oil burner control fails, the boiler can be fired in an emergency mode of operation using a keyed switch (see Photo 4). Unlike firing the boiler using the oil burner control, all steps essential to firing the boiler are carried out manually, and all safety devices, including the flame monitoring device, are bypassed.

Photo 4. Emergency key switch

The emergency running switch, as its name implies, is to be used only in an emergency or when carrying out tests on the boiler. Since its use must be carefully controlled, it is fitted with a key. Despite the danger associated with unauthorized use of the emergency running switch, the key was left in the switch. After the occurrence, considerable resistance was felt as the key was removed from the switch. This, coupled with signs of corrosion, indicates that the key had not been recently removed from the switch.

1. The key to the emergency burner control switch was stored in the switch.
2. Clothing worn by the chief engineer and senior chief electrical officer had no flame-retardant properties and offered no protection against the flame fronts of the explosions. This contributed to the severity of the chief engineer's injuries and exposed the senior chief electrical officer to the risk of sustaining more extensive and serious injuries.
3. The protective clothing supplied to the crew by the owners was inconsistent with the crew's risk profile.

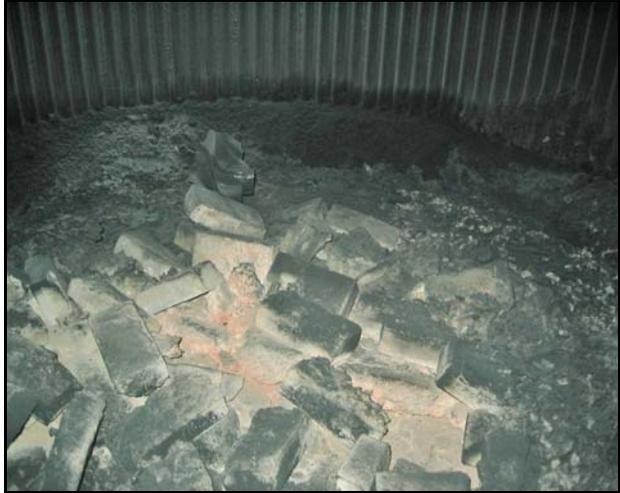
The force of the explosions was greater than the boiler burner assembly door could withstand; the four securing dogs were sheared off, and the burner was partially opened. The force of the blast also dislodged the main and pilot burner tubes, and the tertiary air register, and severed the linkage to the main burner air regulator. It was also of sufficient magnitude to disturb the fire bricks lining the floor of the boiler (see Photo 5).

Photo 5. Internal damage to starboard auxiliary boiler

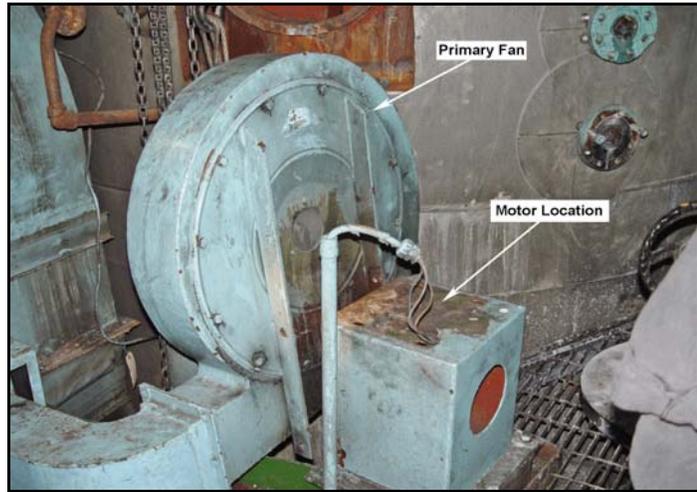
At the time of the occurrence, the electric motor for the primary fan was still ashore for repairs, and the starboard auxiliary boiler was being operated without it (see Photo 6). This resulted in less than adequate atomization of the fuel from the main burner and an unstable main flame. It would also cause large droplets of unburned fuel oil to carry over and accumulate in the secondary and tertiary register air boxes, as well as in the combustion chamber.

**Photo 6.** Primary fan with motor removed

Although the primary fan motor on the mechanically-defective port boiler was available, it was originally hoped that repairs to the port boiler would have been completed sooner than they ultimately were. Consideration, therefore, was not given to having it replace the missing motor on the starboard unit. The functioning of the primary fan is essential to safely operate the boiler.

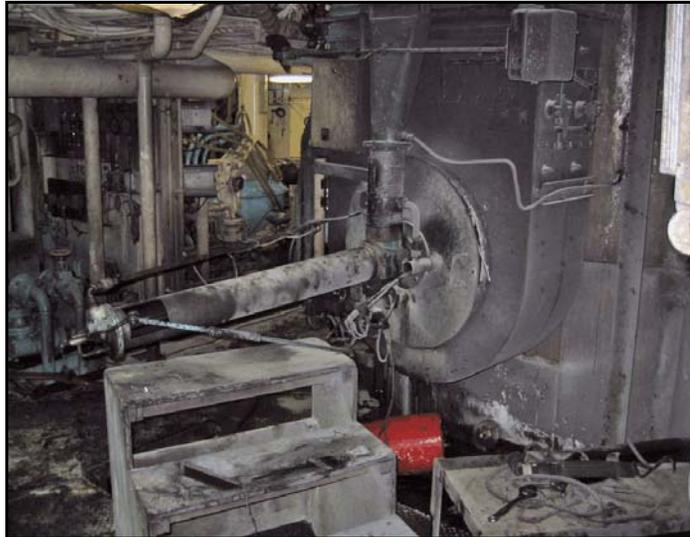
When the chief and second engineers left the starboard auxiliary boiler, the main power switch was left in the ON position, the emergency running switch was in the automatic position, and the hand-auto switch was either in the automatic or in the manual position. Therefore, it is likely that soon after the emergency running switch was switched to automatic, the oil burner control commenced a normal start-up cycle. The first furnace explosion was the result of the ignition and instantaneous combustion of a flammable air-fuel mixture that had carried over from the secondary and tertiary register air boxes and had accumulated in the combustion chamber and uptake. The likely source of ignition was the pilot burner ignitor. The second and third explosions were most likely secondary (tertiary) explosions.

**Photo 7.** External damage to starboard auxiliary boiler

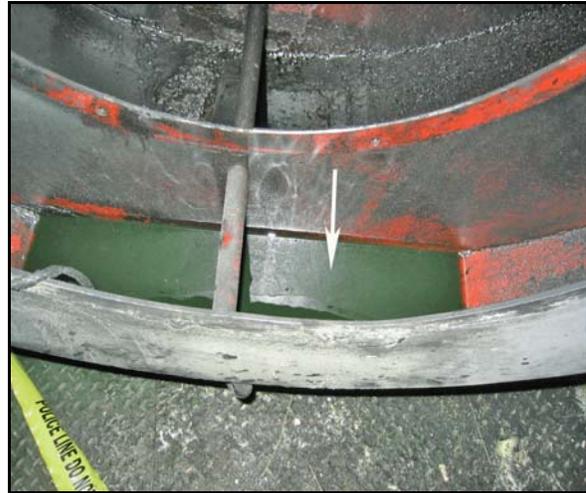
The cause of the fires that followed each of the three furnace explosions were likely the result of the ignition of the fuel oil that had pooled in the secondary and tertiary register air boxes and its subsequent discharge out of the boiler during each explosion (see Photo 8).

**Photo 8.** Pooled fuel oil in air boxes
