MARINE INVESTIGATION REPORT

M09W0141

TUG GIRDING AND CAPSIZING

TUG *NORTH ARM VENTURE* WHILE TOWING THE BARGE

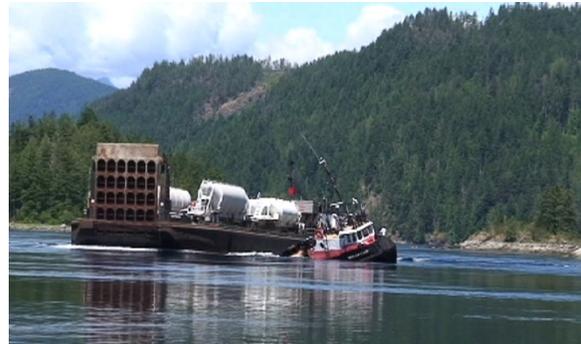
Pulled starboard by the force from the towline, the tug girded on its starboard side (see Photo 2) and quickly capsized at approximately 1250 in position 49° 44.5' N, 123° 54' W.

Photo 2. Tug in early stages of girding. ⁷

With the tug on a heading of approximately 136° True (T), and the barge on approximately 220° T, and given the shortened towline, the barge quickly covered the distance to the tug's stern at an approximate right angle. Although the shortened towline was intended to improve manoeuvrability, with the vessels in this position, it pivoted such that its force was acting athwartships on the tugboat, and no longer directly behind it. This resulted in the tug capsizing to starboard.

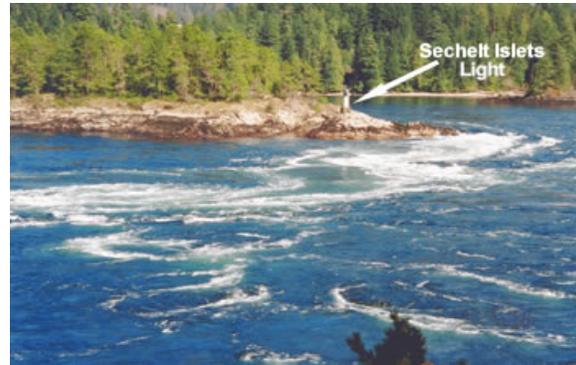
The strongest ebb stream occurs just west of Sechelt Islets light (see Photo 3), with a strong cross-channel set towards the west-northwest. A large back eddy occurs to the north of the light, and whirlpools form close to the light.

Photo 3. Sechelt Rapids looking southeast at maximum ebb tide

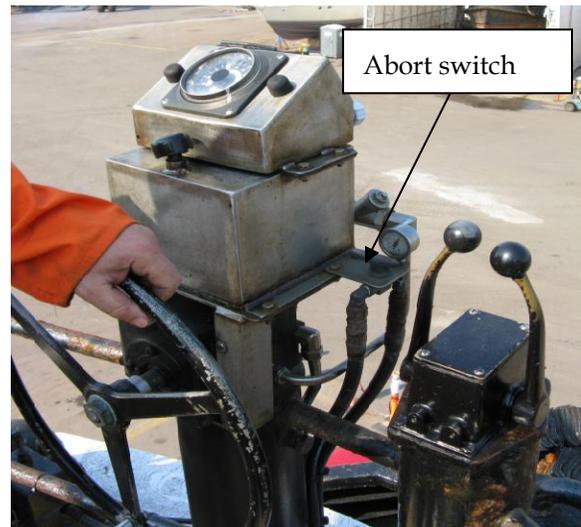
The *North Arm Venture* was fitted with an abort switch that could be activated from any of the vessel's three steering positions and could be reset after activation to stop the full length of the tow line from running off the drum (see Photo 4).

Photo 4. Abort switch on top of wheelhouse

In this occurrence, the abort switch had been tested prior to departure and was readily available to anyone at either steering station and at the towing winch.
