**MARINE INVESTIGATION REPORT
M10C0092**

**CONTACT WITH ICE AND
SUBSEQUENT MECHANICAL FAILURE**

**CABLE FERRY *ECOLOS*
OTTAWA RIVER
NEAR ROCKLAND, ONTARIO
09 DECEMBER 2010**

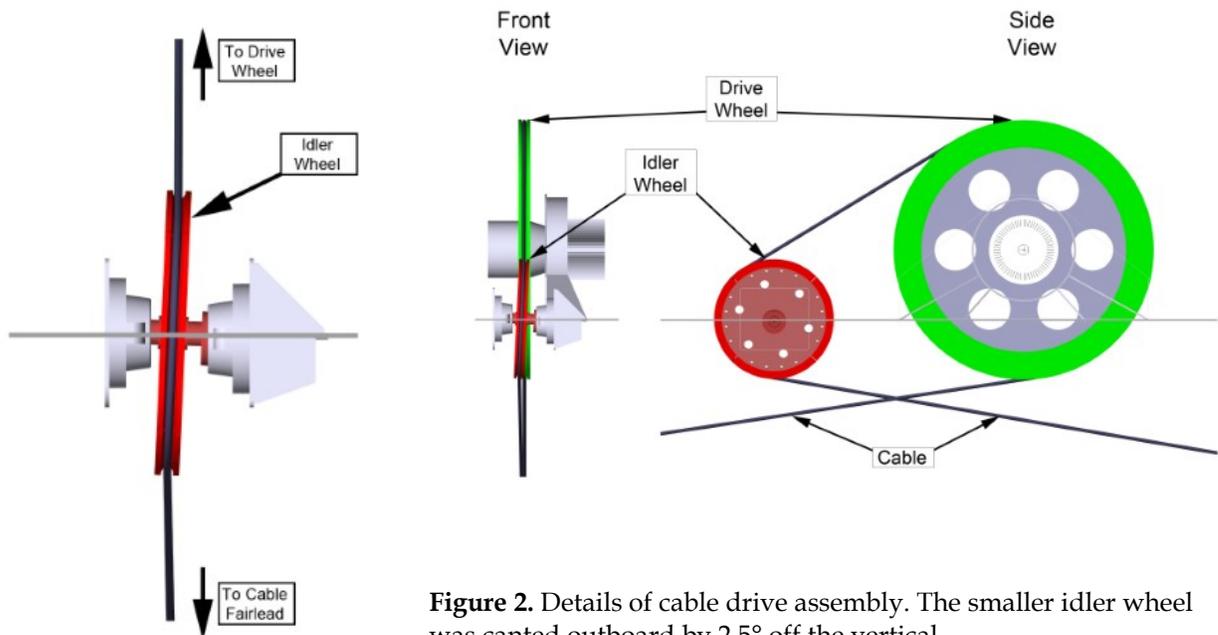
Figure 2. Details of cable drive assembly. The smaller idler wheel was canted outboard by 2.5° off the vertical.

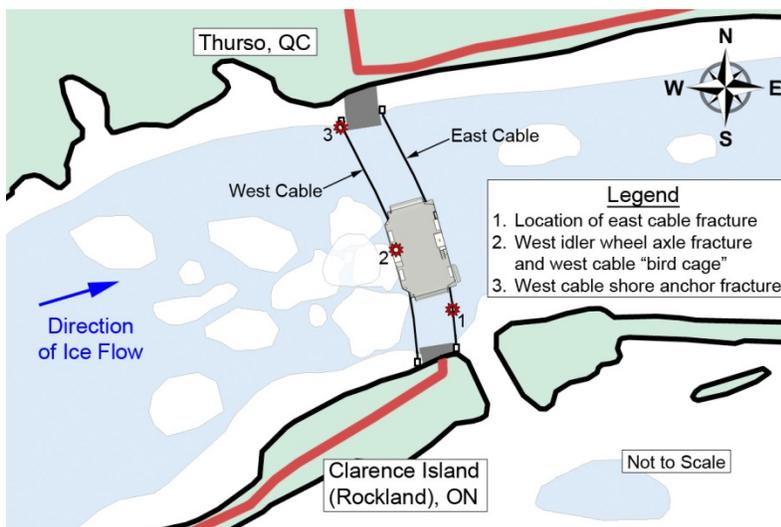
Figure 3. Location of failures. The failures were nearly simultaneous.

The west (upstream) idler wheel shaft had sheared off and the west cable was “bird caged”⁶ in way of the deck structure. The east drive assembly was intact. Around the same time, the east cable parted and unspooled from the drive system. Finally, the north shore attachment (at Thurso) on the west cable failed.

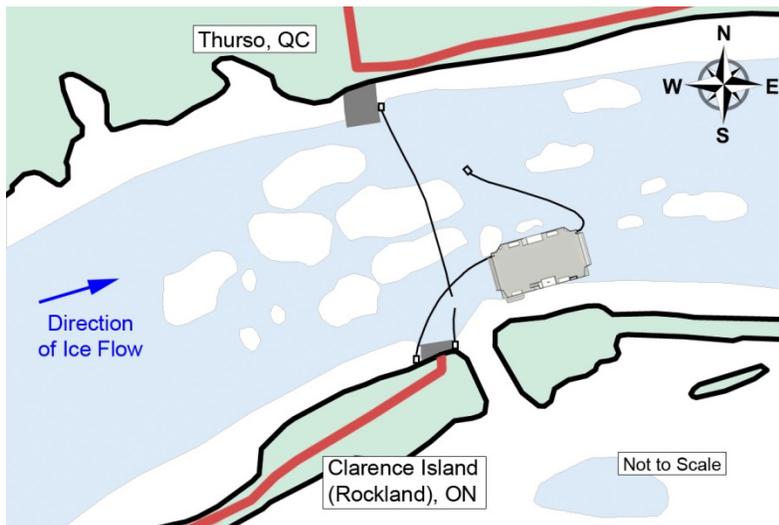
Figure 4. *Ecolos* position after failures; the ferry remained tethered only by the west cable.

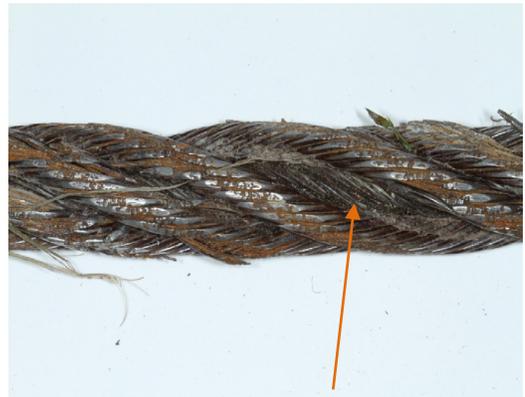
In April 2010, the east cable had been replaced at the start of the operating season. It was scheduled for replacement before the start of the 2011 season. Examination and testing by the TSB¹¹ revealed that the overall condition of the east cable in the service portion was poor, showing extensive wear with complete loss of galvanization and several broken strands. The residual strength of the cable was approximately 25% of its original strength. The east cable had deteriorated to the point that entire strand sections were missing near the point of failure. At the time of the occurrence, all 10 of the outer wires of each strand had been worn through or fractured. The east cable failed under relatively low stress with no strand deformation.

Photo 2. A section from the east cable showing the core strand exposed due to a missing strand

Cable manufacturers recommend that a wire cable be replaced when the outer strands are worn to a 1/3 of their original diameter. After one season of service, all of the external strands of the east cable were either worn through or fractured due to friction with the undersized fairlead rollers. The east cable had a residual strength of 25 000 pounds and the normal operating load of the cable was calculated at 3100 pounds. Thus, even badly worn, the east cable's residual strength exceeded the expected design operating conditions by a factor of 8.

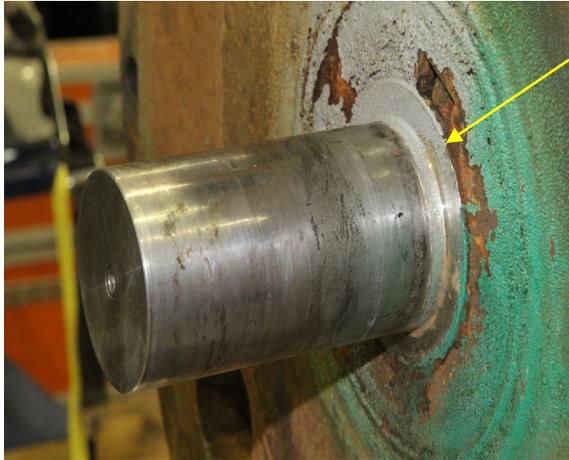
Photo 3. The outboard end of the east idler wheel axle; note the stepped section (arrow)

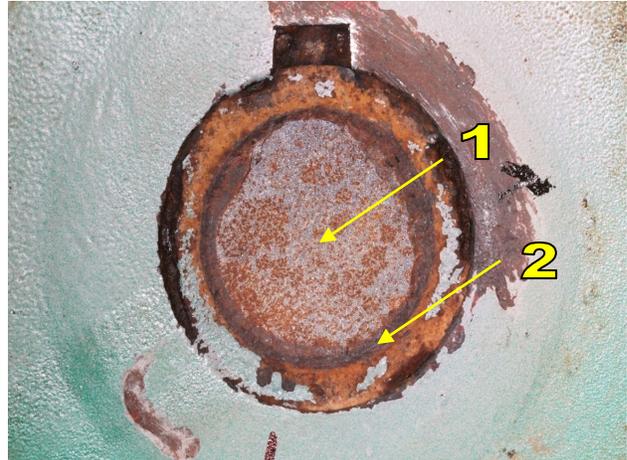
The west idler wheel axle had failed at the outboard and inboard change of radius on both sides of the wheel. This was due to the overstress extension of pre-existing fatigue cracks. Examination of the failed idler wheel axle revealed other factors that may have contributed to its failure. The axle diameter was 10.6 cm inside the idler wheel and stepped down to 7.62 cm inside the bearings, located on either side of the wheel. The investigation determined that the 1/32 inch fillet radius between the large and small diameter cross-sections of the failed axle generated a local stress concentration. Surface conditions such as sharp edges or fillets, surface flaws and roughness reduced the fatigue limit by acting as stress risers.¹² The material of the failed idler wheel axle was low alloy steel, which had a lower ultimate tensile strength than the stainless steel axle in use on the drive wheel. Therefore the fatigue resistance of the failed west idler axle was approximately one-third that of the intact east idler axle.¹³

Photo 4. A close-up of the outboard end of the fractured west idler wheel axle, after cleaning
1. Overstress failure (90%)
2. Fatigue cracking around the periphery at the change of cross section. The corrosion indicates that the cracks had been present for some time.

The west idler wheel had pre-existing fatigue cracks which penetrated to a maximum of 25% of the surface area. The mode of failure for the idler wheel axle was primarily overstress caused by the increased tension in the cables that was caused by the force of the current pushing the ice against the ferry. The design of the axle may have contributed to the existing fatigue crack. Also, the change of section and the small fillet radius acted as local stress risers. Once the west idler wheel axle failed, the west cable bent against the deck structure and birdcaged.

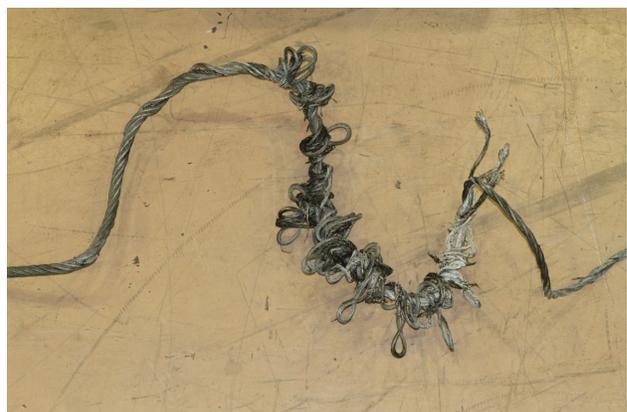
In August 2010, the west cable had been replaced halfway through the operating season. When the idler wheel axle failed, the west cable was no longer supported by the idler wheel. Its tension increased as it was bent against the tight radius of the deck structure when the vessel was pushed downriver by the force of the build up of ice against the upstream side of the hull. Examination of the cable showed that it had not completely failed but was reduced from 6 outer strands and the core strand to only 3 outer strands.

Examination of the failed strands showed primarily tensile failure. The strength of 3 sample sections of the intact cable was equal

Photo 5. Section of west cable showing "bird cage" and the reduction of the cable from 6 strands and core, down to 3 strands

to or greater than the cable's nominal strength of 100 000 pounds.¹⁵ The west cable had recoiled on itself as the fractured strands "bird caged," which is consistent with failure under high tensile stress. Little wear or corrosion was observed on this cable.

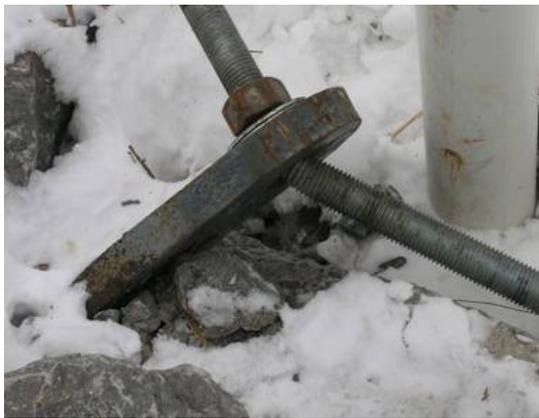
Field examination of the west cable's south shore attachment (at Clarence Island) showed that it had also experienced high tensile loads. The threaded shore attachment rod was bent and the attachment plate, fabricated from thick plate material, had been plastically deformed toward the river.

Photo 6. Close-up of deformation to the west cable, south anchor assembly; this shore attachment did not fail

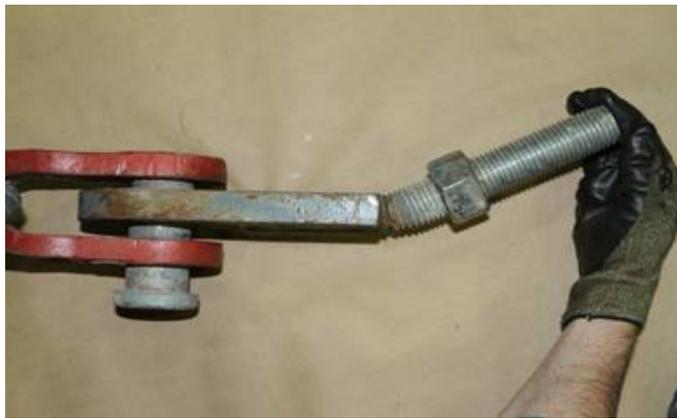
The west cable's attachment to shore at Thurso had fractured and was found in the snow approximately 3 m from its original location, consistent with failure under tension. The recovered shore attachment had failed at the point of a change in cross-section where the threaded rod had been welded to a piece of plate. Matching the fracture surfaces showed that the shore attachment had been heavily deformed before failure with no indication of pre-existing cracks.

Photo 7. West cable, north anchor showing approximate deformation in the downriver direction before fracture

The north shore attachment failed under high tension. It had no pre-existing faults and was found in the snow approximately 3 m from its attachment point. This indicates that the cable ferry drive system experienced higher than normal forces due to the flowing ice.

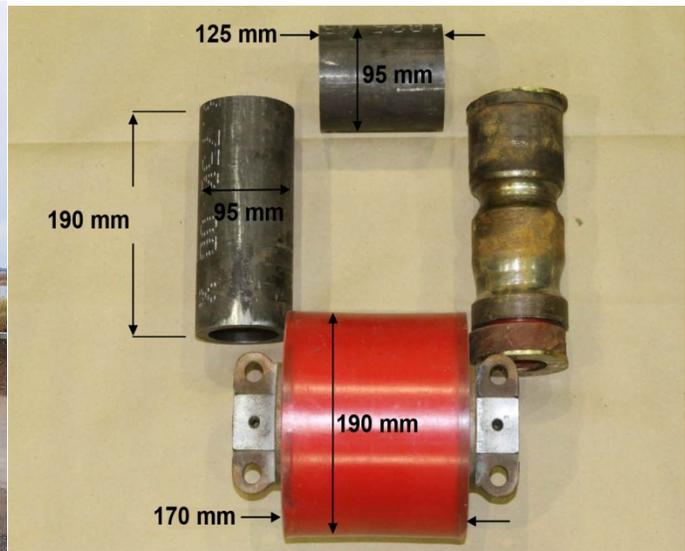
Photo 9. Roller fairlead assembly showing top, side and bottom rollers; note that the right side roller (upstream roller) is used while the others are new

The upstream rollers were replaced approximately every month while the other rollers were replaced every couple of years, depending on the level of wear. Roller wear on a cable ferry is dependent on the roller's location; upstream rollers tend to wear more quickly due to the friction caused by the cable that is in near constant contact with the surface, and is dependent on the water level of the river; higher water levels cause faster currents, pushing the vessel further downriver and hence off its track, thus increasing the angle of the cable entry/exit onto the roller.

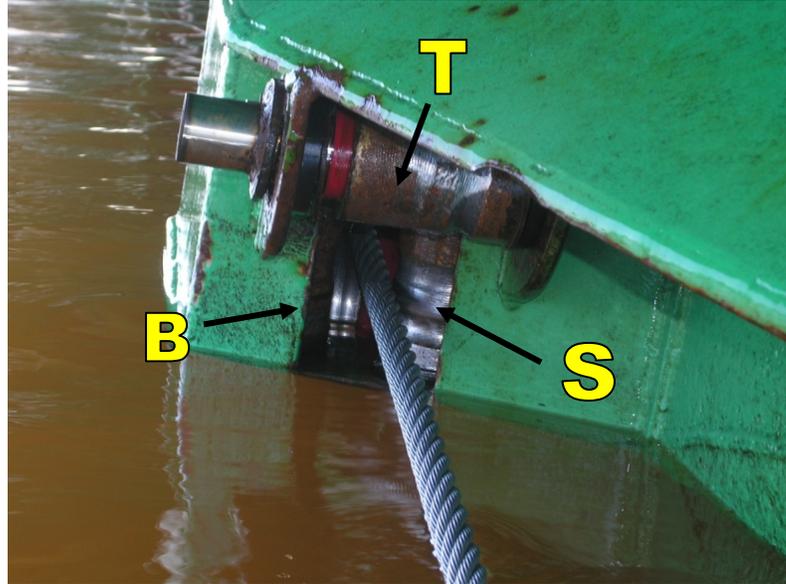
There is a suggested minimum recommended diameter size roller for each diameter of wire cable. The cable in use, 6 x 26 Warrington seal independent wire rope core (IWRC) 2.54 cm (one inch) wire cable, should be used with a 76.2 cm (30 inches) minimum diameter roller.¹⁶ Fatigue breaks may occur whenever a cable bends, especially when the minimum diameter is smaller than that suggested. A smaller diameter roller does not adequately support the cable and increases contact pressure. On the *Ecolos*, the fairlead rollers were of a smaller size (10.16 cm/4 inches) than the suggested minimum (76.2 cm/30 inches) and thus rotated more slowly than the speed of the steel cable, even though they were adequately lubricated.

Photo 10. Close-up of south west roller fairlead assembly showing roller wear; the top (T), one of the side (S) and bottom (B) rollers are visible

As a result of travelling over the smaller rollers and working at an angle, after a full season of service, the external strands of the east cable exhibited wear. The use of undersized rollers is not uncommon, nor is the bending stress, to which the ferry cable is subjected. Information obtained by the TSB during the investigation indicated that many cable ferry operators, including the *Ecolos* operator, make provisions during the construction and the operation of the ferry to allow for accelerated cable wear. This practice is both common and acceptable within the cable ferry industry.
