MARINE INVESTIGATION REPORT

M12W0054

CAPSIZING AND GROUNDING

**SMALL FISHING VESSEL *JESSIE G*
OFF CAPE BEALE, VANCOUVER ISLAND,
BRITISH COLUMBIA
04 MAY 2012**

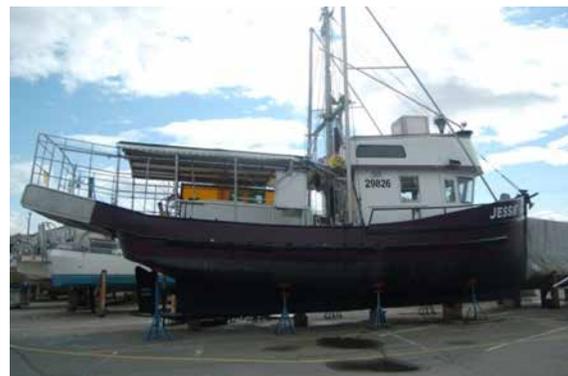
The *Jessie G* was a small fishing vessel of closed wooden construction (Photo 1) built in 1951 as a West Coast salmon troller/seiner. Its original configuration had been modified several times to meet various operational needs. The original hull had been covered over with fibreglass, and the original main deck had been covered with aluminum plating. The helm station, galley, and dinette were located forward of amidships in the aluminum deckhouse on the main deck. The bridge deck, located above the deckhouse, contained 4 crew bunks. The bunks were also accessible from inside the deckhouse.

Photo 1. *Jessie G* dry docked in Steveston, BC.

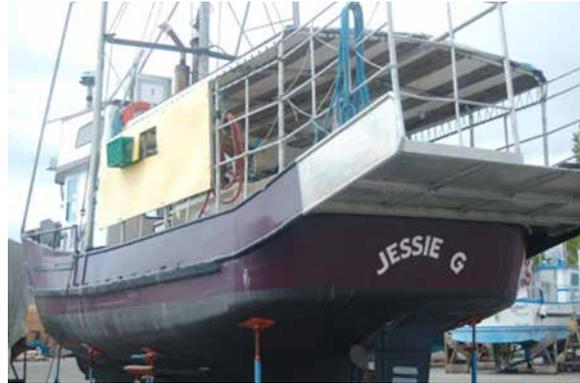
A stern platform extended the main deck by 1.83 m. The main deck was surrounded by solid aluminum bulwark and the aft main deck was encompassed by an aluminum cage. The port-forward half of the cage consisted of a solid weather guard. Approximately three-quarters of the cage roof was covered by a tarp reinforced with wooden planks (Photo 2).

Photo 2. Stern platform, aluminum cage, and weather guard.

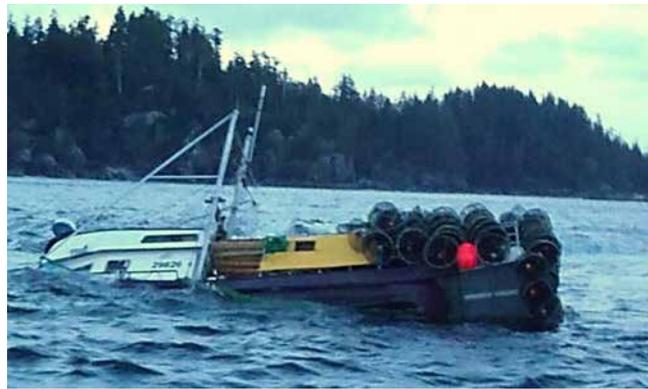
While the crew stood on the port side, the vessel continued its starboard roll onto her beam ends in position 48°47.18' N, 125°13.76' W (Appendix A). All of the crew members had donned PFDs except for the engineer, who had located and donned his immersion suit. The 6 m aluminum skiff remained lashed to the roof of the aluminum cage. While some crew tried to free the skiff, others attempted to make a raft by tying prawn bladders together in preparation to abandon the vessel.

Photo 3. *Jessie G* grounded off Cape Beale.

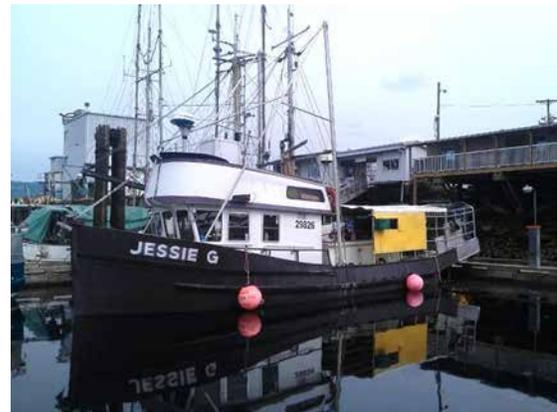
Photo 4. *Jessie G* moored, April 2012.

When the new owners launched the *Jessie G* in Steveston in March 2012, it had an estimated 18 cm of freeboard (Photo 4). Before departure to the fishing grounds on the morning of the occurrence, the vessel's freeboard was reduced to an estimated 7.5 cm. Just prior to the occurrence, the freeboard was further reduced by the prawn catch, the water retained in the gear, as well as the water that had shipped on deck.
