**MARINE INVESTIGATION REPORT**  
**M13L0055**

**ACCIDENTAL DEATH**

**BULK CARRIER *FEDERAL YOSHINO***  
**BAIE-COMEAU, QUEBEC**  
**08 MAY 2013**

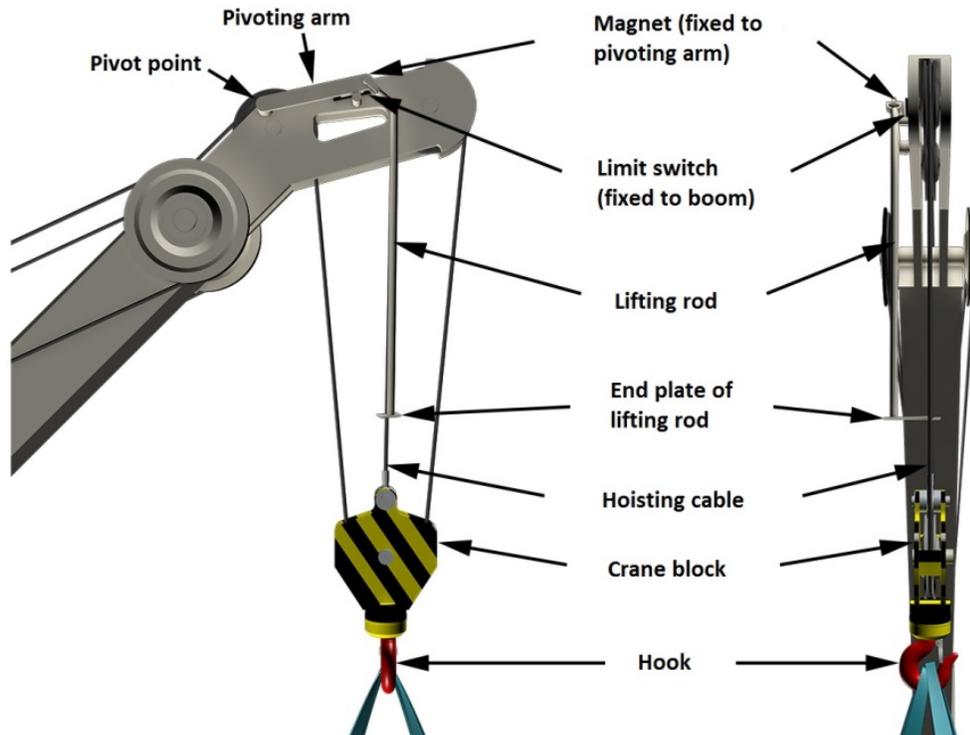
that was connected to a limit switch. This limit switch was located on the boom head (Figure 1) and worked in conjunction with a magnet on the pivoting arm to prevent the crane block from making contact with the boom head and potentially overstressing the hoisting cable.

When the crane block was operating within its set limits, the magnet fixed to the pivoting arm rested in line with the limit switch, creating a closed electrical circuit that allowed the motor to operate. However, if the crane block traveled upward beyond a set limit, it would push up on the lifting rod's end plate (Figure 1). This action on the lifting rod would cause the pivoting arm to pivot upwards, de-aligning the magnet from the limit switch and opening the electric circuit, which would cut power to the motor. For the limit switch to be activated, the pivoting arm

Figure 1. Side view of boom head and limit switch components (left) and front view of boom head (right). See Appendix C for the full view of the port provision crane.

needed to pivot upwards by approximately  $10^\circ$  (3D Animation 2).<sup>14</sup> Post-occurrence, the pivoting arm was observed to be resting at an angle of approximately  $90^\circ$  in relation to the limit switch.

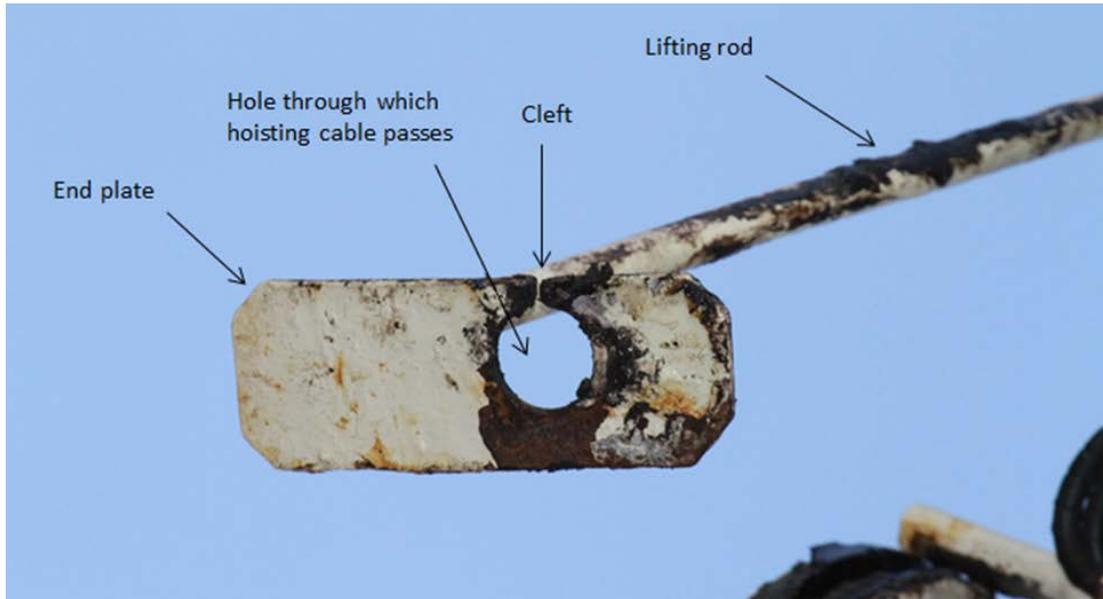
In order for the lifting rod to function as intended, it was designed to be fitted such that the hoisting cable passed through a hole in the lifting rod's end plate (Photo 2). This secured the end plate of the lifting rod around the hoisting cable and held the lifting rod in line with the crane block (while still allowed the hoisting cable to move freely up and down through the hole in the end plate). When under tension and fitted correctly through the end plate, the hoisting

Following the occurrence, the lifting rod was found to be structurally intact. There was grease visible on the rod itself, but minimal grease visible on the end plate. Between the hole through which the hoisting cable was to pass and the outer edge of the end plate, there was a cleft that was approximately 10 mm wide (Photo 2).

Photo 2. Lifting rod that was in use at the time of the occurrence

This incorrect rigging of the hoisting cable with the lifting rod is also suggested by the lack of grease on the lifting rod's end plate and by the extent of grease on the rod itself. The hoisting cable in this occurrence had been freshly greased 5 days prior. In a situation where the freshly-greased hoisting cable passed through the hole in the end plate, the transfer of grease from the hoisting cable to the end plate would be expected; however, minimal grease was present on the end plate. Furthermore, the rod itself had a significant amount of grease on it, suggesting that it had likely dangled freely alongside the hoisting cable and had rubbed against it.<sup>26</sup>

<sup>26</sup> Given that the hoisting cable was most likely not fitted through the hole in the end plate, the presence of the cleft in the end plate was unlikely to be causal.

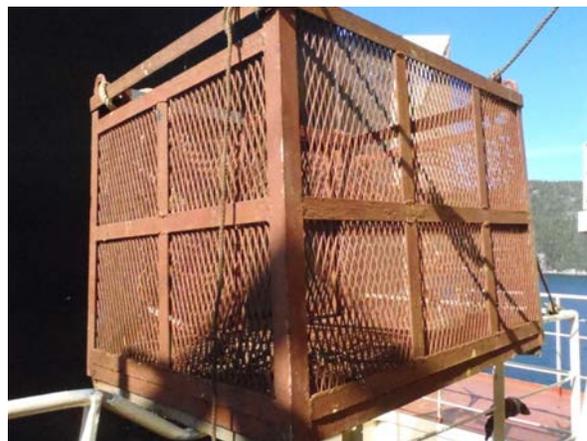
Photo 3. Steel basket on the *Federal Yoshino*

To facilitate the transfer of supplies, the crew on the *Federal Yoshino* used a steel basket that could be hooked to the on-board provision cranes. The basket, fabricated by the vessel's crew, was made of steel angle bars, flat bars, and metal grating (Photo 3). It weighed 200 kg<sup>15</sup> and was 96 cm high. Its base measured 102 by 132 cm.

At the time of the occurrence, the basket was attached to the hook of the port provision crane by means of 2 nylon slings that were approximately 4.2 m in length. The slings were secured to the basket by 4 shackles. A post-occurrence examination found that the nylon slings were worn (Photo 4) and that the working load limit was marked on 2 out of the 4 shackles. None of the threaded pins on the 4 shackles were moused.<sup>16</sup>

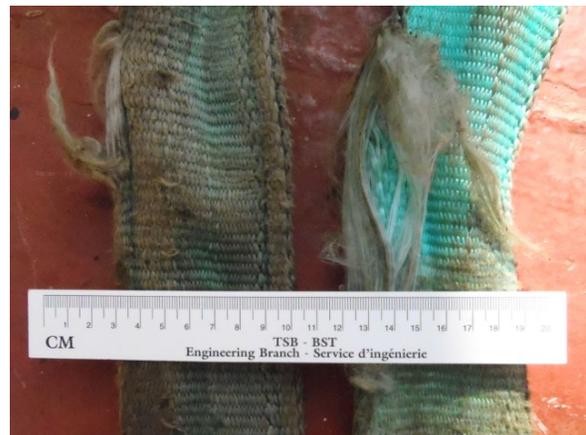
Photo 4. Extent of wear on the nylon slings

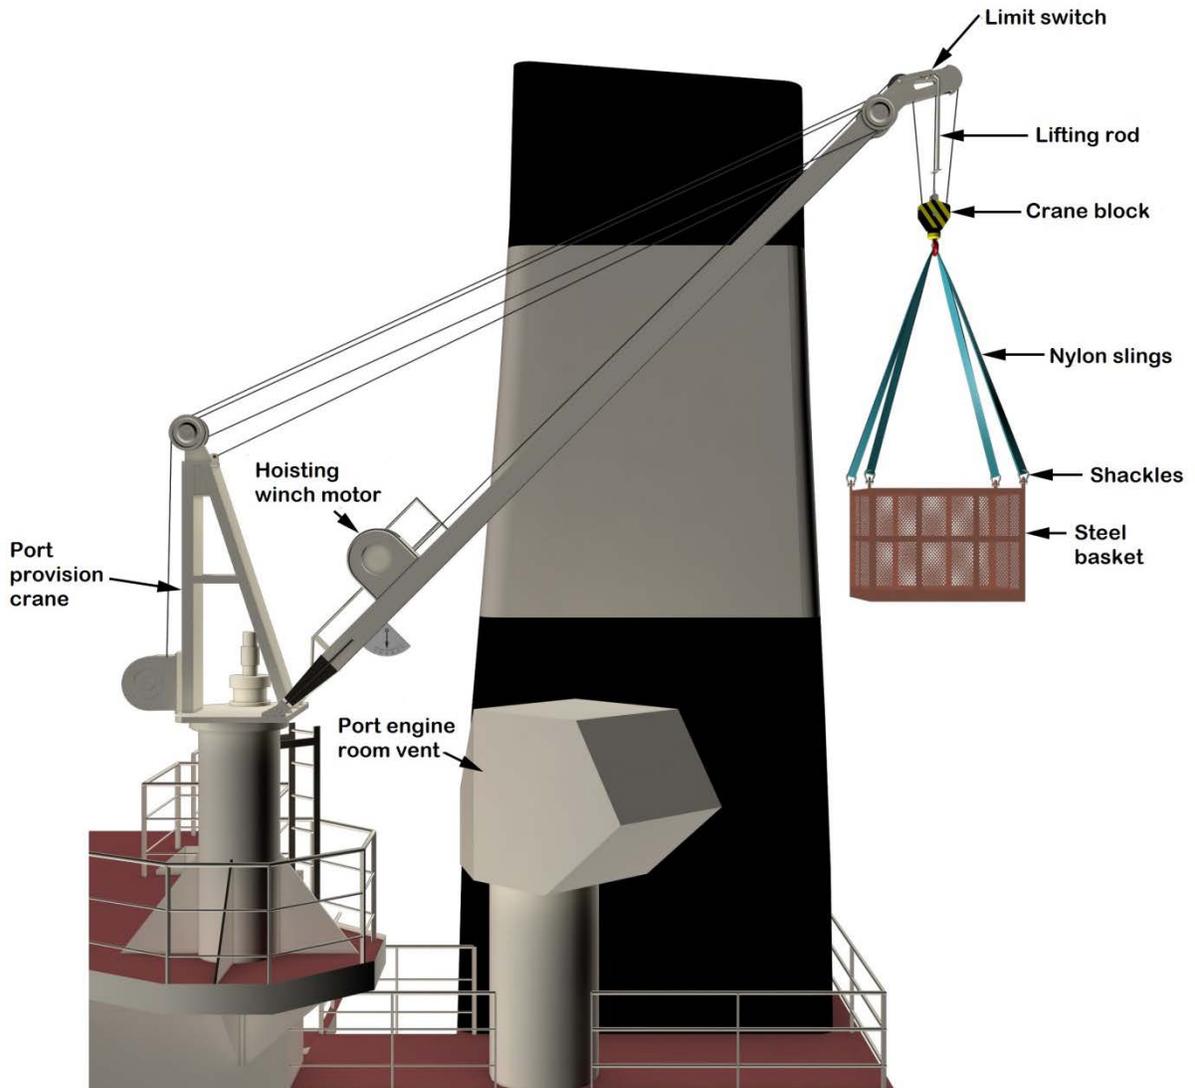
*Appendix C – Port provision crane*

The purpose of the port provision crane on the *Federal Yoshino* was to transfer supplies (e.g., engine parts, galley supplies, and deck supplies) between the vessel and the dock. The port provision crane was operated using a push button remote control, enabling the crane operator to manoeuvre the crane from various vantage points on the deck. The remote control could be used for raising and lowering the hook, slewing the crane right and left, and luffing the boom up and down. The boom had a maximum radius of 8 m (when at a 25° angle) and a minimum radius of 2.75 m (when at a 75° angle). Post-occurrence photographs indicated that the angle on the boom was approximately 45° at the time of the accident.

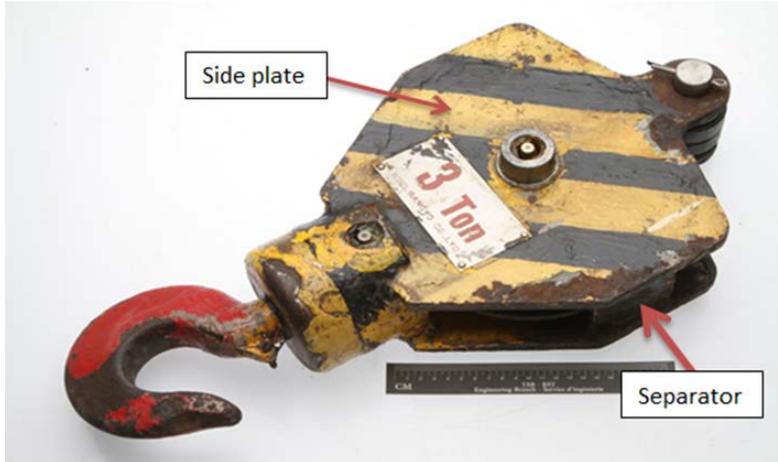
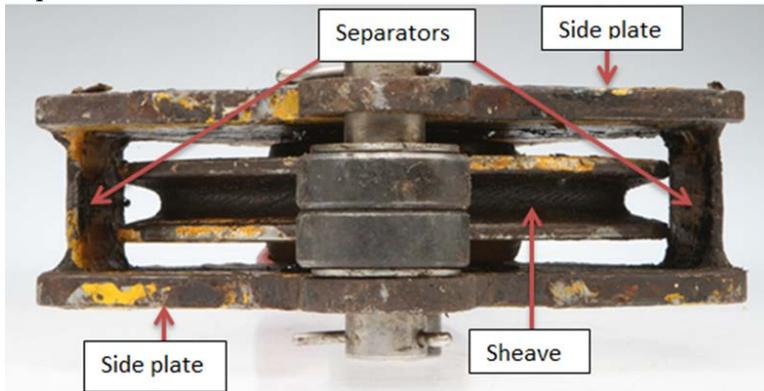
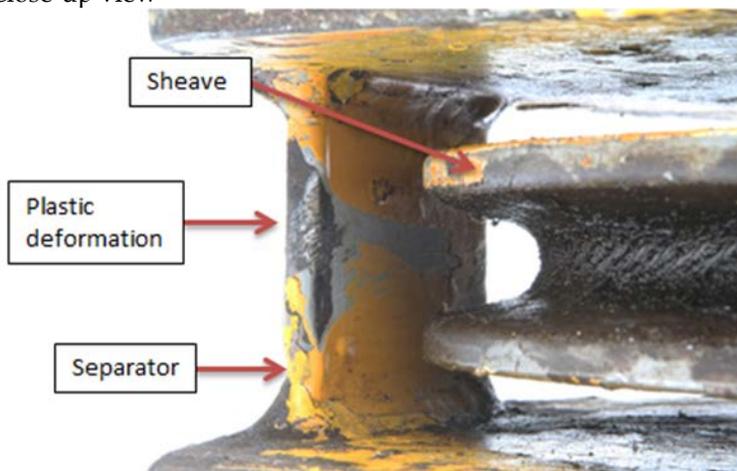
## Appendix E – Crane block assembly

The crane block<sup>12</sup> on the port provision crane was constructed of steel and included the hook and sheave (Appendix E). The hoisting cable, which was 10 mm in diameter, passed around the sheave. The sheave was enclosed by side plates that were reinforced by separators. A post-occurrence examination of the separators revealed that one of them (the separator nearest to the point where the hoisting cable exited the sheave and connected to the winch) had sustained plastic deformation<sup>13</sup> (Appendix E).
