**PIPELINE INVESTIGATION REPORT  
P14H0011**

**NATURAL GAS PIPELINE RUPTURE**

**TRANSCANADA PIPELINES LIMITED  
LINE 400-1 AT MAINLINE VALVE SITE 402  
NEAR OTTERBURNE, MANITOBA  
25 JANUARY 2014**

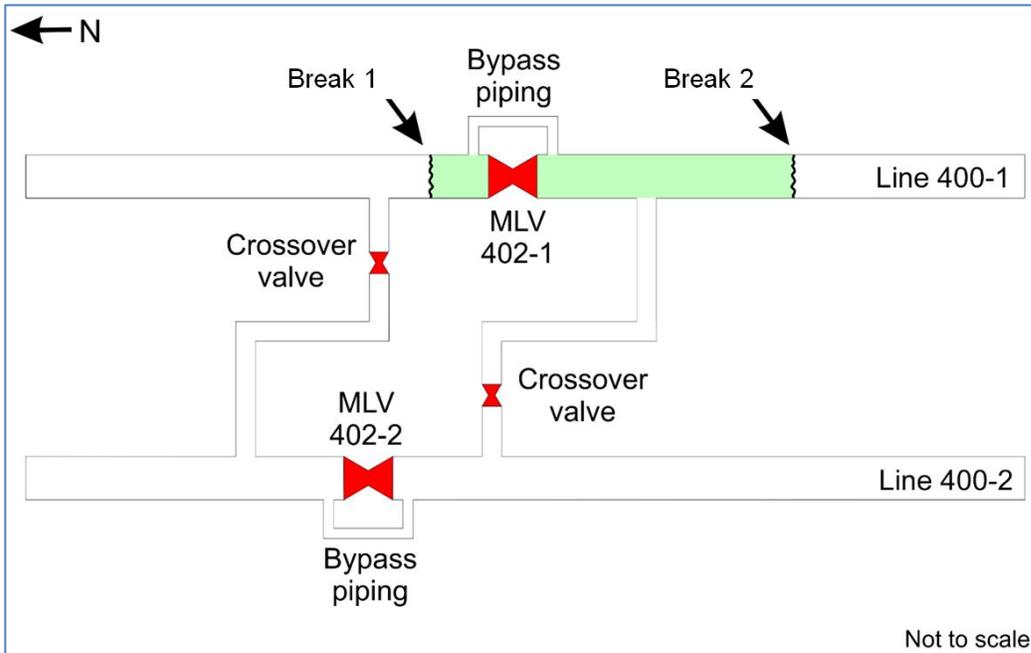
Figure 2. Lines 400-1 and 400-2 and associated piping and valves in the vicinity of the failure at the MLV 402

- The pipeline failure resulted in 2 separate break locations approximately 11 metres apart (Figure 2).
- Break 1 occurred approximately 1 metre north of MLV 402-1, at a circumferential transition weld between a fitting (bypass tee) and the adjoining pipe. There was no significant metal deformation observed at this break location.
- Break 2 occurred south of MLV 402-1, at a girth weld between two sections of welded pipe. A sharp wrinkle at the top of the pipe was observed at this break location, indicating that this was likely a secondary break.
- A large crater (approximately 24 metres long by 12.5 metres wide) had been formed, exposing the failed pipeline as well as MLV 402-1 (Photo 1).
- Within the crater, the external coating of the pipeline was completely destroyed by the fire.
- One concrete support pad was observed under MLV 402-1.

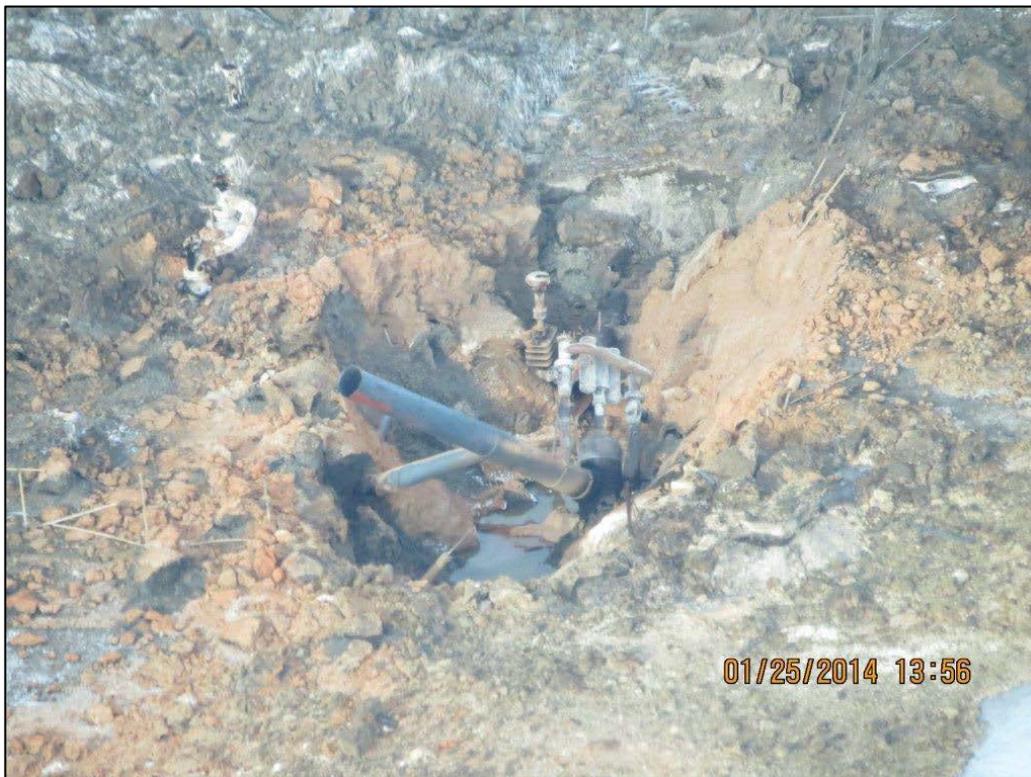
Photo 1. Pipeline failure damage

2. The crack had formed at the time of the pipeline's construction, likely due to an inadequate welding procedure and poor welding quality.
3. During the failure, MLV 402-1 and an 11 metre-long section of pipe to the south lifted up, resulting in a sharp wrinkle at a girth weld at the top of the pipe, causing a secondary break.

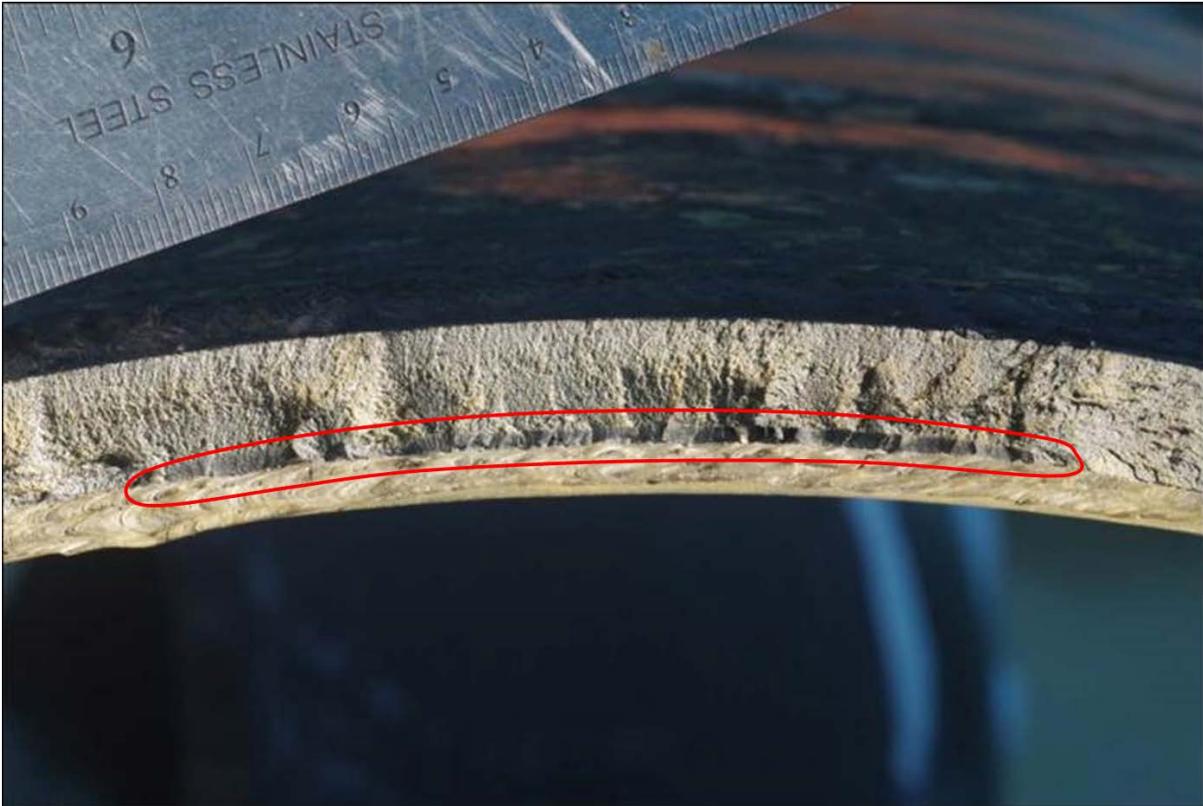
- The pipe failed at a pre-existing crack that was present in the heat-affected zone<sup>6</sup> of a girth weld, located north of MLV 402-1 (Photo 2). This girth weld joined the pipeline to the bypass tee. The bypass tee<sup>7</sup> was completed in 1960 as part of the original construction.

- The pre-existing weld crack had acted as the initiation site for the circumferential brittle fracture of the pipe section.
- The pre-existing weld crack had likely formed at the time of the pipeline’s construction due to poor welding quality and an inadequate welding procedure. There was no indication that it had grown in service.

- The heat-affected zone at the girth weld exhibited very high hardness and was more brittle than the base steel.

Photo 2. Pre-existing crack at girth weld

Line 400-1 ruptured approximately 1 metre north of MLV 402-1 due to a circumferential brittle fracture that initiated at a pre-existing crack. The pre-existing crack was a delayed hydrogen crack located in the hard heat-affected zone of the circumferential transition weld between a bypass tee and a short section of adjacent pipe. This crack had been formed at the time of the pipeline's construction, likely due to an inadequate welding procedure and poor welding quality. The weld defect had remained stable for over 50 years prior to the failure and there was no indication that it had grown in service. Due to internal pipe pressure and forces in reaction to the failure, MLV 402-1 and an 11 metre-long section of pipe to the south were lifted up during the failure. This resulted in a sharp wrinkle at a girth weld at the top of the pipe, causing a secondary failure. The natural gas released from the pipeline ignited, and the resulting fire burned for approximately 12 hours.

1. Line 400-1 failed due to a circumferential brittle fracture that initiated at a pre-existing crack that had remained stable for over 50 years prior to the occurrence.
