RAILWAY OCCURRENCE REPORT

R97T0075

TRUCK SIDE FRAME FAILURE

TANK CAR PROX 88181

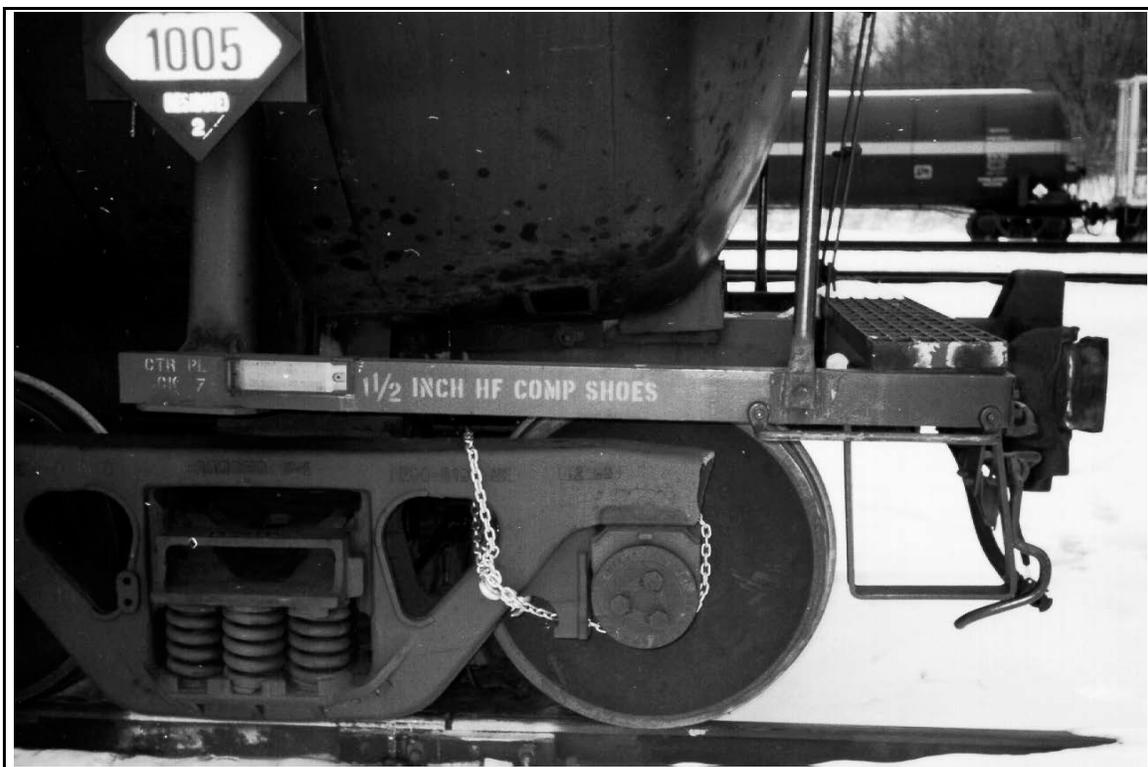
At approximately 1500<sup>1</sup>, on 30 January 1997, at Mile 117.9 of the Kingston Subdivision, a Canadian National (CN) trainman on CN freight train No. 590 (train 590), while switching at Maitland, Ontario, observed that the pedestal leg on the “A” end of the truck side frame (R-4 position) was missing on tank car PROX 88181 (tank car). The train was stopped and the tank car was examined by the crew. The conductor instructed the locomotive engineer to return train 590 to Brockville Yard, Brockville, Ontario, at a reduced speed of 20 mph. Upon arrival at Brockville Yard, the tank car was placed in bad order status and the axle was chained to the truck side frame by a carman to allow the tank car to be switched through the yard and into the repair track (see Figure 1).

A crack, originating in the radius between the pedestal roof and outer pedestal jaw, propagated vertically through the truck side frame separating the outer pedestal jaw from the truck side frame. The fracture topography indicated brittle overstress fracture as the mode failure.

Procor Limited revised their methods and modified the weld configuration of the wear liner. They have also initiated a program to inspect the transverse welds when the trucks are dismantled.
