RAILWAY INVESTIGATION REPORT

R04Q0040

MAIN-TRACK DERAILMENT

CANADIAN NATIONAL

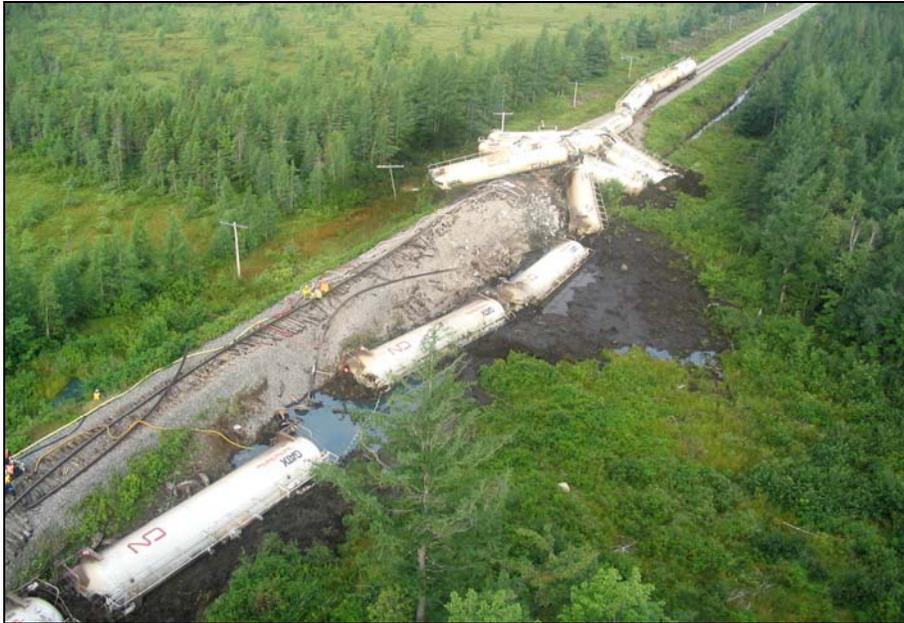
The 39th car on the train remained upright 100 m north of the primary derailment site, its leading truck having derailed on the east side of the main track. The preceding eight cars jackknifed and plowed into the peat surface (see Photo 1). The other cars rolled over parallel to the east side of the track. Right behind the 29th car, the track collapsed and a depression is noted at the centre of the track (see Photo 2). A total of 250 m of track was destroyed.

Photo 1. Aerial view of the derailment site

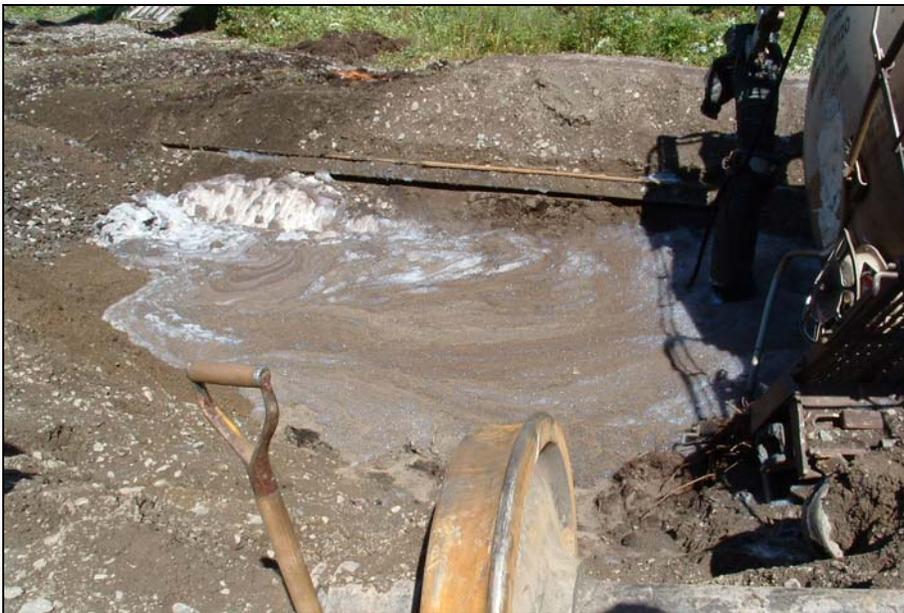
Photo 2. Depression at the centre of the track

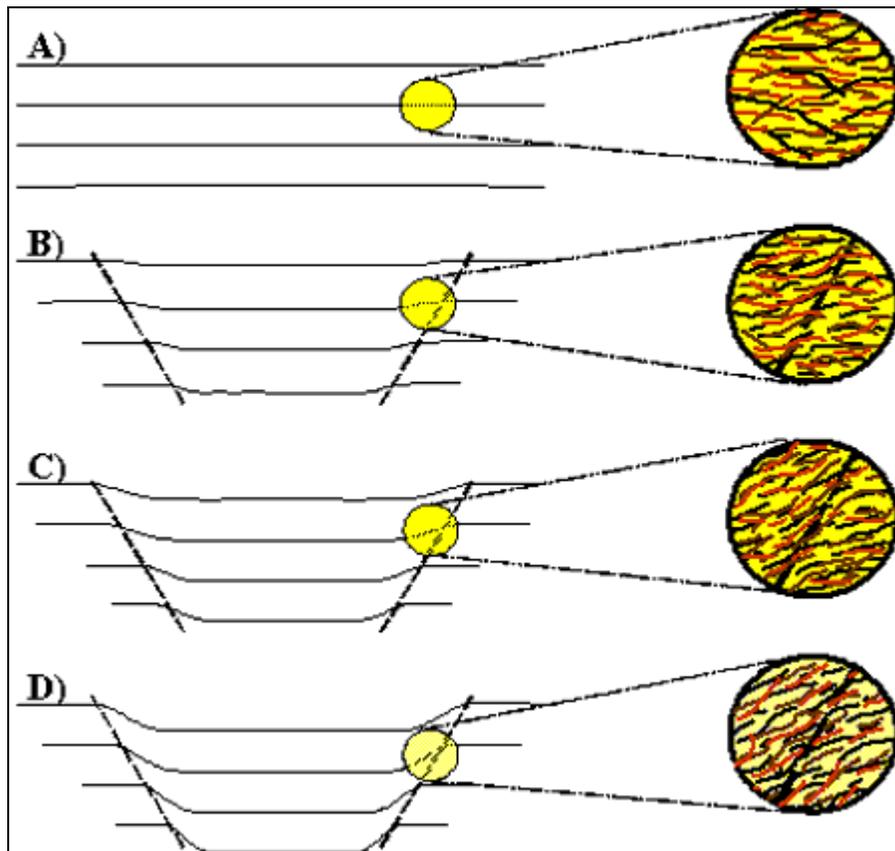
According to the study, settlement accumulation in the peat occurred beneath the railway track only, which results in fibre distortion, as the peat outside of the influence area does not experience settlement (see Figure 4). This distortion leads to a realignment of the peat's fibre until it forms two shear planes that develop gradually as the permanent settlement under the railway track increases.

Each time a loaded train passes, the fibres sustain increased shear stress and, just like in the centre of the layer, the excess pore pressure reduces the effective stresses, and a gradual failure mechanism begins. The fibres are gradually broken from the centre of the peat. When the loading imposed by the trains along the shear planes reaches the shear strength of the peat, a punching failure will occur (see Figure 5). This type of failure is accompanied by sudden significant settlements.

Figure 4. Evolution of settlement and distortion of peat fibres

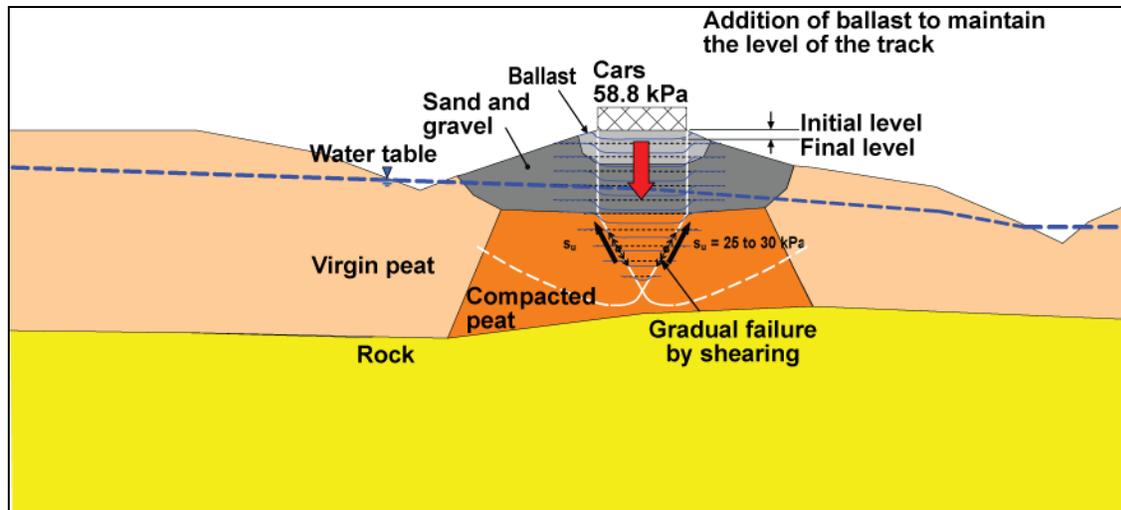
Figure 5. Shearing failure by punching at Mile 3.87

According to the Civil Engineering Department of Université Laval, this phenomenon results in fibre distortion and realignment of the peat fibres until the formation of two shear planes that develop gradually as the permanent settlement under the railway track increases. Once the shear strength of the peat is reached, a sudden failure caused by punching could occur. This type of failure is accompanied by sudden collapse of the railway track, as confirmed by the depression observed at the centre of the track behind the 29th car. The accident occurred when the cars were unable to negotiate the sudden collapse of the track resulting from the failure of the subgrade most likely caused by punching and thus derailed.

1. Track subgrade settlements accumulated under the repeated effect of loads gradually resulted in distortion and realignment of peat fibres, which most likely led to the sudden punching failure.
2. The cars were unable to negotiate the sudden collapse of the track brought on by subgrade failure and thus derailed.

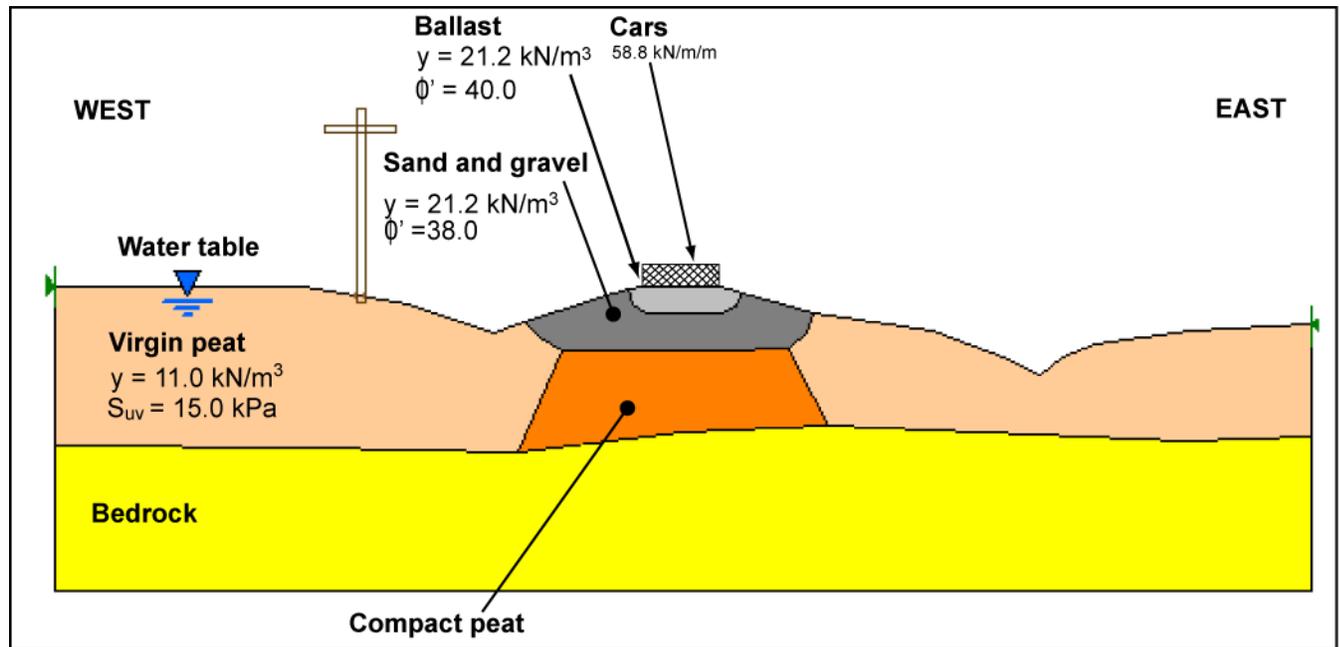
Appendix C2 – Stability Analysis of Track Fill Slopes at Mile 3.87

A factor of safety of 1.0 (slope becoming unstable) is obtained when $s_{uv} = 5$ kPa, which is physically impossible. Accordingly, the railway fill built on the peat deposit is stable under the circumstances in terms of slope failure under the load of cars.

Stability of track fill slopes under the load of cars - $s_{uv} = 10.0 \text{ kPa}$ for compact peat - Stable slope because the factor of safety obtained equals 1.388 (s_{uv} = shear resistance, γ = unit weight, ϕ' = internal angle friction)
