RAILWAY INVESTIGATION REPORT

R04Q0047

MAIN-TRACK DERAILMENT

Canadian National
Train Q-120-31-12
Mile 114.8, Montmagny Subdivision
Lévis, Quebec
12 November 2004

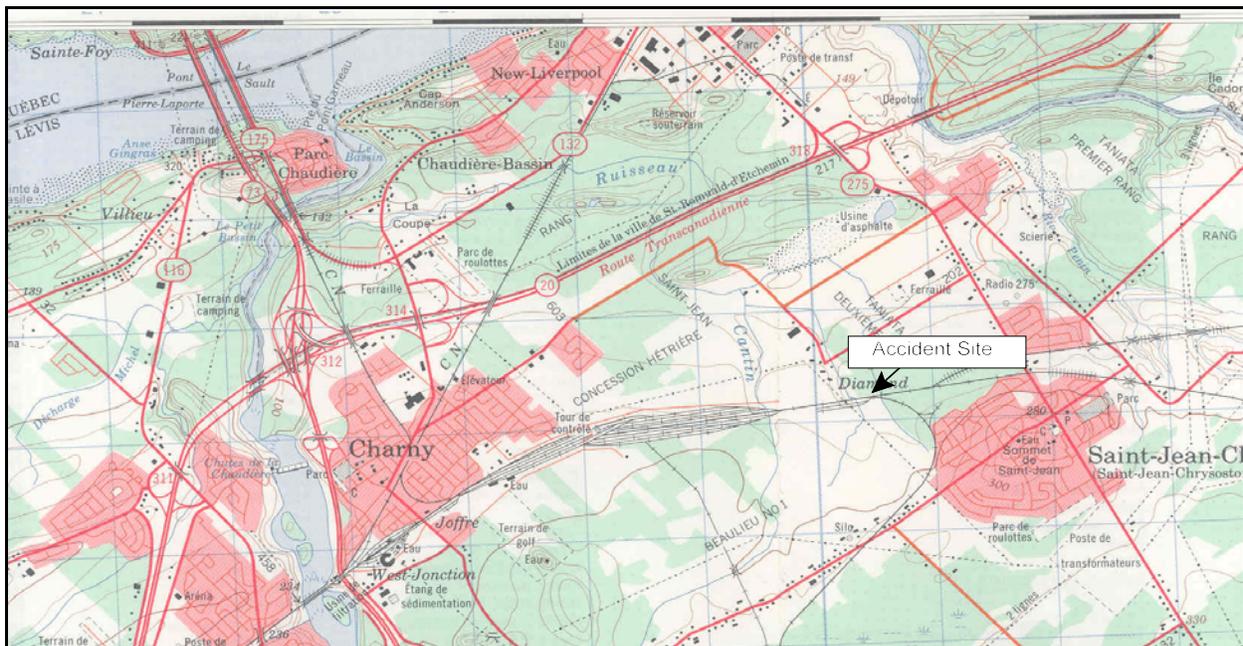
The train derailed while rolling over the crossover between the passing track and the main track of the Montmagny Subdivision at Mile 114.8 (see Figure 1). The Joffre Yard passing track is adjacent to and south of the main track. It is approximately 16 000 feet long. At the east end, where the derailment occurred, it connects to the main track through a crossover consisting of two turnouts with number 20 switches. The track consists of 136-pound continuous welded rail on hardwood ties. The maximum speed authorized for freight trains on the passing track is 15 mph.

Figure 1. Accident site

The derailed cars remained upright and coupled. They were immediately east of the crossover, and the last derailed car came to rest over the passing track turnout switch point. Examination of the derailed cars revealed that the rim of the lead wheel of the trailing truck on the first derailed platform of car DTTX 25029 was broken and that a portion of the rim and a 38-inch section of the wheel flange were missing (see Photo 1). The mate wheel exhibited no flaws. The roadbed and right-of-way were inspected over a distance of 3.5 miles to the west of the passing track turnout, but the broken pieces of wheel rim were not recovered. East of the turnout, impact marks were visible on the ties, spikes and tie plates on the south, outside of the track.

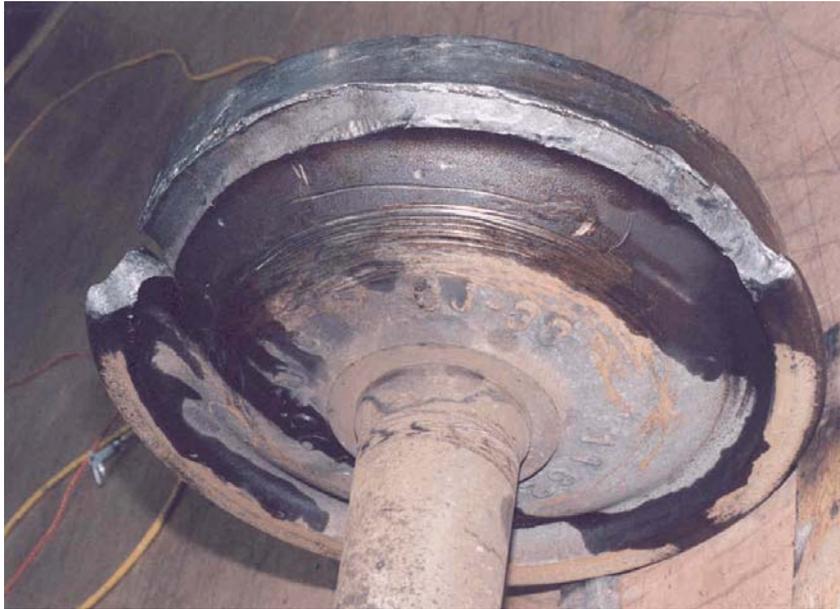
Photo 1. Fracture of rim of wheel L-3 of car DTTX 25029

- The surface of the fracture on the outer portion of the wheel rim had a dark area, located about 5 mm below the running surface, with semi-circular features and changes in colouration consistent with progressive fatigue cracking. One crack extended from this area towards the centre of the wheel plate. Observation of the crack contact surfaces revealed chevron markings and secondary cracks with polished sides.
- Metallurgical analysis of rim samples revealed a high level of porosity due to voids left by bubbles of dissolved hydrogen trapped during manufacture of the wheel. Some cracks propagated from these voids. The hardness and chemical composition of the wheels were within AAR specifications.

Based on the analysis by the TSB Engineering Laboratory, the major portion of the fracture of the outer part of the wheel rim was caused by instantaneous overstress. However, the direction of the chevron markings observed on the fracture surfaces indicates that the crack originated in the rim and progressed into the wheel plate. The walls of the secondary cracks were polished, indicating that they had been progressing for some time.

The high level of porosity observed shows that the wheel was not properly cooled, which resulted in trapped hydrogen bubbles and the creation of voids. As a result of service stresses, sub-surface cracks propagated from these voids and subsequently combined to form a larger crack below the running surface. Even though a portion of the wheel rim was not recovered, the presence of porosity and cracks and their positions indicate that the wheel failed when the sub-surface fatigue cracks intersected with the cracks caused by the shelling spots on the running surface.

1. The train derailed following a wheel failure on car DTTX 25029.
2. The wheel failed when sub-surface cracks propagated from porosity and intersected with cracks caused by shelling of the running surface.

The Association of American Railroads (AAR) has issued an instruction for the removal from service of all Southern wheels manufactured in 1995 when cars are in repair shops or tracks.

Canadian National and Canadian Pacific Railway have initiated programs that go beyond the requirements of the AAR. They are removing all Southern wheels from their equipment and have instructed their suppliers to not install Southern wheels on any cars owned or leased by them.

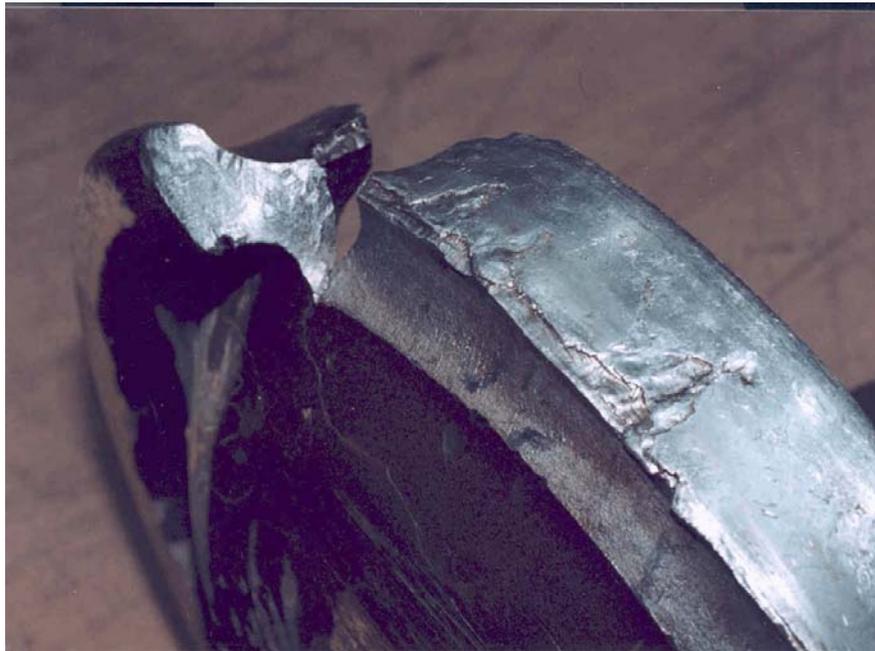
- The running surface of the failed wheel exhibited shelling spots adjacent to the wheel flange, one with a diameter of 1.7 inches and the other with a diameter of 2.4 inches (see Photo 2). The 2.4-inch shelling spot was not continuous, but the 1.7-inch shelling spot exceeded the limit prescribed by the Association of American Railroads (AAR), which requires that wheels with continuous shelling spots on the running surface measuring 1 inch or more in diameter be taken out of service. There were no indications or flaws due to heating.

Photo 2. Shelling on the running surface

The sub-surface cracks observed on the failed wheel could not have been detected by hot box detectors because they originate and propagate with no significant emission of heat. However, the failed wheel had exceeded the limits allowed by the AAR for shelling of the running surface, although neither the safety inspection conducted at Brampton nor the WILD near Bagot identified it as defective. Since there is nothing to indicate that these different inspections were not carried out in accordance with existing standards, there is reason to believe that there are still some cases where the existing safety barriers can be inadequate, either because of the performance of the barriers themselves or because some flaws can develop rapidly.
