RAILWAY INVESTIGATION REPORT
R09H0010

LOCOMOTIVE ENGINE FIRE

VIA RAIL CANADA INC.
PASSENGER TRAIN 46
MILE 14.26, SMITHS FALLS SUBDIVISION
RICHMOND, ONTARIO
16 AUGUST 2009

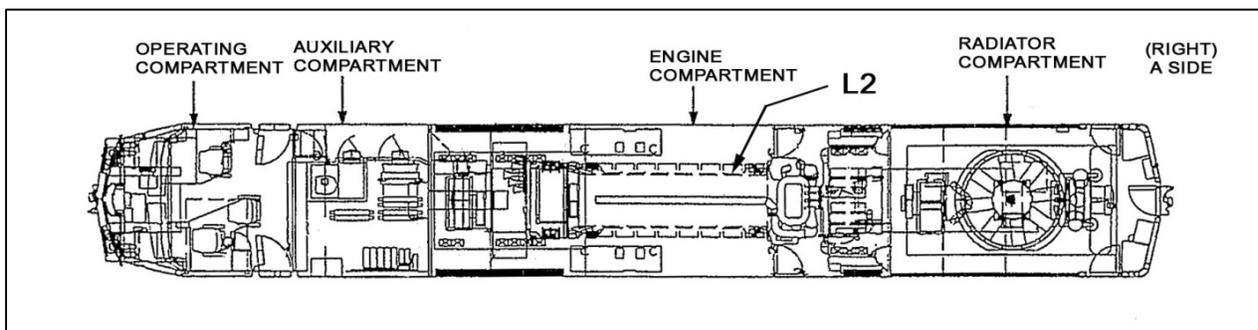
Figure 3. Genesis P42 locomotive showing location of L2 power assembly

VIA 902 was a Genesis P42 locomotive manufactured by General Electric (GE). It entered into service in 2001. Post-occurrence examination of the locomotive determined that the fire started at the top of the L2 power assembly of the V-16 diesel engine (see Figure 3).

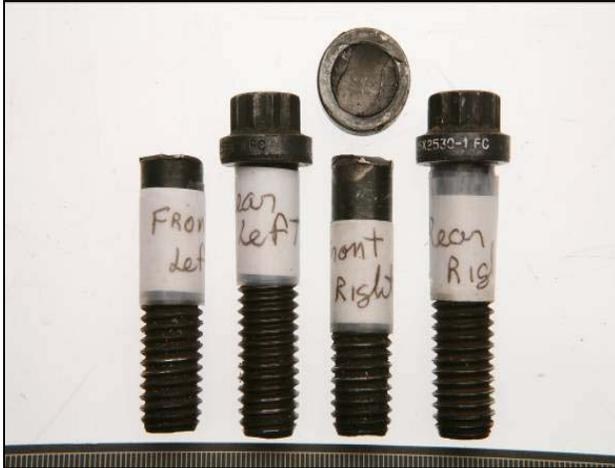
Photo 1. Fuel injector pump mounting bolts

- The mounting bolts used to fasten the L2 fuel injector pump to the cylinder were the original bolts that had been installed during factory assembly.
- The fuel injector pump front mounting bolts (left and right) failed due to progressive (high-cycle fatigue) cracking.
- The fatigue cracks advanced in different intersecting directions, which was most obvious in the case of the front right mounting bolt (see Photo 2).
- No discrepancies were found when compared with the mounting bolt specifications (that is, dimensions and material).

Examination of the bolts revealed that fatigue cracks had advanced in different intersecting directions. This suggests a change in the direction of the applied stresses. The most probable explanation for such a change is rotation of the bolts. The bolts could have turned on their own if they became loose during operation, or they could have been installed at a different turn position during removal and re-installation of the fuel injector pump. The re-use of fuel injector pump mounting bolts during scheduled maintenance increases the risk that bolts will fail in service due to undetected fatigue cracking, leading to locomotive engine fires.

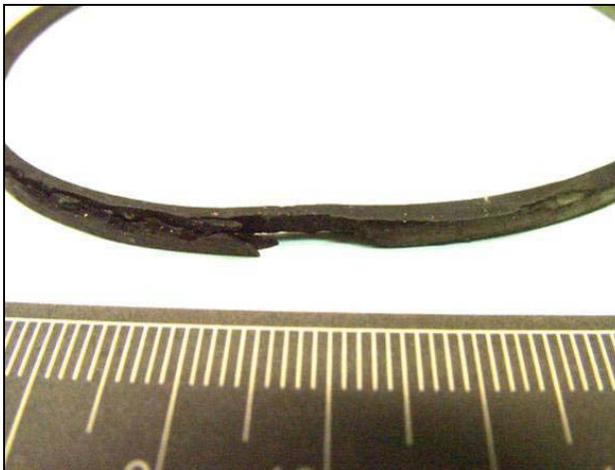
Photo 3. Damaged O-ring gasket

- A portion of the rubber O-ring gasket had jammed between the pump base plate and the cylinder seat. There were scrapes and small cuts along half of the outside surface of the gasket, including a 15 mm longitudinal tear and a 10 mm missing portion.

Laboratory analysis determined that the O-ring gasket, which is intended to ensure proper fit of the fuel injector pump, had been pinched between the fuel injector pump base plate and its cylinder seat. During normal train operation, this misaligned fuel injector pump created

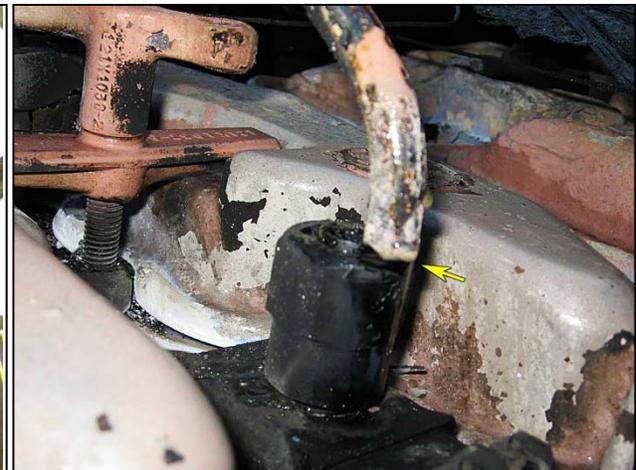
Photo 4. Broken fuel injection line

- Subsequent to the bolt failure, the fuel pump-to-cylinder joint became loose, leading to the development of fatigue cracks in the high-pressure fuel injection pipe.
- The fuel injection line broke in overstress mode due to the reduction of its load-bearing cross-section.

excessive vibration of the pump, leading to progressive, high-cycle fatigue cracking and failure of two of the four mounting bolts that secure the pump to its seat. Once the fuel injector pump was loose, continued vibrations led to fatigue cracks and the eventual failure of the high-pressure fuel injection line.

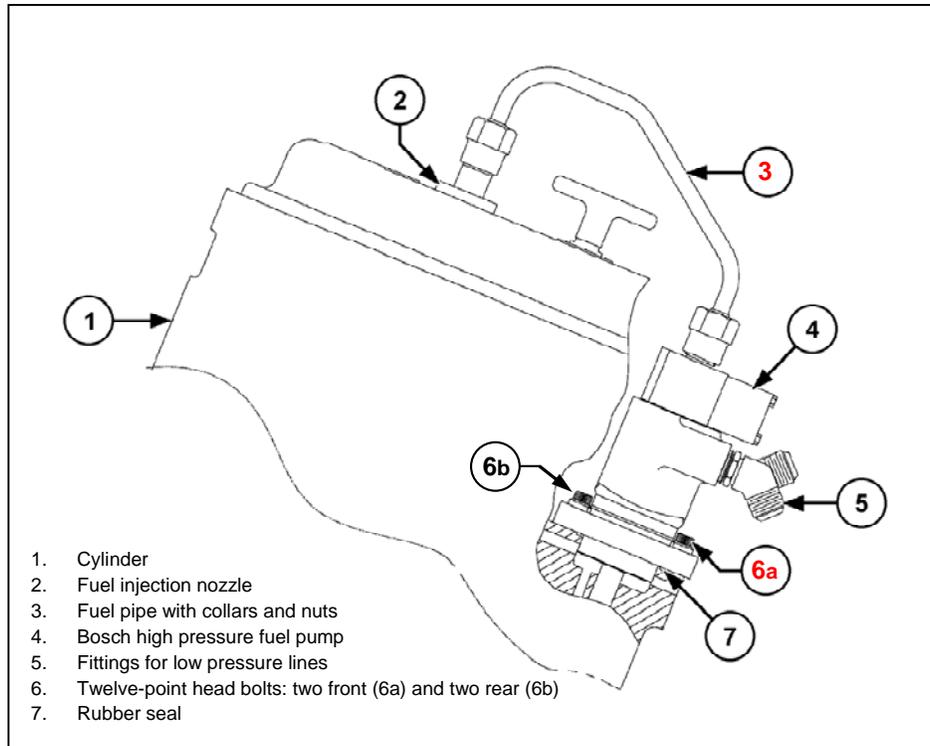
Figure 4. Schematics of the fuel pump-to-cylinder attachment (adapted from GE Parts Catalog PBE-93342-006D). Items 3, 6a and 7 were the failed components.
