**RAILWAY INVESTIGATION REPORT  
R14Q0047**

**CROSSING COLLISION**

**A VEHICLE AND  
VIA RAIL CANADA INC.  
PASSENGER TRAIN NUMBER P60321-05  
MILE 120.18, ST-MAURICE SUBDIVISION  
PARENT, QUEBEC  
05 DECEMBER 2014**

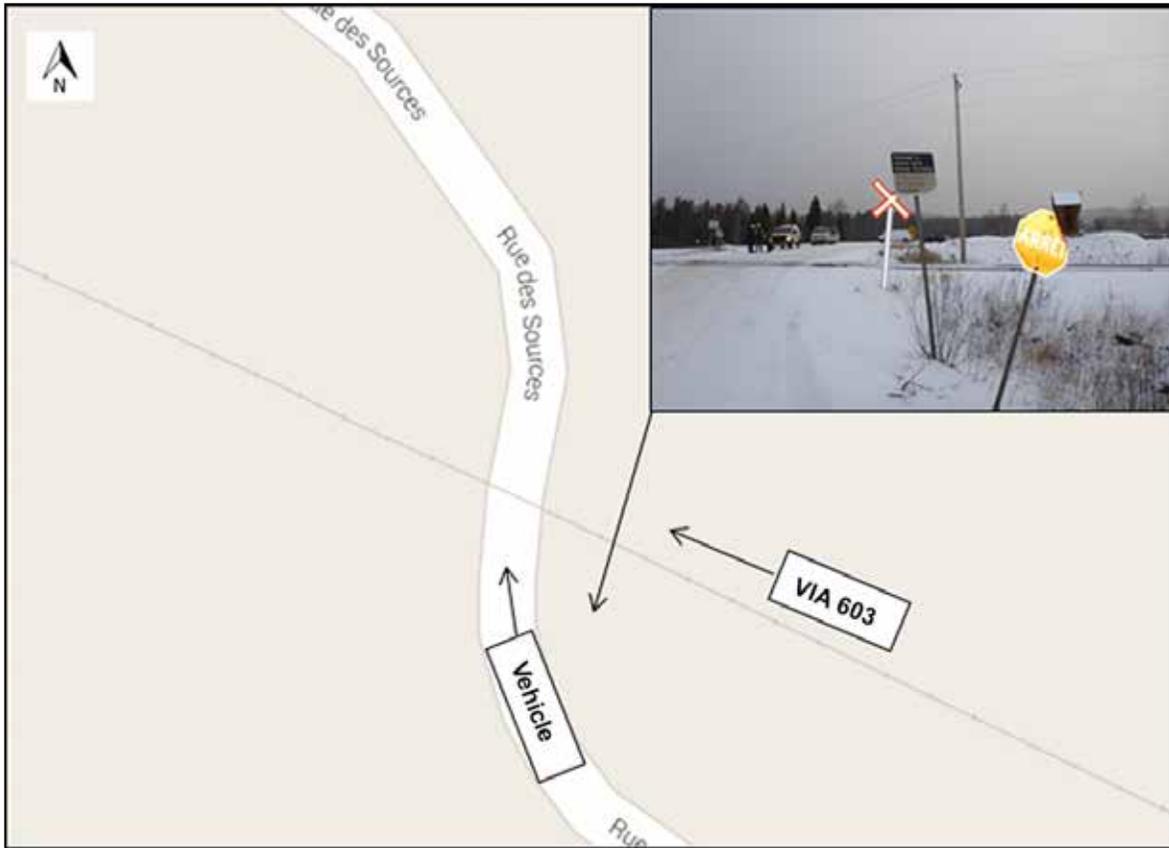
Figure 2. Path of vehicle in relation to the des Sources Street crossing and arrangement of road signs

The cross buck and stop sign on the south side of the track were visible to northbound vehicles from about 100 feet.<sup>3</sup> The stop sign was bent and leaning and one of the cross buck arms was hidden by the private crossing sign (Figure 2).

The road signs were not maintained as per *Manual of Uniform Traffic Control Devices for Canada* (MUTCDC) standards. In addition, since the road surface was gravel, there were no markings to serve as a stop line. Such factors compromise driver compliance with signs at crossings. If road signs at a crossing are poorly maintained, vehicle driver compliance with crossing signs may be affected, which increases the risk of vehicle-train collisions.

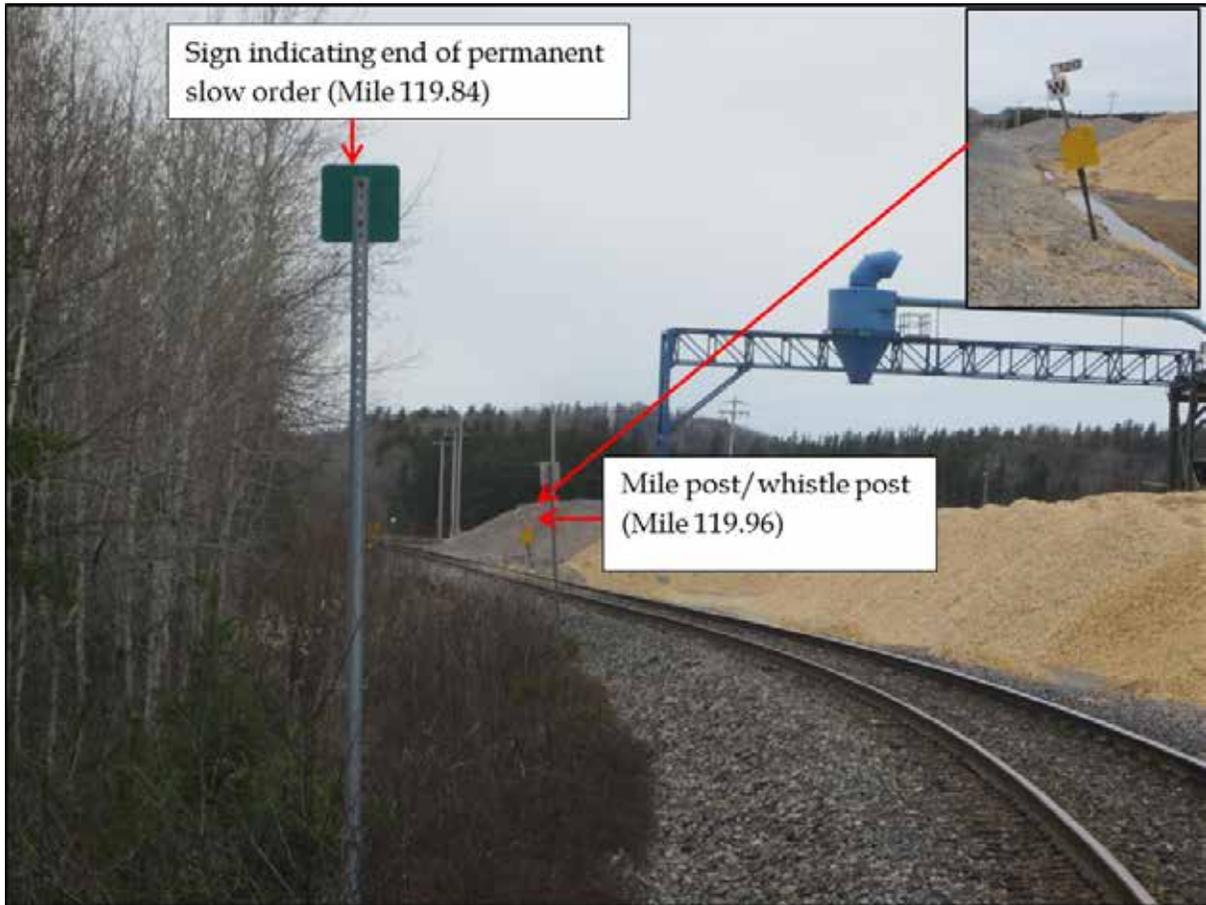
Photo 1. Westward view of sign indicating the end of the permanent slow order in relation to the whistle post (Source: VIA)

In this accident, the sign indicating the end of the permanent slow order (green square) was at Mile 119.84 and the whistle post, along with the Mile 120 sign, was positioned at Mile 119.96. The Mile 120 sign was somewhat bent and at an angle (Photo 1).

Given that the mile post and the sign indicating the end of the slow order should have been located at Mile 120 and that the whistle post should have been located at Mile 119.93, the incorrect location of these signs caused confusion among the crew members with respect to the train operation. As a result, the train was travelling at 37.1 mph when its tail end reached the end of the 10 mph slow order. To ensure the safe operation of trains, rail signs should be correctly placed and visible so they can be clearly identified. Rail signs that cannot be properly identified or that are not properly located can lead to confusion among train crew members and/or to an inconsistent application of the rules, which increases operating risks, especially in the vicinity of crossings.

Upon completion of the internal investigation into this accident, VIA Rail Canada Inc. (VIA) managers went to the site and noted that the signs were not properly located. VIA communicated this information to the track owner, Canadian National (CN).

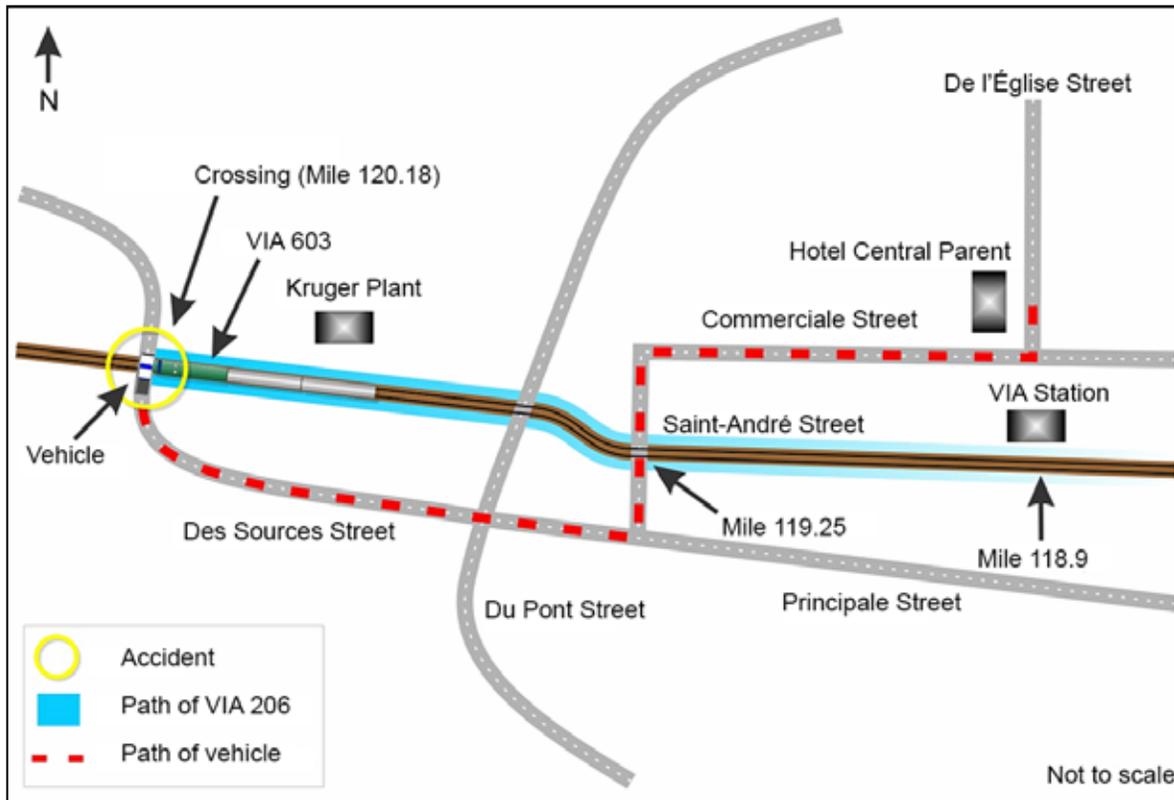
Figure 3. Path of VIA 603 and of the vehicle

Upon leaving the restaurant, only the driver buckled her seatbelt. The vehicle passed over the Saint-André Street crossing at Mile 119.25 and continued travelling westward (Figure 3). At the approach of the des Sources Street crossing, the vehicle slowed to 7 km/h. The front passenger would have looked to the east (right) and then told the driver that she had time to go over the crossing. The vehicle accelerated and reached a speed of 14 km/h at the time of the collision. The vehicle's windows were closed and the heating and radio were on. The driver had used this crossing about 4 times in the past, the last time being about 1 year ago.
