RAILWAY INVESTIGATION REPORT

R16D0076

Crossing collision

Canadian National Railway Company

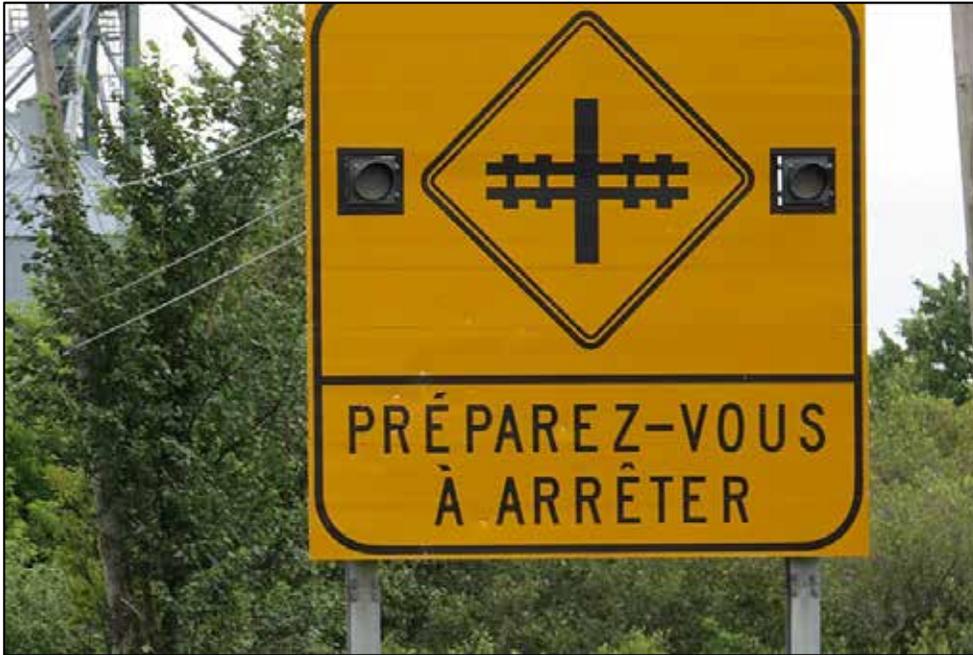
Figure 2. Active advance warning sign (Translation: PREPARE TO STOP)

For road vehicles approaching from the west on Highway 347, the flashing lights of the advance warning sign, when activated, are visible from a distance that is sufficient to warn vehicles of a train at the grade crossing. However, on the night of the occurrence, neither the advance warning sign nor the crossing warning device was activated, because the multi-crane was electrically insulated and the flag-person had not manually activated the warning device. Given that the advance warning sign and the crossing warning device had not been activated, the tractor-trailer driver was expecting the crossing to be clear and therefore did not prepare to stop the vehicle at the crossing.

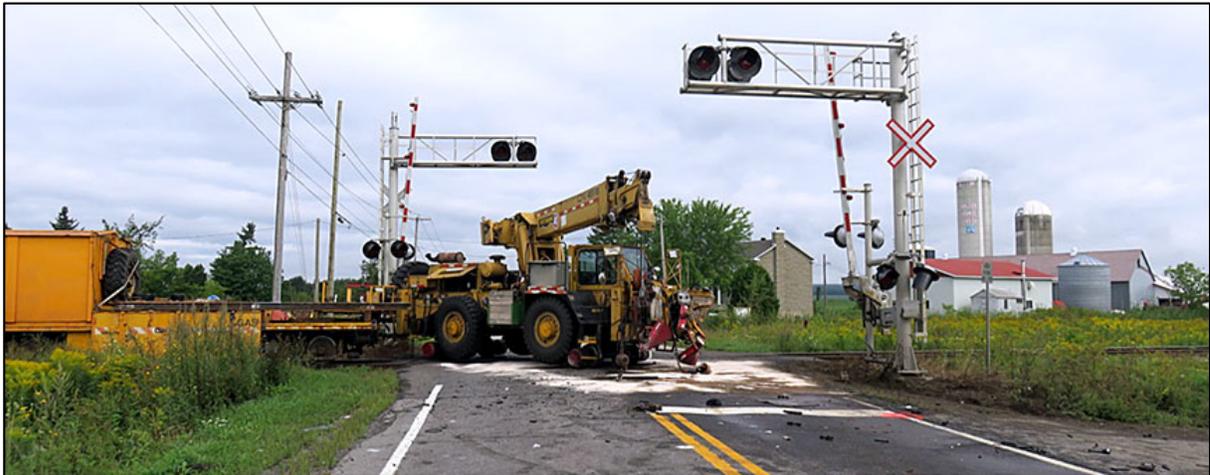
Figure 3. Accident site

The multi-crane remained upright and came to rest at an angle of approximately 45° from the track centreline (Figure 3), obstructing the crossing for several hours. The guide wheels derailed and dug grooves into the asphalt surface of the roadway.

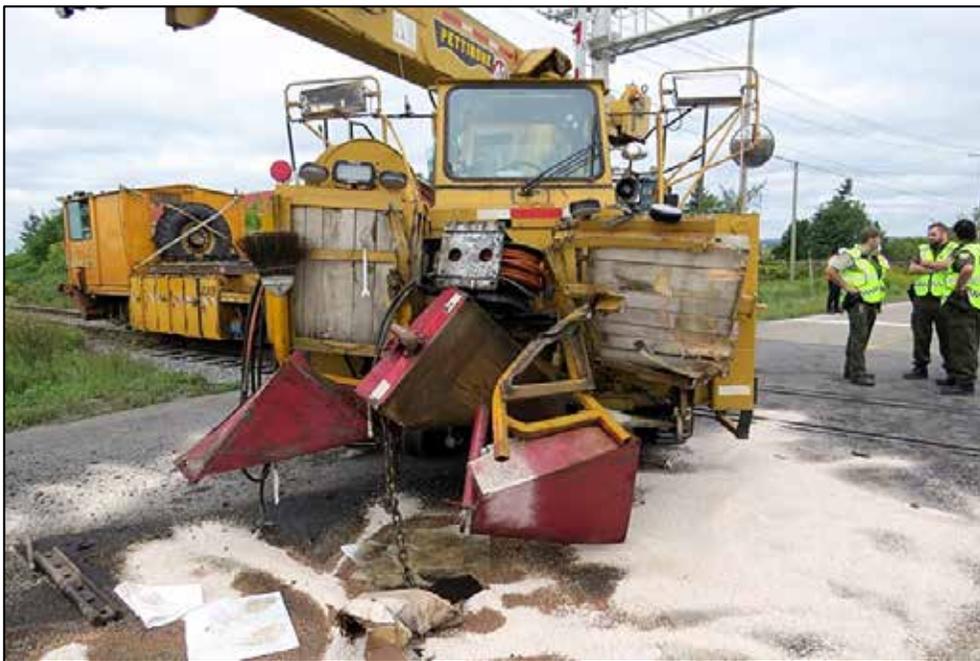
Figure 4. Front view of the multi-crane

The multi-crane was substantially damaged. The windows on either side of the cabin were shattered. The multi-crane boom locking mechanism was broken and the boom was turned approximately 30°. The devices on the tip of the boom and attached to the front of the multi-crane were destroyed (Figure 4).

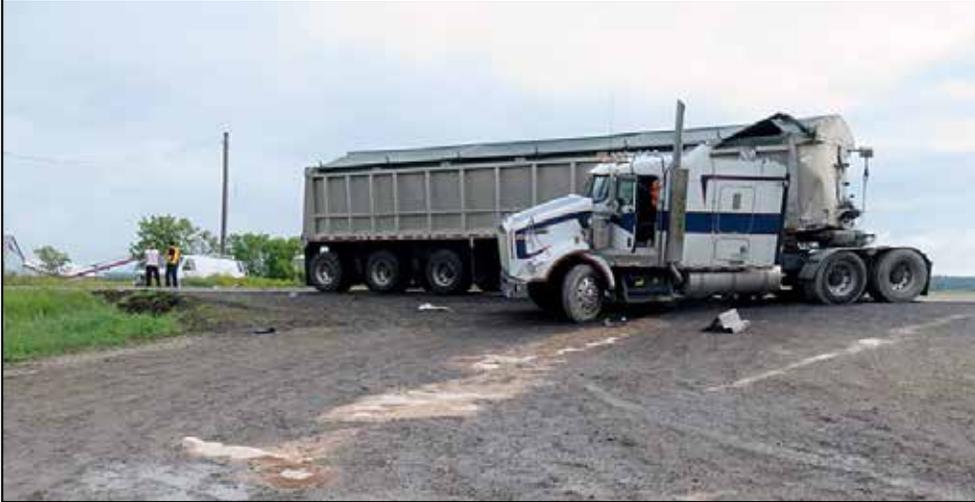
Figure 5. Resting position of the tractor-trailer

The tractor-trailer, which had been loaded with sand, came to rest on the roadway approximately 150 feet (46 m) east of the crossing. The tractor and trailer were still attached and had jackknifed (Figure 5). The tractor was significantly damaged. The front of the cab had impact marks above the passenger door. The roof and part of the rear of the cab had been torn off and launched into the ditch.

The trailer was substantially damaged. The front was dented, and the side panels of the dump body and several reinforcing ribs were torn off. The articulating arm of the tarp covering the dump body was broken off.

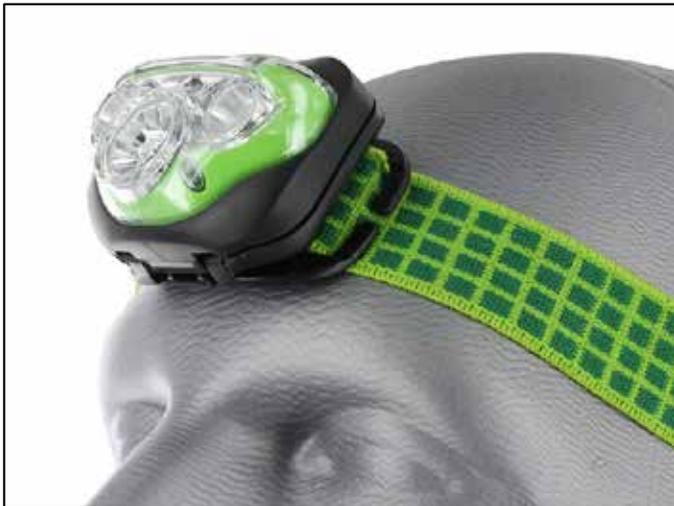
Figure 6. White headlamp

White headlamps worn by workers during night work produce a luminosity of approximately 200 lumens.⁶ Depending on the type of headlights installed on a road vehicle, the light they produce can range from 1200 to 1600 lumens for a halogen headlight to 3200 lumens for xenon headlights. Therefore, the visual conspicuity⁷ of the truck's headlights was greater than that of the white headlamp used by the flag-person.

Given that the tractor-trailer driver was travelling on a familiar segment of road, and given that the flashing lights of the advance warning sign and the crossing warning device were not activated, his attention was not focussed specifically on the crossing. As a result, he did not notice the flag-person signalling for him to stop in time. In addition, the visual conspicuity of the truck's headlights was greater than that of the white headlamp used by the flag-person, making the headlamp more difficult to detect. Regardless, the personal protective equipment and the white headlamp used by the flag-person did not constitute stimuli that were sufficiently compelling to alert the driver and make him aware of the abnormal situation at the grade crossing.
