**AVIATION INVESTIGATION REPORT
A10Q0132**

**LOSS OF VISUAL REFERENCE WITH THE GROUND, LOSS OF
CONTROL, COLLISION WITH TERRAIN
HÉLI-EXCEL INC.
EUROCOPTER AS350-BA (HELICOPTER) C-GIYR
SEPT-ÎLES, QUEBEC, 22 NM N
17 AUGUST 2010**

Report Number A10Q0132

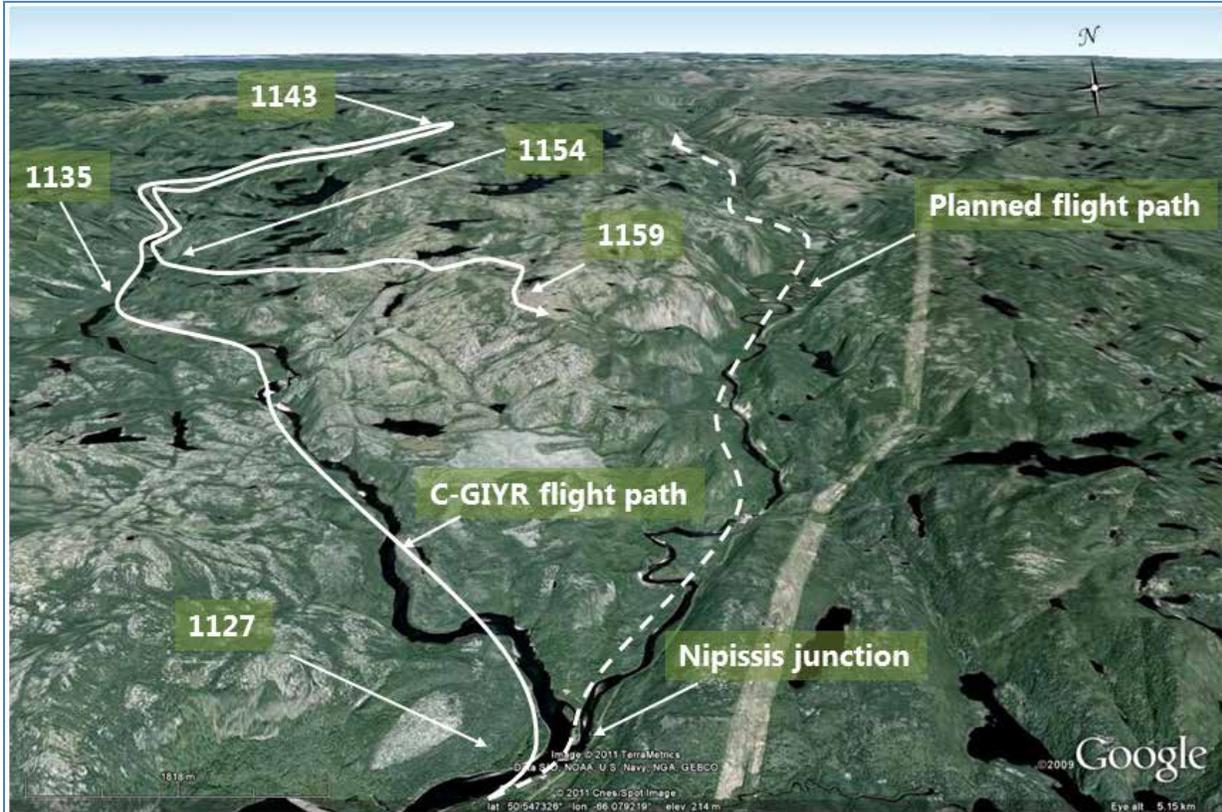
At 1127, at the junction of the Nipissis River, the pilot remained above the Moisie River, which veers northwest, instead of following the railway tracks that run along the Nipissis River valley until Poste Montagnais (Figure 2). The helicopter was flying over the Moisie River at normal cruising speed, at an altitude of about 200 feet agl.

Figure 2. Satellite image of terrain overlaid with C-GIYR flight path from the Nipissis River junction

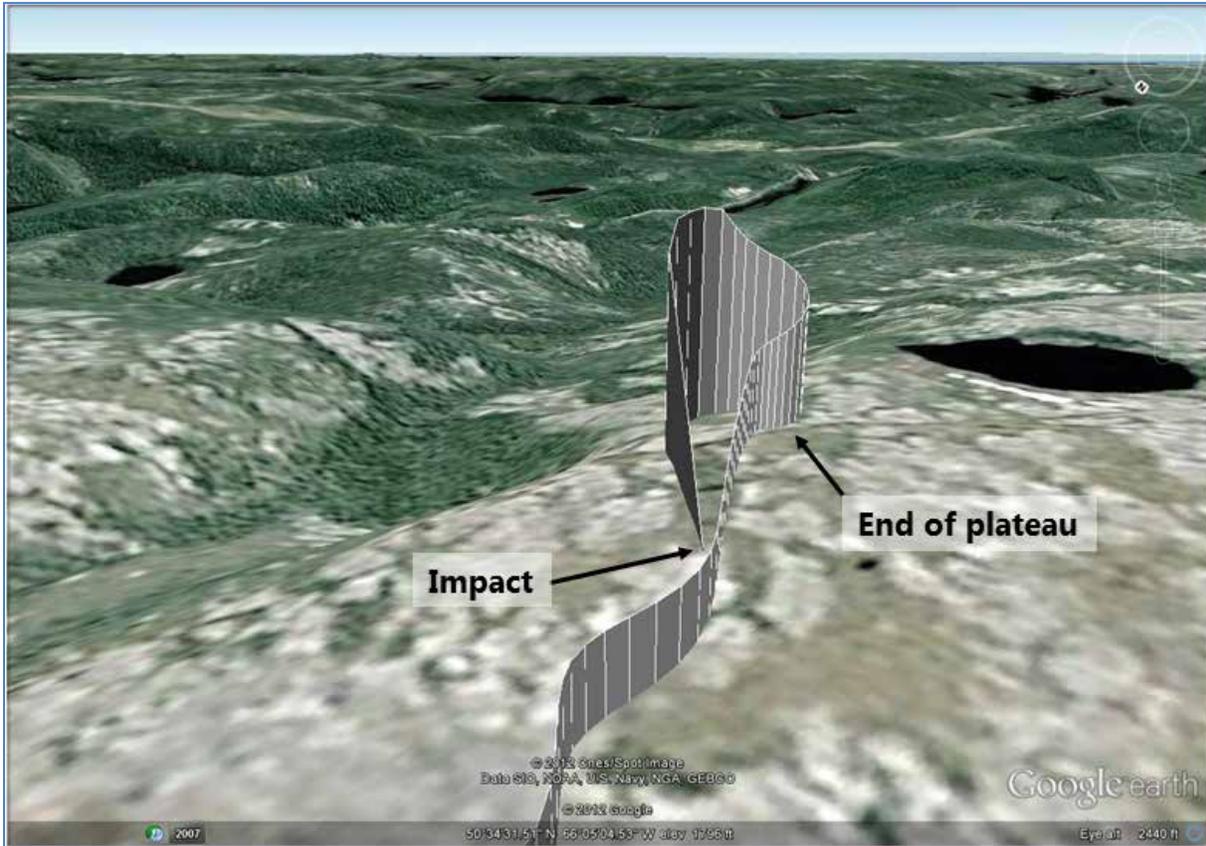
At 1201:5, the helicopter reached the southeast edge of the plateau, where the ground quickly descends towards the Moisie River valley. The helicopter began climbing, levelling off at about 300 feet above the plateau while turning left; less than 4 seconds later it struck the ground at a steep angle, in a northwest direction (Figure 3). The accident occurred at 1201:37.

Figure 3. Satellite image of terrain overlaid with a flight profile showing the helicopter’s position at 1-second intervals preceding impact

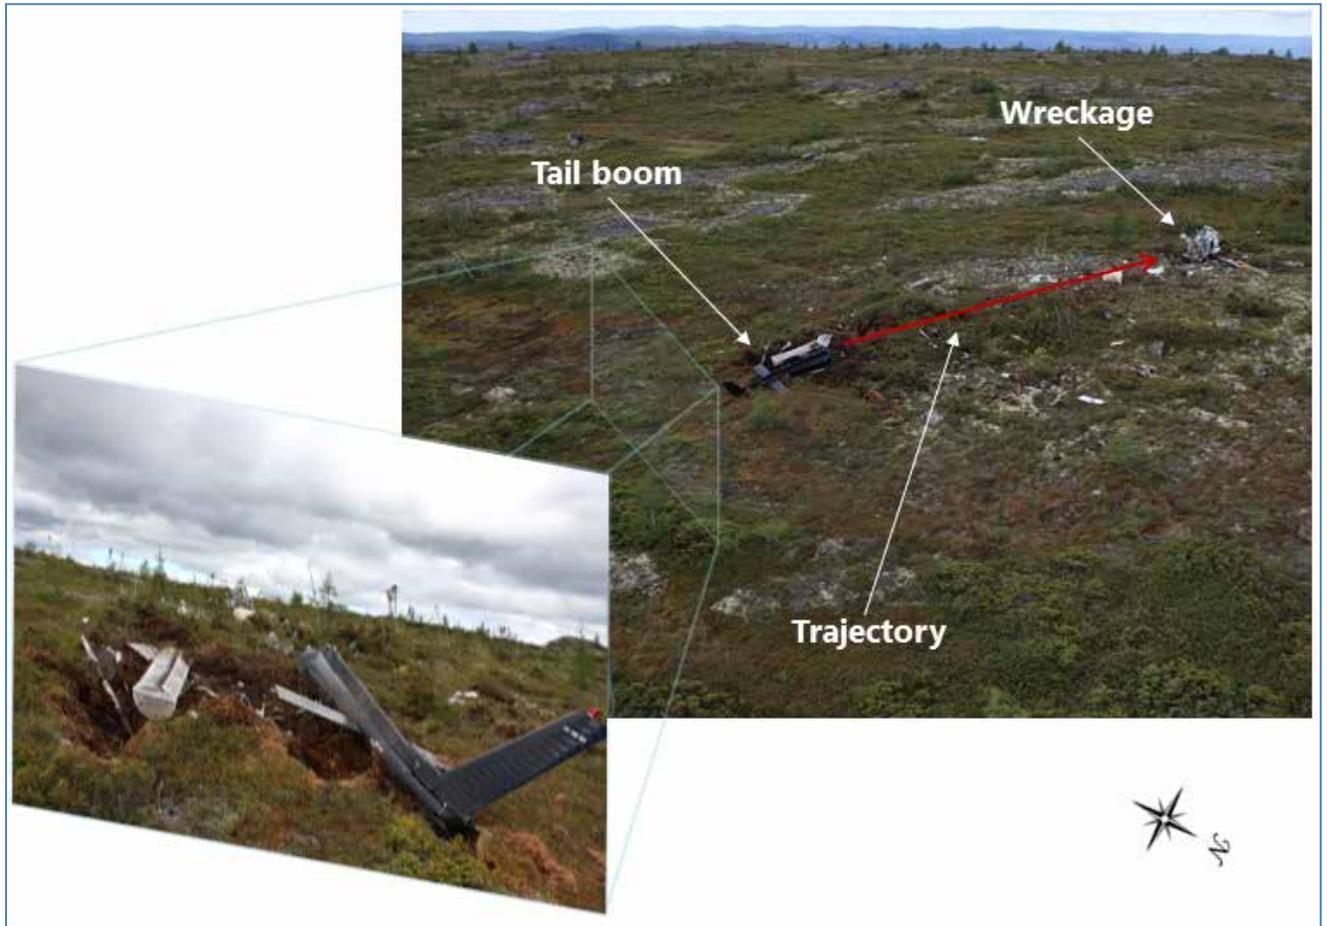
The tailskid left a straight furrow of about 6 feet before the crater caused by the impact of the helicopter. The crater rim had an angle of about 45° and was about 3 feet deep. The tail boom was severed; the 2 skids and the carrying basket remained in the crater (Figure 4). The main rotor crashed through the front of the cabin and severed the instrument panel. The helicopter then bounded and came to rest on its back 90 feet away.

Figure 4. Photographs of accident site showing helicopter wreckage and breakup trajectory

The possibility of hydraulic failure or a malfunction of the flight controls was eliminated. According to the analysis performed by the TSB Laboratory, engine torque was at the maximum allowable limit at the time of impact with the ground, indicating that the pilot fully applied the collective. Hydraulic failure or a flight control malfunction would have caused an uncoordinated shift and a sharp yaw to the left when the collective was applied. However, the groove left on the ground by the tailskid and the breakup trajectory were rectilinear.

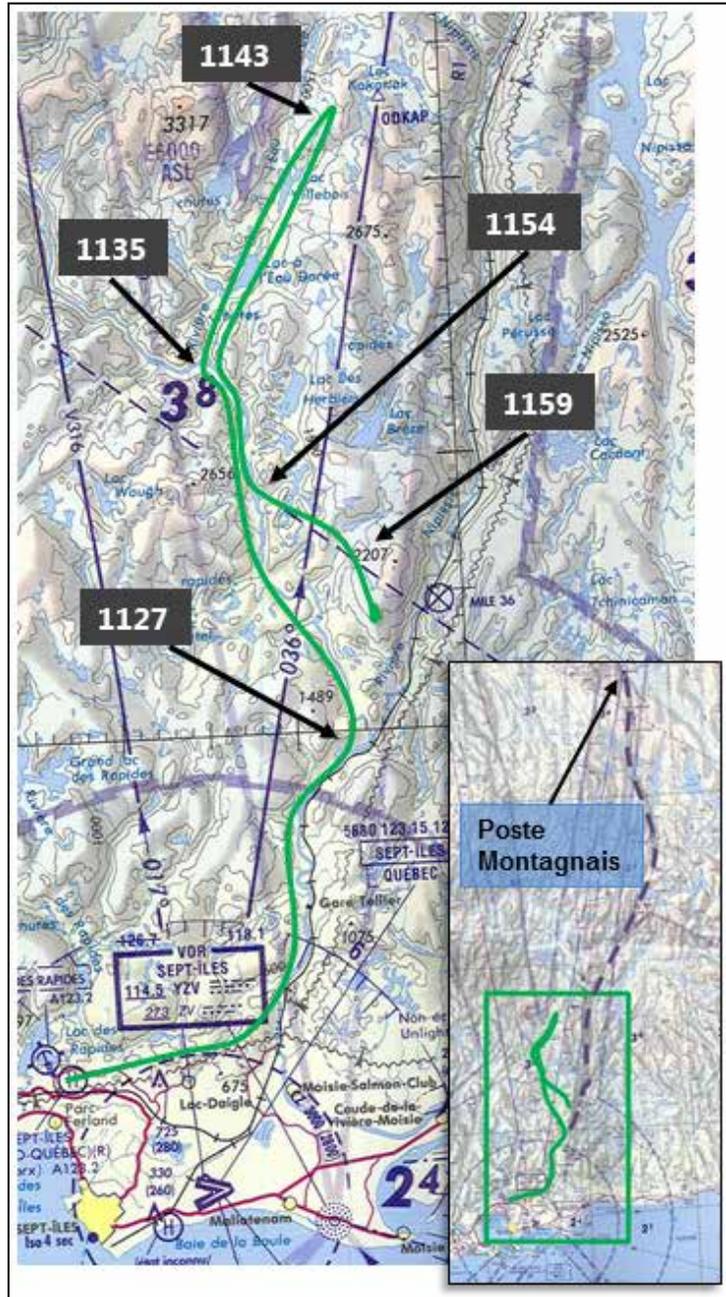
At the junction of the Nipissis River, the pilot continued over the Moisie River instead of maintaining the flight path and following the railway tracks north (Figure 5, 1127). It was not possible to determine why the pilot made this decision.

Eight minutes later, the pilot turned right, leaving the Moisie River and taking a valley towards Poste Montagnais (Figure 5, 1135). However, he made a half-turn at the end of that valley (Figure 5, 1143), going back to the Moisie River. The reduction in speed before the half-turn indicates that visibility was reduced at the end of the valley and that the mountain pass, which was over 2000 feet asl, was in the clouds.

While flying south over the Moisie River, he veered left towards the mountains in the east (Figure 5, 1154). At this point, the helicopter had been in flight 43 minutes and had consumed about 215 pounds of fuel, leaving 385 pounds on board, or fuel endurance of 1 hour 17 minutes.

Figure 5. Map showing flight path with time indications
