**AVIATION INVESTIGATION REPORT  
A10Q0218**

**ENGINE FAILURE AND HARD LANDING  
ESSOR-HÉLICOPTÈRES INC.  
BELL 206B (HELICOPTER), C-GIFV  
CAP-CHAT, QUEBEC  
09 DECEMBER 2010**

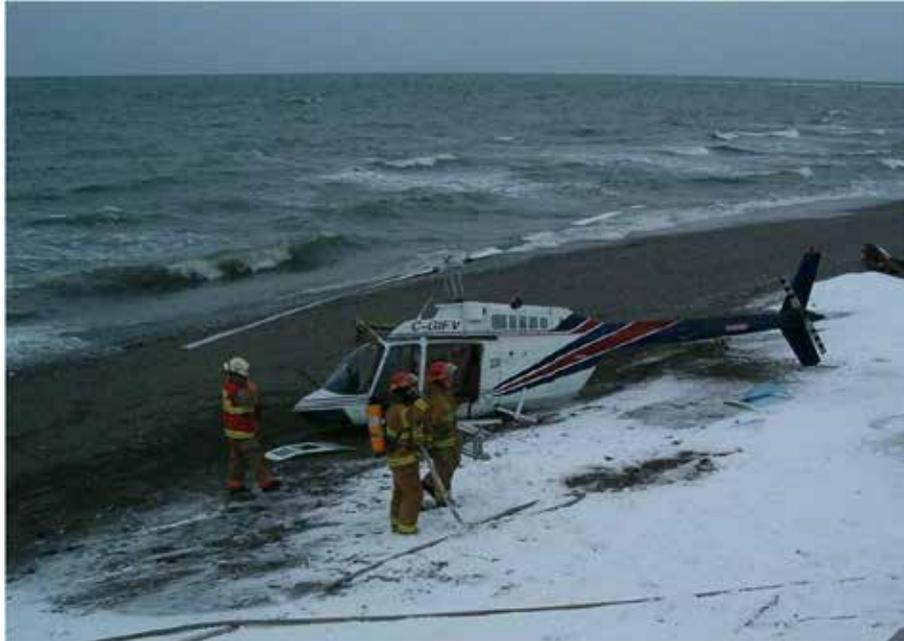
**Photo 1.** View of the wreckage

At 1042, C-GIFV landed on the shore of the Saint Lawrence 1 nautical mile (NM) north of Matane Airport and the pilot shut off the engine. At 1104, the helicopter resumed the survey flight, heading northeast. Approximately 27 minutes later, when the helicopter was 120 feet above the river and 75 feet from the shore, travelling at 70 knots, there was a bang and the aircraft briefly yawed right. A few seconds later, another bang was heard. The pilot immediately lowered the collective and turned right to land on the beach into the wind. The low rotor rpm warning horn sounded during the descent. The aircraft landed hard on the sand and the landing gear broke (Photo 1).

The aircraft had forward speed when it crash-landed on the beach. The skids sank into the sand, causing rapid deceleration and then the rotor mast and gearbox to topple forward. The movement of the gearbox broke the forward joint of the gearshaft connecting the engine to the main gearbox. This movement also caused the hydraulic pump housing and shaft to break. Examination of the aircraft revealed that all damage observed on the fuselage, rotor assembly, flight controls, and power train resulted from the impact with the ground.

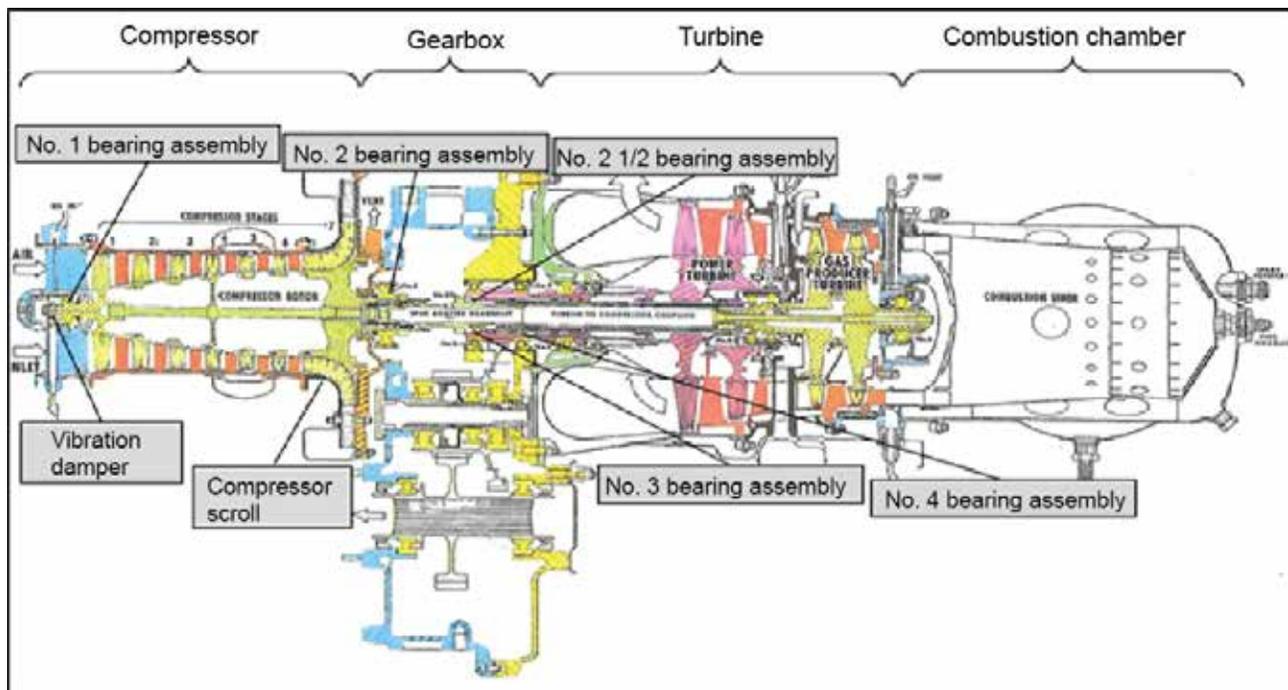
**Figure 1.** Rolls-Royce 250-C20B turboshaft engine

The engine is a turboshaft modular-type engine and consists of a compressor, a gearbox, a turbine, and a combustion chamber (Figure 1). It is rated at 420 shp (shaft horsepower).
