**AVIATION INVESTIGATION REPORT
A15A0045**

**COLLISION WITH WIRES
CANADIAN HELICOPTERS LIMITED
AIRBUS HELICOPTERS AS 350 BA (HELICOPTER), C-GBPS
RIGOLET, NEWFOUNDLAND AND LABRADOR, 5 NM WSW
30 JULY 2015**

Aviation Investigation Report A15A0045

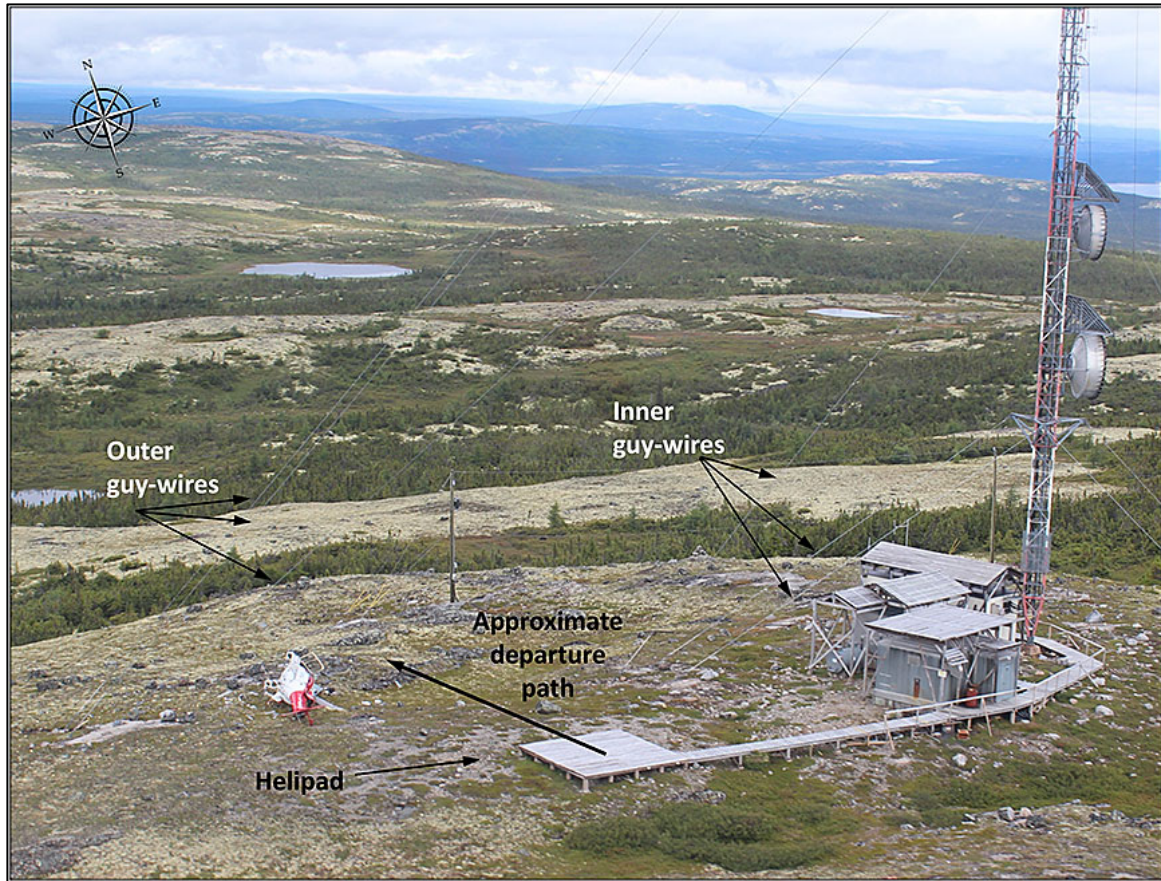
Photo 1. Occurrence site – Moliak microwave tower site

The helicopter was just clear of the helipad and about 2 metres above downward-sloping terrain, when the contractor touched the pilot's left shoulder. The pilot's attention was drawn left and he then saw the tower guy wires in front and to the left of the helicopter. As the pilot moved the cyclic control aft and to the right to avoid the wires, the helicopter's main rotor struck a guy wire. The helicopter rolled rapidly to the right, struck the ground and settled on its upper right side directly below the outer guy wires (Photo 1).

The main guy wire, the lowest of the 3 outer guy wires located west of the microwave tower, was damaged by one of the main rotor blades.

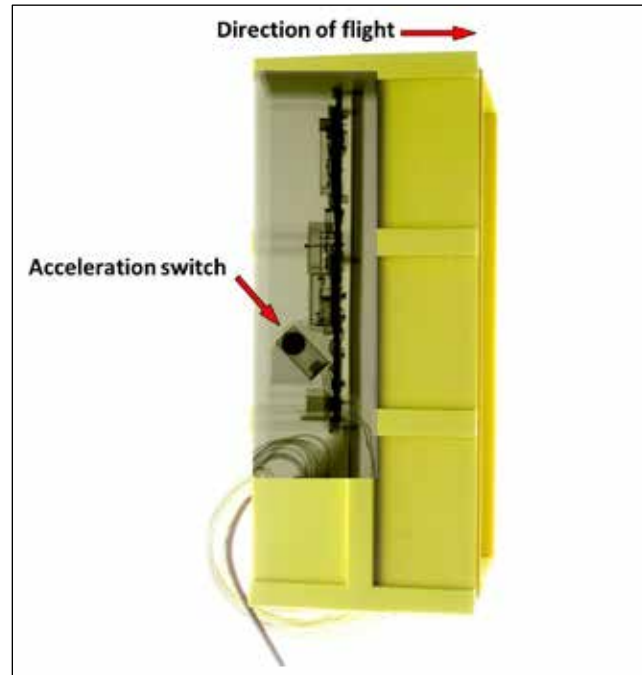
Figure 1. Kannad 406 AF-H ELT (with superimposed TSB radiograph of acceleration switch installation)

When installed in a helicopter, the ELT's acceleration switch axis of detection is angled 45° down in relation to the longitudinal axis of the helicopter in the direction of forward flight (Figure 1).

The helicopter struck the ground on its right side. The ELT did not automatically activate due to insufficient impact forces along the acceleration switch axis of detection.

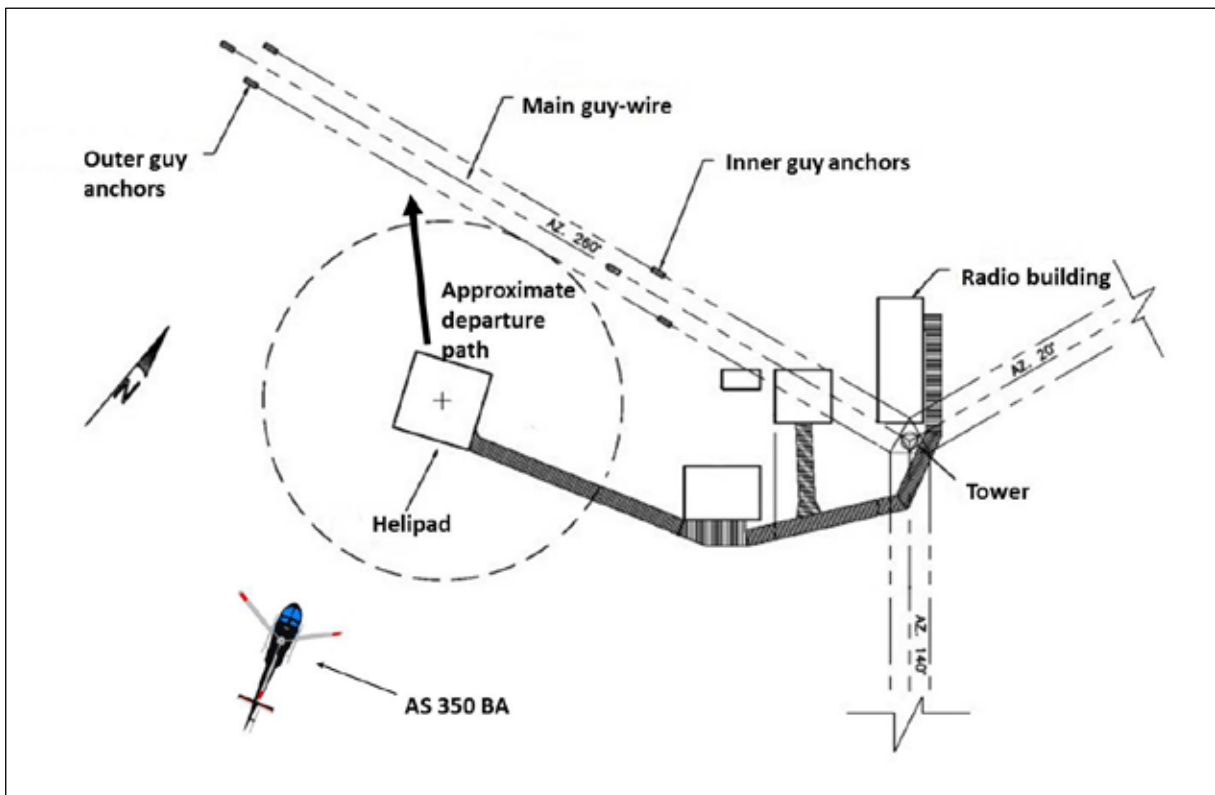
Figure 2. Moliak microwave tower site layout (Source: Bell Aliant with TSB annotations; scale approximate. Helicopter shown for reference only)

The Moliak microwave communications tower site is operated by Bell Aliant and is constructed at the top of a hill at an elevation of 365 metres. The tower height is 67.1 metres above ground and is supported on 3 sides (120° azimuth spacing) by steel cable guy wires, arranged in inner and outer groups of wires. The inner group of 3 wires are anchored about 25 metres from the tower, and the outer group of 3 wires are anchored about 55 metres from the tower (Figure 2).

The 3 small buildings at the site contain communications and power generation equipment and are connected by raised walkways covered with wooden decking. One such walkway extends about 35 metres west of the tower to the helipad, which is a raised square wooden deck about 0.5 metre above ground level and about 6 metres square. The centre of the helipad is about 14 metres away from the closest guy wire.

Moliak is the only Bell Aliant site with the helipad located within the circumference of the outer guy wire anchor points.

The investigation determined that all of the guy wires were visible from an AS 350 helicopter when parked facing north on the helipad, but did not have high-visibility markings.

- Following this occurrence, the helipad at Moliak was moved outside of the circumference of the outer guy wire anchor points.
- Bell Aliant collaborated with CHL to conduct reviews of all Labrador tower sites to identify hazards. The resulting mitigation includes activities such as removing old wind turbines and high brush, and installing high-visibility guy wire marking at all sites.
- A process has been undertaken to contract an independent organization to conduct risk assessments at all Bell Canada sites accessed by aircraft (sites that would not have an airport used for landing), and to audit all aviation service providers used by Bell Canada.

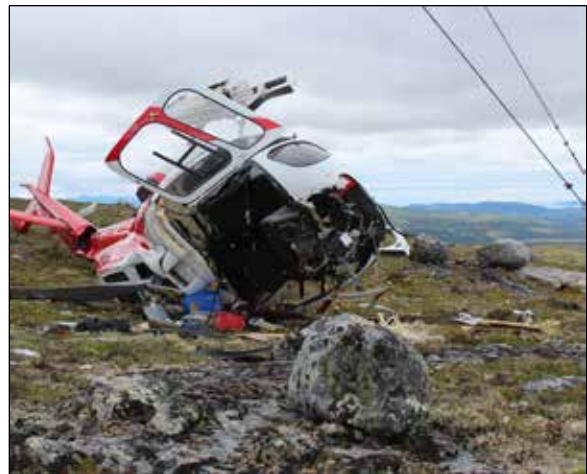
Photo 2. Occurrence helicopter

The helicopter's main rotor hub assembly and blades were destroyed from high-energy impact damage. The forward cabin roof, windscreen and nose section were destroyed from main rotor blade impact. The right cabin door was destroyed, the tail boom was fractured, and the upper aft cabin structure, engine and its cowling received substantial damage from ground contact (Photo 2).
