**AVIATION INVESTIGATION REPORT
A15C0134**

**INCORRECT FUEL TYPE AND FORCED LANDING
KEYSTONE AIR SERVICE LTD.
PIPER PA-31-350, C-FXLO
THOMPSON, MANITOBA, 1 NM SW
15 SEPTEMBER 2015**

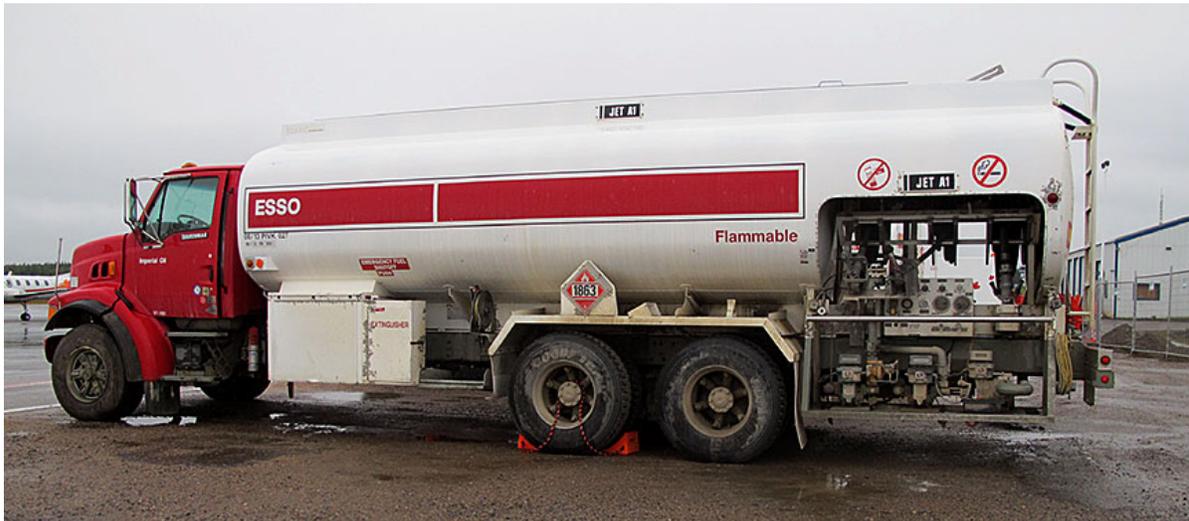
Prior to the arrival of KEE208, the AFHT in CYTH fuelled an aircraft with Jet-A1 fuel and returned in the fuel truck (Photo 1) to the fuel dealer's office. The AFHT parked the Jet-A1 fuel truck outside the office, left it running, and entered the building.

Photo 1. Jet-A1 truck

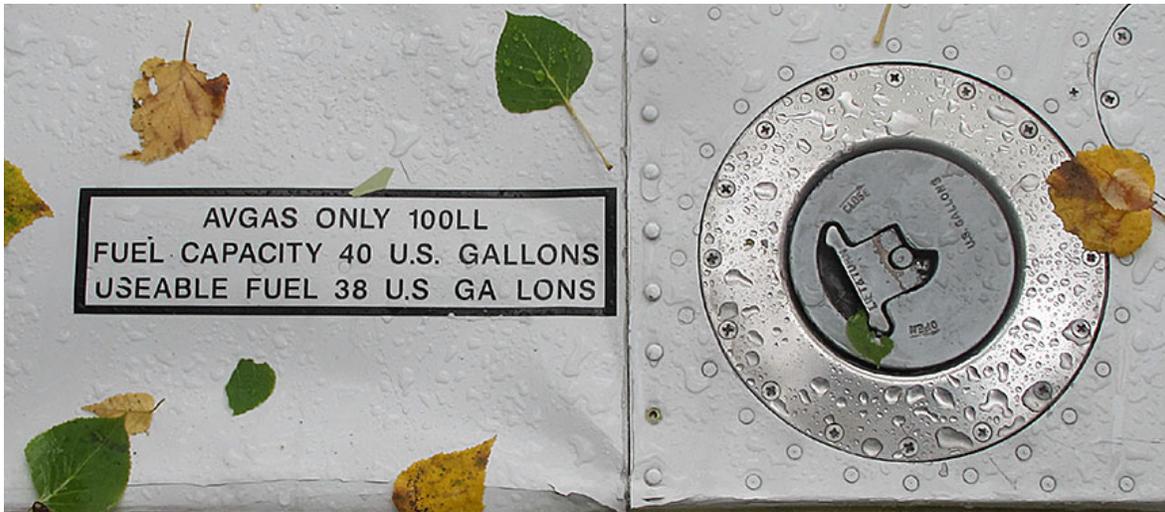
The AFHT did not see the fuel-type placards adjacent to the aircraft filler openings, but noted that the Jet-A1 flared spout² did not fit into the aircraft's fuel filler opening (Photo 2). The AFHT removed the Jet-A1 flared spout and replaced it with a reduced-diameter spout (Photo 3).³ The aircraft was fuelled with 406 litres of Jet-A1, distributed among all 4 tanks. After the fuelling was completed, the Jet-A1 flared spout was re-installed. The AFHT printed a fuel slip and recorded the removal and re-installation of the Jet-A1 flared spout in the fuel truck's Depleting Inventory Log. The AFHT drove back to the fuel dealer building, parked, and shut down the truck.

Photo 2. Placard and fuel filler opening

A placard is required to be installed on the wing surface near each fuel filler opening specifying the fuel type and minimum grade required.⁴ On the occurrence aircraft, adjacent to 3 of the fuel filler openings, was a placard that specified the aircraft's fuel type and grade as well as its fuel capacity (Photo 2). The placard adjacent to the left-main fuel filler opening

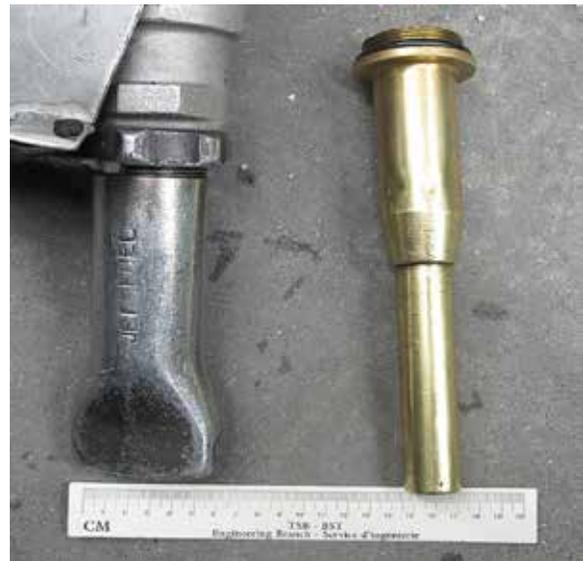
Photo 3. Exemplar flared spout (left) and reduced-diameter (brass) spout

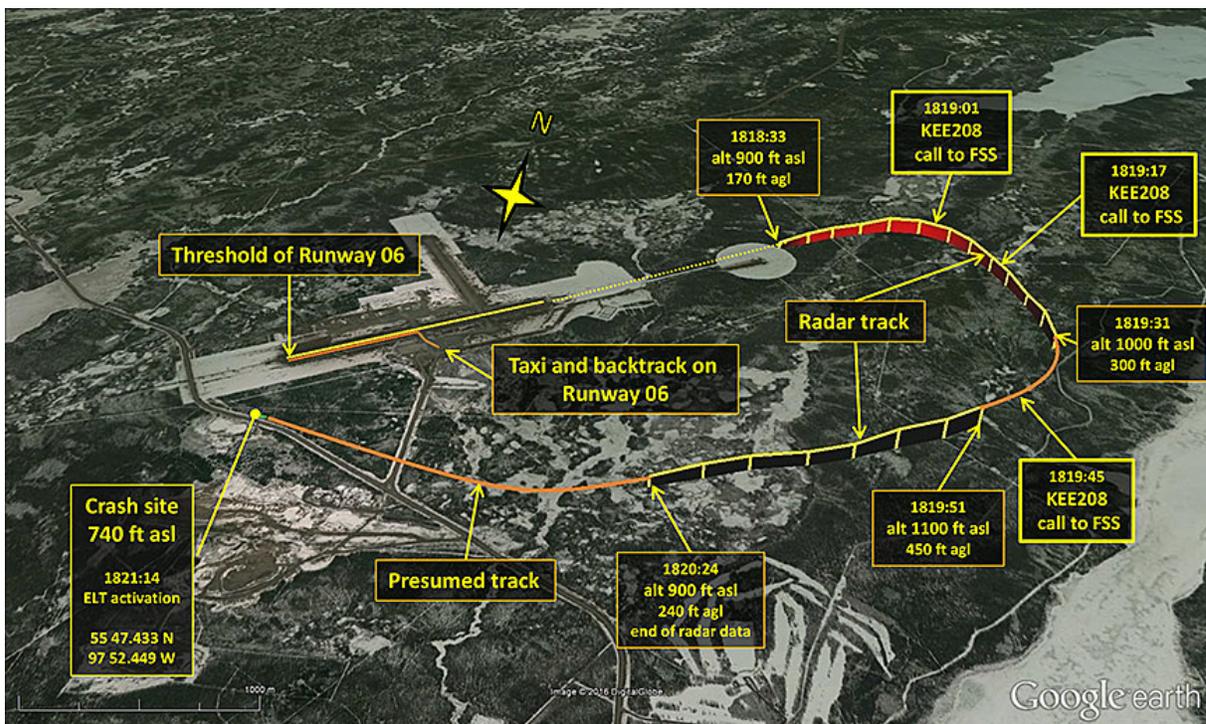
Figure 1. Aerial view of Thompson Airport, showing the flight path of KEE208 as plotted by radar (Source: Google Earth, with annotations by TSB)

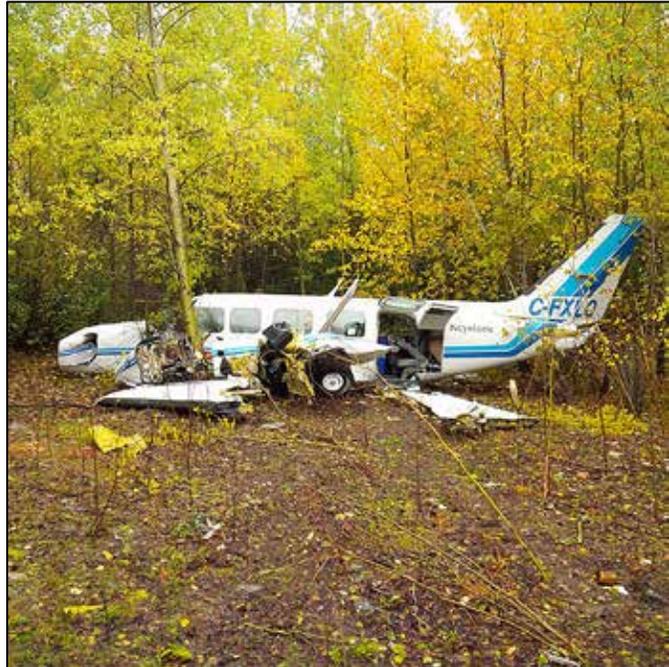
The descent angle through the trees to the impact point of the main landing gear was about a 10° descent angle in a nose-high, wings-level attitude. From the initial impact point, the aircraft travelled another 30 m before coming to a stop. The total length of the wreckage trail from the first tree impact was approximately 76 m. The crash site was a partial clearing strewn with rocks, debris, and scrap metal, indicating that the area was likely an old dump site.

Both of the aircraft’s horizontal stabilizers had broken away. The wings were torn off outboard of both engine nacelles. The wing flaps were up and the landing gear was down at impact.

The nose landing gear fork and wheel assembly had broken away, and the remaining portion of the nose landing gear leg had been forced back into the wheel bay by the impact. The left main landing gear oleo strut was bent back by 90°. The right main landing gear leg

Photo 4. Accident site
