Air Transportation Safety Investigation Report A18O0093

COLLISION WITH TERRAIN

Champion 7GCAA, C-FXTJ
Deer Lake, West Nipissing, Ontario
08 July 2018

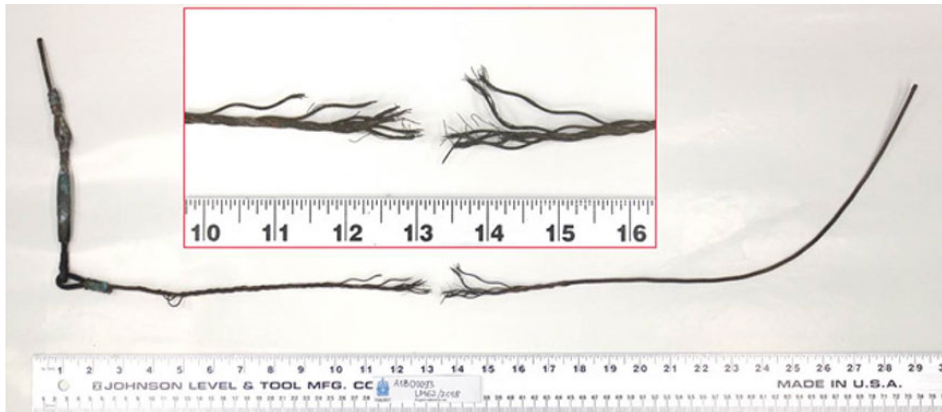
Figure 1. Fractured nose-up elevator control cable

During the examination of the flight controls, it was noted that the nose-up elevator control cable was frayed and split where the cable would normally travel over the first guide pulley forward of the empennage. The nose-up elevator control cable is a primary flight control cable that raises the elevator when tension is applied, which results in increased nose-up pitch. Both ends of the fractured cable (Figure 1) were recovered and sent to the TSB Engineering Laboratory in Ottawa, Ontario, to determine whether the cable damage had occurred before or during the accident sequence.

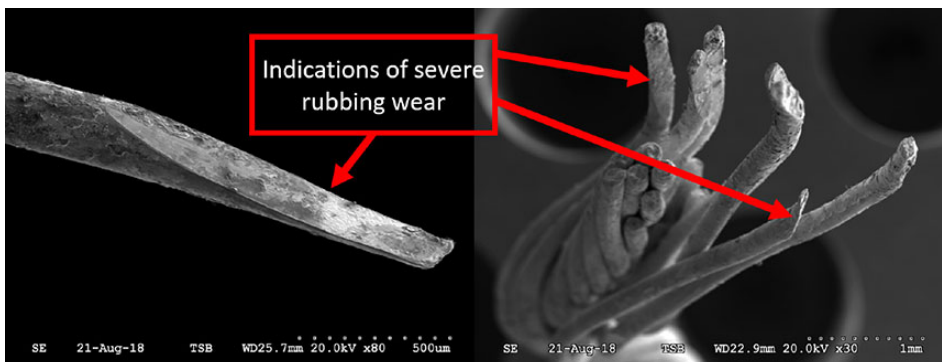
Figure 2. Micrograph of the nose-up elevator control cable's fractured surfaces

The split cable was examined using a scanning electron microscope. The stainless steel nose-up elevator control cable was made up of 7 wound bundles of wires, each containing 19 individual wires. Although the cable had been damaged in the post-impact fire, the examination was able to determine that there were 2 types of wire separation at the split:

- 81 of the split wires exhibited cup-and-cone fractures. This type of fracture is normally indicative of tensile overload, or more simply, when wires fail under tension.
- 52 of the split wires (39% of the total) exhibited severe rubbing wear (Figure 2), which contributed to the fracturing. These fractures likely occurred prior to the tensile overload.

Although it could not be determined with certainty that the nose-up elevator control cable, as a whole, failed in flight, it was determined that several wires within the cable failed due to severe rubbing wear before the remainder of the cable failed in tensile overload.

Primary control cable inspection is not explicitly described within basic annual inspection guidance for small private aircraft. Regular inspection and replacement, as necessary, of these cables could prevent a possible in-flight separation and a resultant loss of control.
