# Air Transportation Safety Investigation Report A18P0115

## LOSS OF CONTROL ON INITIAL CLIMB AND IMPACT WITH THE RUNWAY

Historic Flight Foundation  
de Havilland DH-89A MKIV Dragon Rapide (biplane), N683DH  
Abbotsford Airport, British Columbia  
11 August 2018

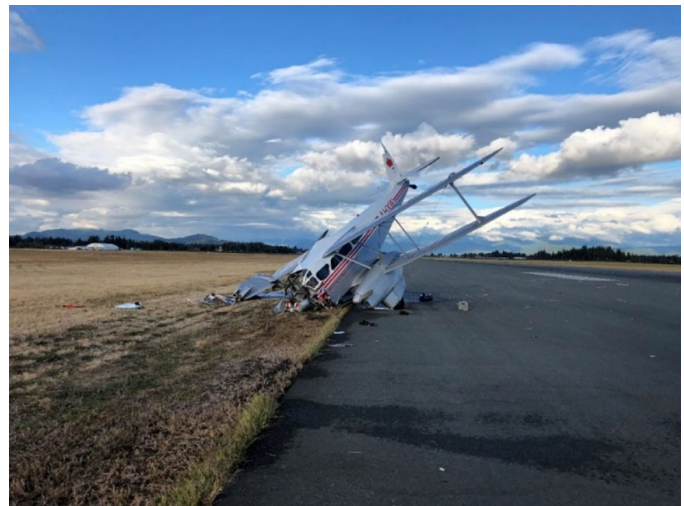
Figure 1. Wreckage and accident site (Source: Abbotsford Airport Authority)

During the takeoff, the aircraft encountered strong, gusting crosswinds. It climbed to about 30 feet above ground level before descending suddenly and impacting the runway, coming to rest on its nose immediately off the right edge of the runway (Figure 1).

The pilot and 1 passenger received serious injuries; the other 3 passengers received minor injuries. All of the aircraft occupants were taken to the hospital. The aircraft was substantially damaged. There was a fuel spill, but no fire. The emergency locator transmitter activated.

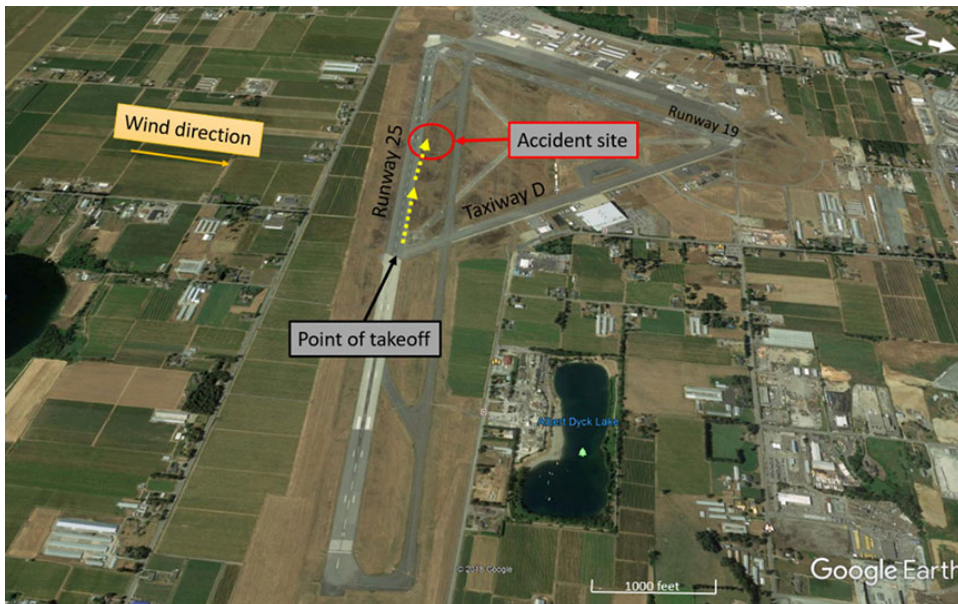
Runway 19 was the active runway at the time and was best oriented for an into-wind takeoff, however, about 60% of that runway was unavailable because of aircraft displays. As a result, the occurrence pilot elected to depart from Runway 25 at the intersection with Taxiway D (Figure 2). While issuing the takeoff clearance, the tower reported the winds to be from 180° at 10 knots, gusting to 15 knots.

Figure 2. Point of takeoff and accident site (Source: Google Earth, with TSB annotations)

While taking off, the aircraft encountered swirling winds, resulting in a sudden loss of airspeed shortly after becoming airborne. Video footage from multiple sources confirmed strong, gusting winds at the time of the accident.
