## **AIR TRANSPORTATION SAFETY INVESTIGATION REPORT A18A0085**

### **RUNWAY OVERRUN**

Sky Lease Cargo

Boeing 747-412F, N908AR

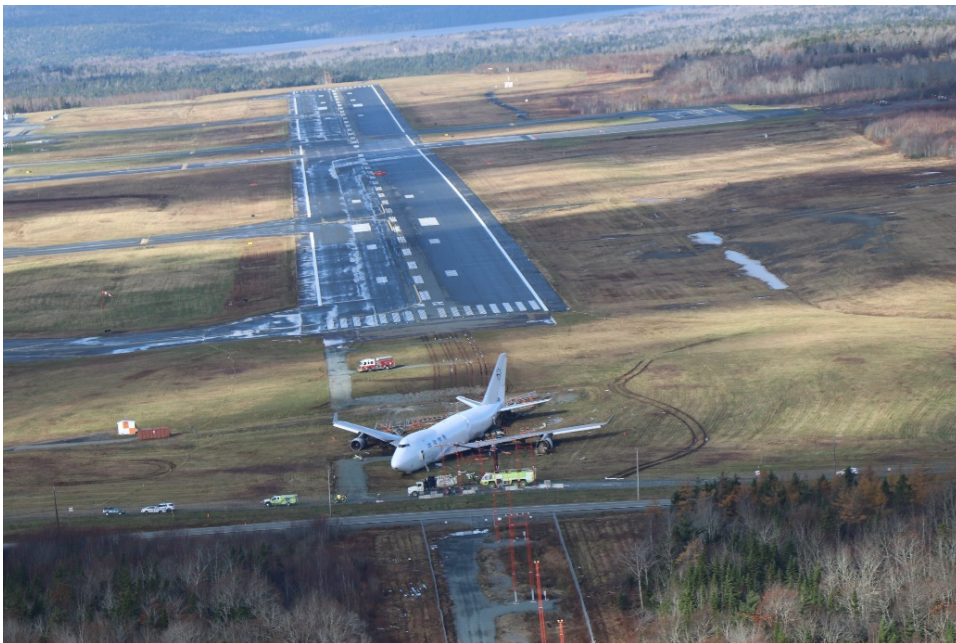
Figure 2. Occurrence aircraft’s final position (Source: Steve Lawrence / CBC Licensing)

The nose of the aircraft came to rest 270 m (885 feet) past the runway threshold, 21 m (70 feet) to the right of the extended centreline, and 47 m (155 feet) from a public road (Figure 2). The aircraft was on a heading of 166°M (23° right of the runway heading).

The No. 2 engine separated from the wing and was jammed under the left horizontal stabilizer and tail section, causing a fire in the tail section of the aircraft after the impact. ARFF extinguished the fire and laid foam to prevent spilled fuel from igniting. The emergency locator transmitter activated, and the tower controller requested that ARFF shut off the device. With the assistance of ARFF, the crew evacuated through the main deck entry door (1L) using a ladder.

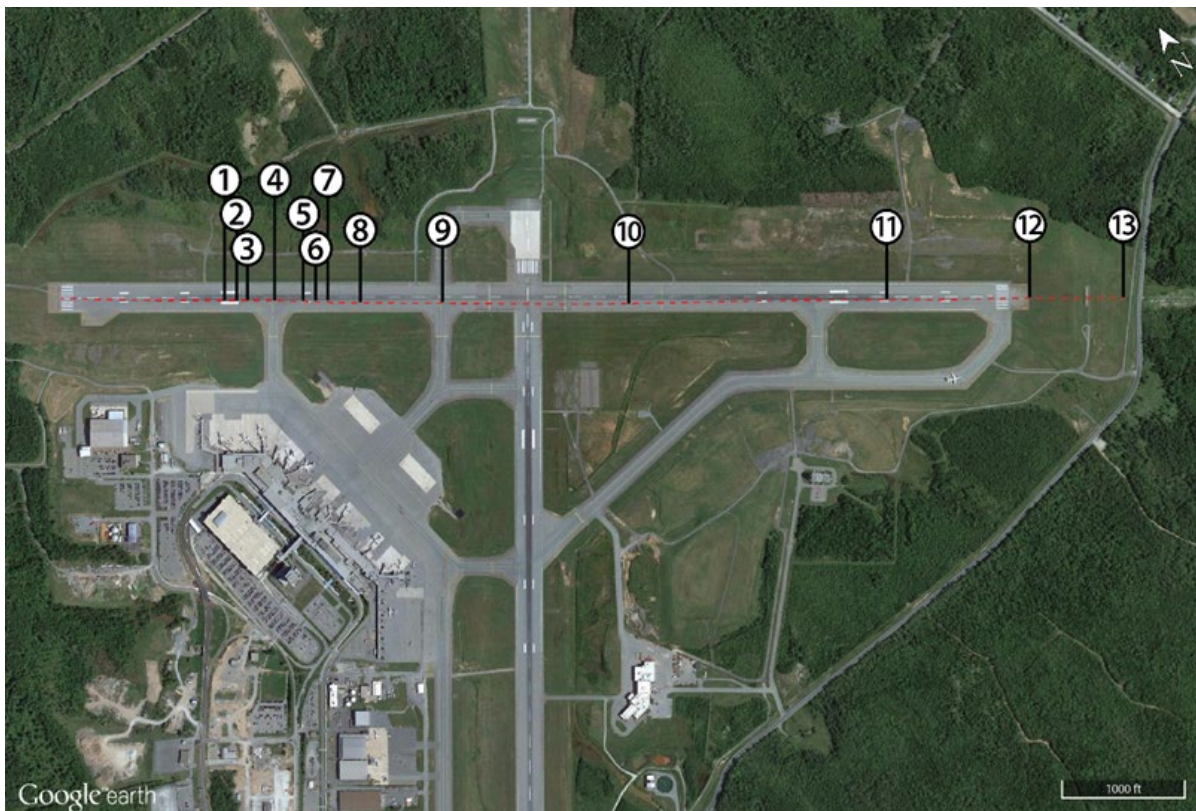
**Appendix B – Events during the landing roll out**

Position marked	Time	Activity
1	0505:37.95	Aircraft initially touches down
2	0505:38.30	Auto speed brake lever moves to the UP position
3	0505:38.56	No. 1 thrust lever is advanced above idle
4	0505:39.16	Auto speed brake lever moves to the DOWN position
5	0505:39.31	Thrust levers No. 2, No. 3, and No. 4 are brought into reverse thrust
6	0505:40.42	Air-ground logic switches indicate a momentary AIR mode logic position
7	0505:40.90	Air-ground logic switches indicate a GROUND mode logic position.
8	0505:41.69	No. 2, No. 3, and No. 4 thrust reversers are deployed
9	0505:44.02	No. 1 thrust lever is reduced; auto speed brakes are deployed to 100%.
10	0505:49.54	Maximum lateral deviation to the right of centreline
11	0505:59	Deceleration rate increases markedly
12	0506:06	Aircraft departs paved surface
13	0506:16 (estimated)	Aircraft comes to rest
