AIR TRANSPORTATION SAFETY INVESTIGATION REPORT A18A0088

LANDING WITH PARTIALLY EXTENDED LANDING GEAR

PAL Airlines Ltd.
Bombardier DHC-8-315, C-FPAE
Stephenville, Newfoundland and Labrador
15 November 2018

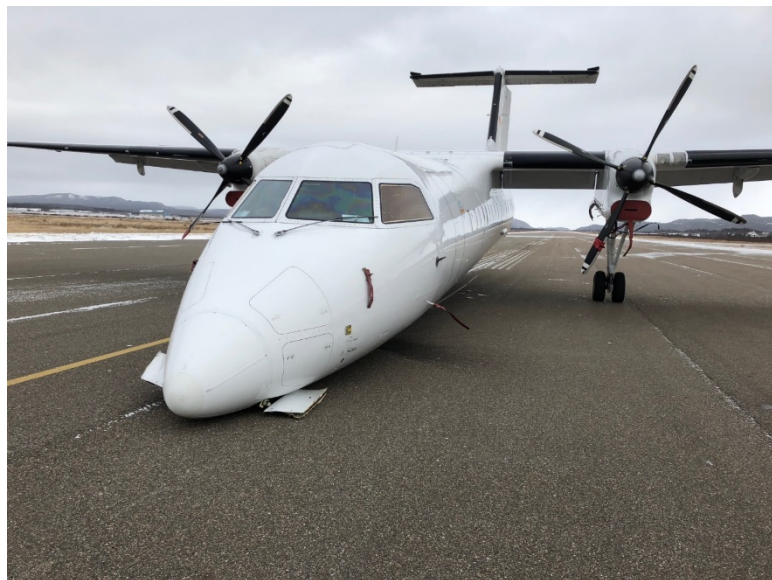
Figure 1. Occurrence aircraft at rest with the nose down (Source: PAL Airlines Ltd.)

The forward and rear NLG doors received crush and abrasion damage. The NLG tires received abrasion damage. The aircraft structure associated with the NLG door hinge attach area was deformed. The skin aft of the NLG bay, and an antenna mounted in this area, received abrasion damage.

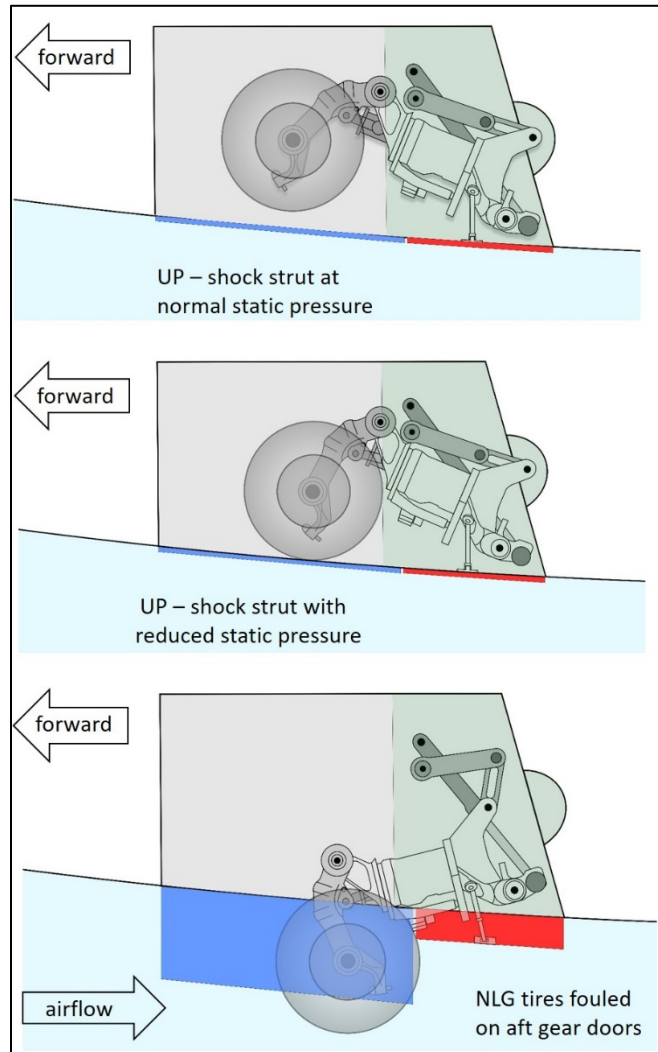
The inner cylinder was not permanently marked to indicate that the rework repair to the lower bore of the inner cylinder had been carried out. The bearing installed in the inner cylinder was a standard-size bearing, whereas an oversize bearing is required by the CMM for this repair. This resulted in an actual clearance that was 0.015 inch larger than required between the bearing and the lower bore of the inner cylinder, measured at the seal ring location.

The excessive clearance resulted in the seal ring having less interference on it (i.e., the seal ring was deformed, or squeezed less) compared to a seal ring installed with the required clearance. This condition had the effect of allowing the seal ring to have less sealing force.

Figure 6. Nose landing gear shock strut showing loss of internal static pressure and subsequent jamming of nose landing gear in a partially extended position (Source: TSB, based on information from FlightSafety Canada and Bombardier)

Examination of the NLG revealed that the NLG shock strut had deflated in flight due to a damaged component of the NLG shock strut seal ring assembly. It was determined that when the landing gear was lowered, slipstream acted to compress the NLG shock strut and allowed the tires to become fouled on the aft landing gear doors, thereby jamming the NLG in a partially extended position.

For undetermined reasons, a previous repair to the inner cylinder of the NLG shock strut was not designated with a specific permanent marking as required by the approved component maintenance manual, resulting in the installation of a standard size bearing where an oversize bearing was required. This resulted in excessive clearance between the installed bearing and the lower bore of the inner cylinder. The reduced sealing force caused by the smaller-than-required bearing installation likely allowed the NLG shock strut to leak.
