# Air Transportation Safety Investigation Report A18P0090

## VISUAL FLIGHT RULES FLIGHT INTO DETERIORATING WEATHER AND COLLISION WITH TERRAIN

Cessna 182P, C-GKKU  
Hope, British Columbia, 19 nm NE  
28 June 2018

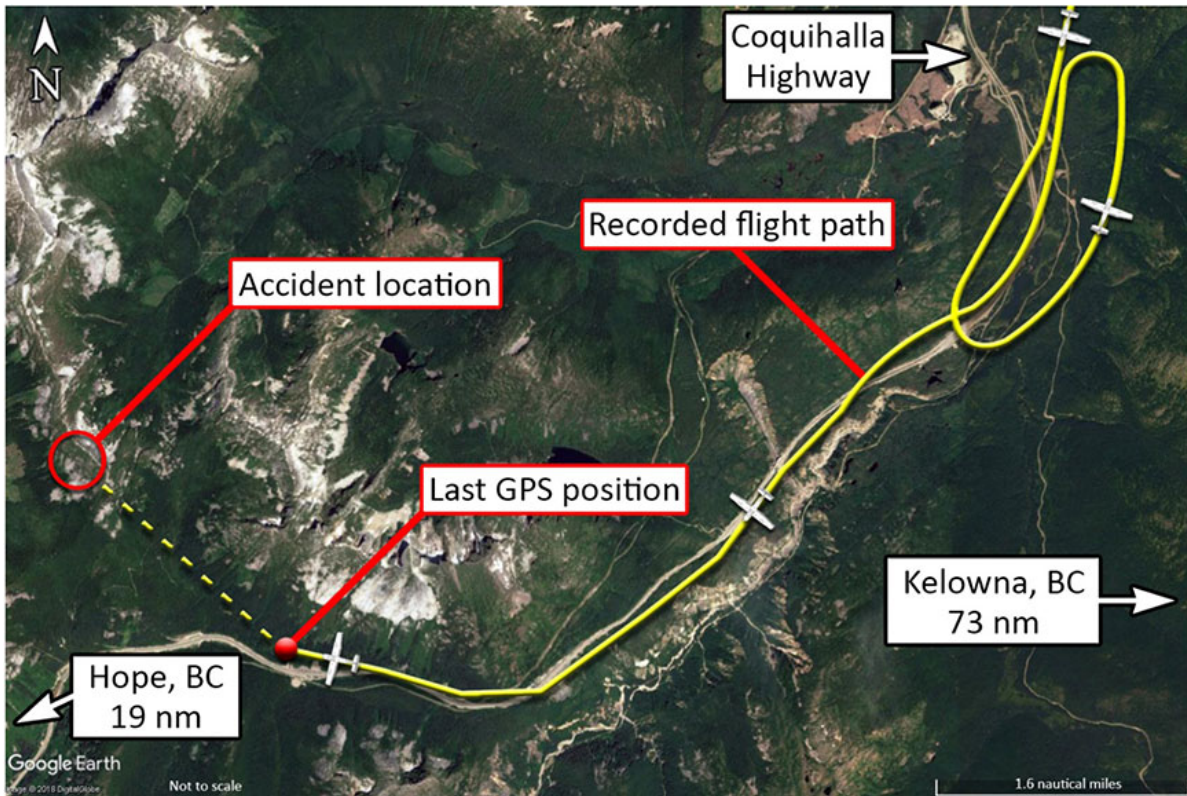
The last reliable global positioning system (GPS) position, at 1133, placed the aircraft in a climb at 4700 feet above sea level (740 feet above ground level) on a heading of 285° true. The aircraft flew northwest, away from the highway, and collided with a granite mountain slope (Figure 1).

Figure 1. Depiction of the aircraft's flight path, based on GPS data (Source: Google Earth, with TSB annotations)

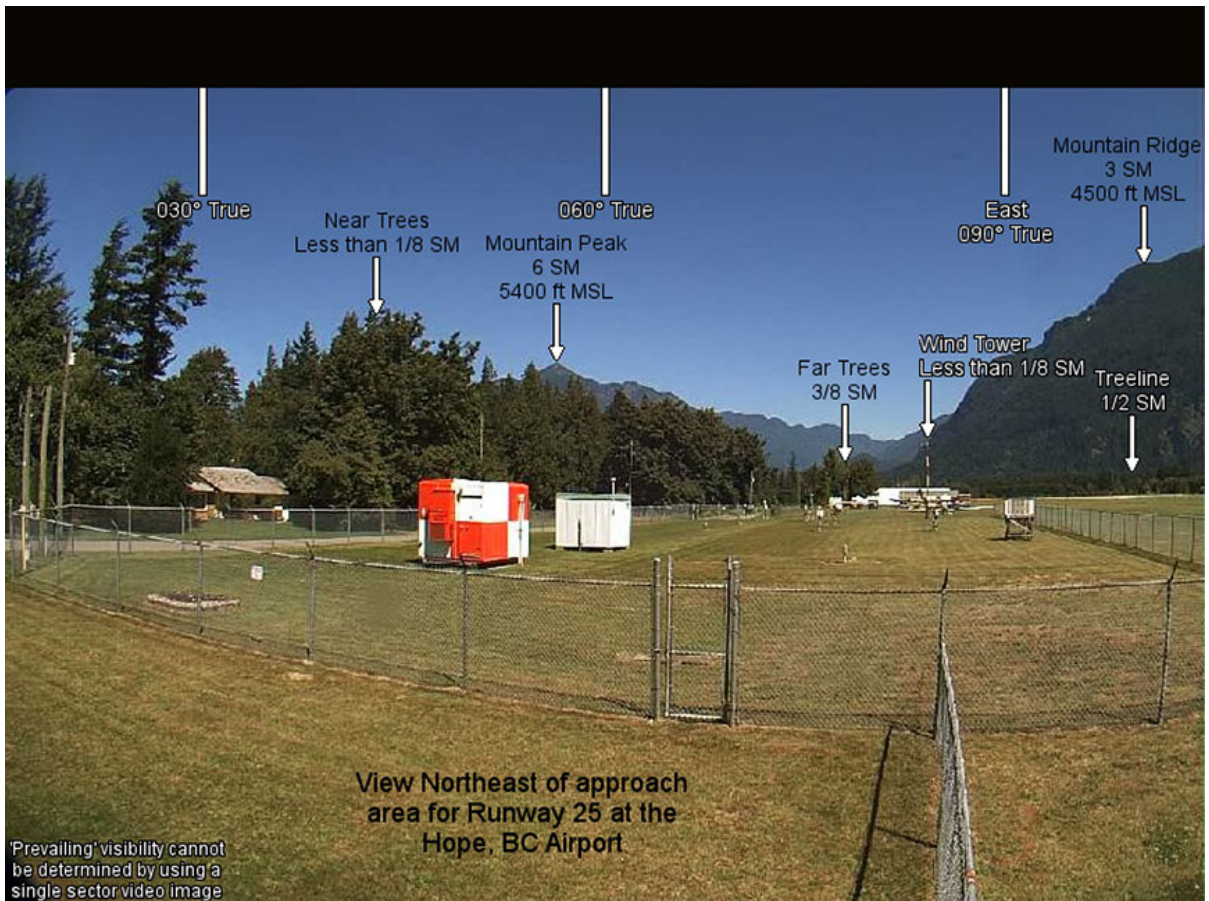
Figure 2. Northeast view taken at CYHE on a clear day (Source: NAV CANADA)

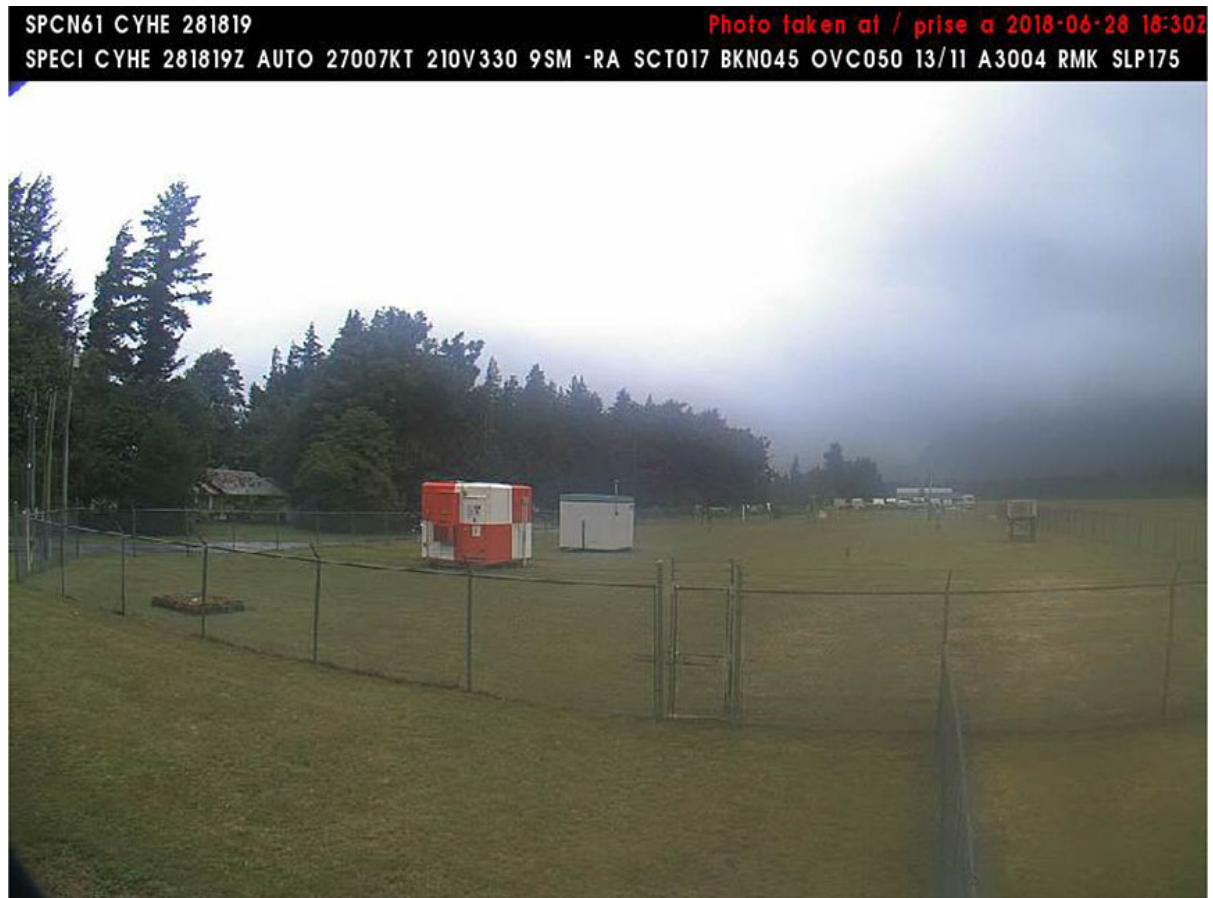
Figure 3. Northeast view taken at CYHE at 1130 on the day of the occurrence (Source: NAV CANADA)

Intermittent rain and low ceilings were reported in the Coquihalla Summit Recreation Area around the time of the occurrence. More specifically, thick cloud had accumulated along the mountains and against the slopes, obscuring the mountain tops.

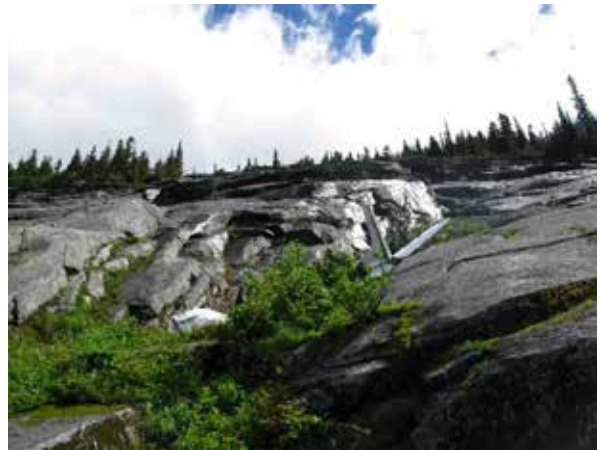
Figure 4. Accident site

Examination of the wreckage did not reveal any pre-existing mechanical conditions that could have contributed to the crash. All on-board flight instruments were destroyed. A portable GPS unit was found at the wreckage site and sent to the TSB Engineering Laboratory in Ottawa, Ontario, for data retrieval. The GPS provided a flight track for the occurrence flight.

The aircraft struck Zupjok Peak<sup>7</sup> on the northeast-facing slope at an elevation of 5800 feet. The aircraft then slid down the granite rock and came to rest at an elevation of 5200 feet (Figure 4), where it was consumed by fire.
