Air Transportation Safety Investigation Report A18W0052

LOSS OF NOSE WHEEL ON TOUCHDOWN

Air Georgian Ltd.
Beechcraft 1900D, C-GZGA
Calgary International Airport, Alberta
09 April 2018

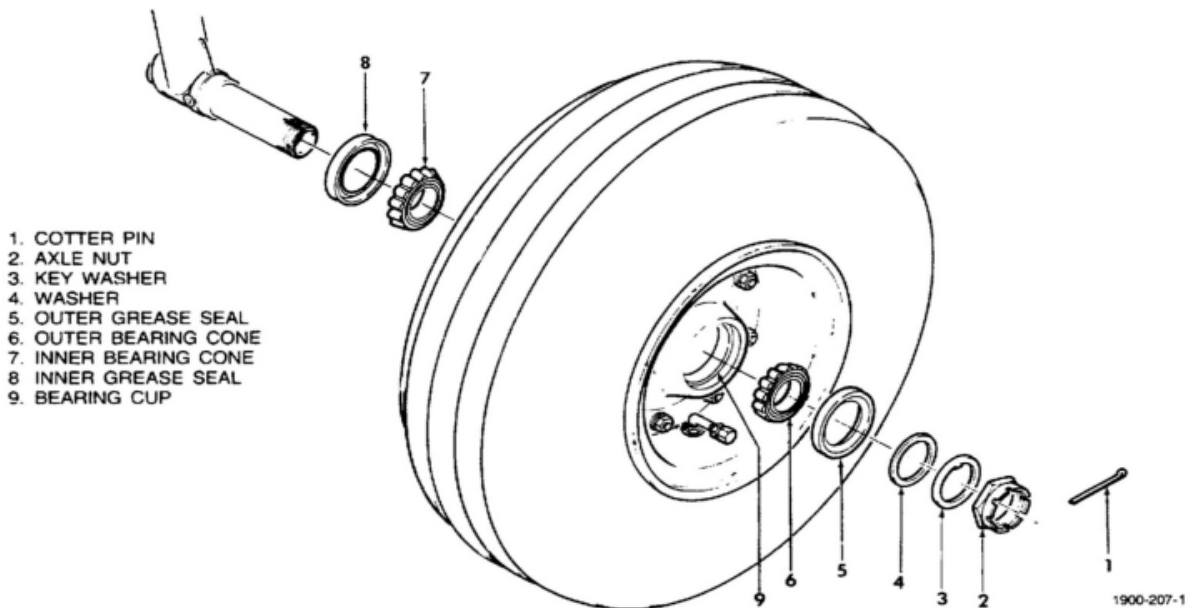
Figure 1. Beechcraft 1900D nose landing gear wheel (Source: Textron Aviation Inc., Beechcraft 1900D Maintenance Manual, Revision B12 [01 November 2009])

The day after the occurrence flight departed CYXC, the airport authority found remnants of wheel bearings on Runway 16. At CYXC, the nose wheel was found in the grass to the right of Runway 17R, and maintenance staff found the remains of nose wheel bearings on the runway. The axle nut, key washer, washer, and cotter pin (Figure 1) remained attached to the axle.

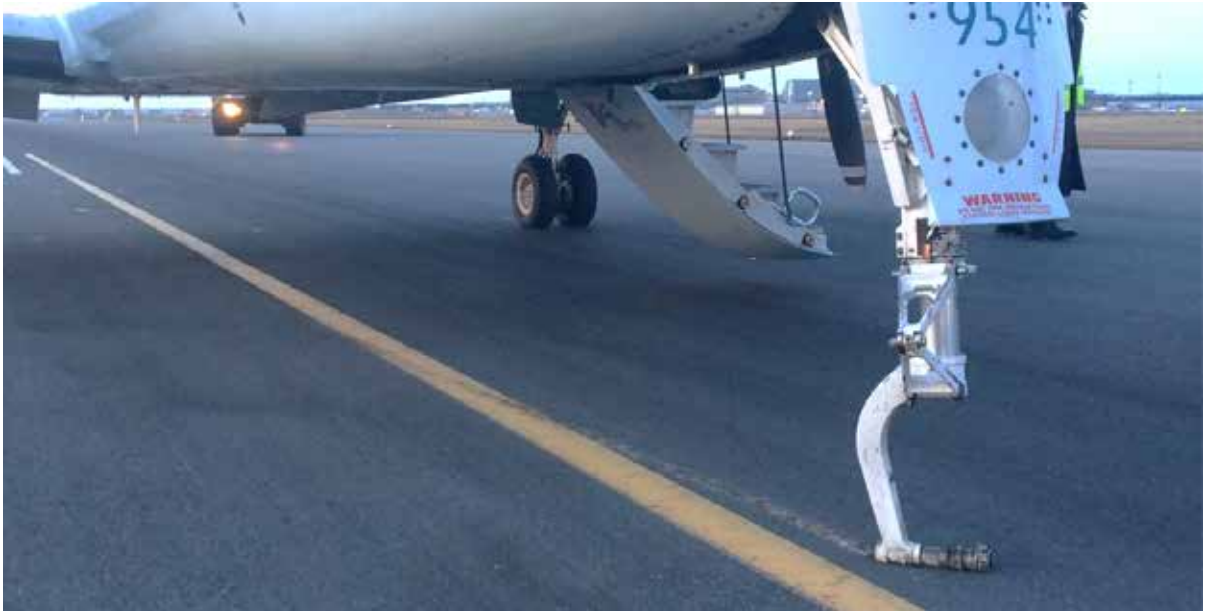
Figure 2. The occurrence aircraft on Runway 17R (Source: Calgary Airport Authority)

The aircraft sustained damage to the lower nose landing gear assembly. There was damage to the opening of the nose landing gear bay because the displaced nose wheel had come into contact with

it during the retraction cycles. The valve stem side of the nose wheel half bearing recess had been completely reamed out, allowing the wheel to slide over the retaining hardware. The aircraft slid approximately 1200 feet down Runway 17R after the nose wheel separated from the axle, leaving a scar in the runway surface. The axle and the heel of the lower nose landing gear casting were ground down to half of their normal diameter (Figure 2).

grease was used to push out the old grease and no cleaning or detailed inspection of the bearing was carried out. The old grease was then inspected for contamination. The bearings were rotated to check for freedom of movement and then installed. The investigation learned that although the company procedure reflects the manufacturer's requirement, the aircraft maintenance engineer who performed the work on the occurrence aircraft adapted one of the elements of the procedure.

- The work card has been modified to provide clearer guidance and additional notes referencing the bearing-cleaning methodology.
- A general (all maintenance employees) Maintenance Technical Bulletin was published describing cleaning, inspection, and lubrication best practices. The bulletin was to be posted for 6 months and required that all maintenance employees sign off after having read it.
- The aircraft maintenance engineer who performed the work was coached on the proper procedure to follow.
