# Air Transportation Safety Investigation Report A18W0098

## COLLISION WITH WIRES

Mosquito XE, C-FHEZ  
Okotoks, Alberta, 5.5 nm NE  
15 July 2018

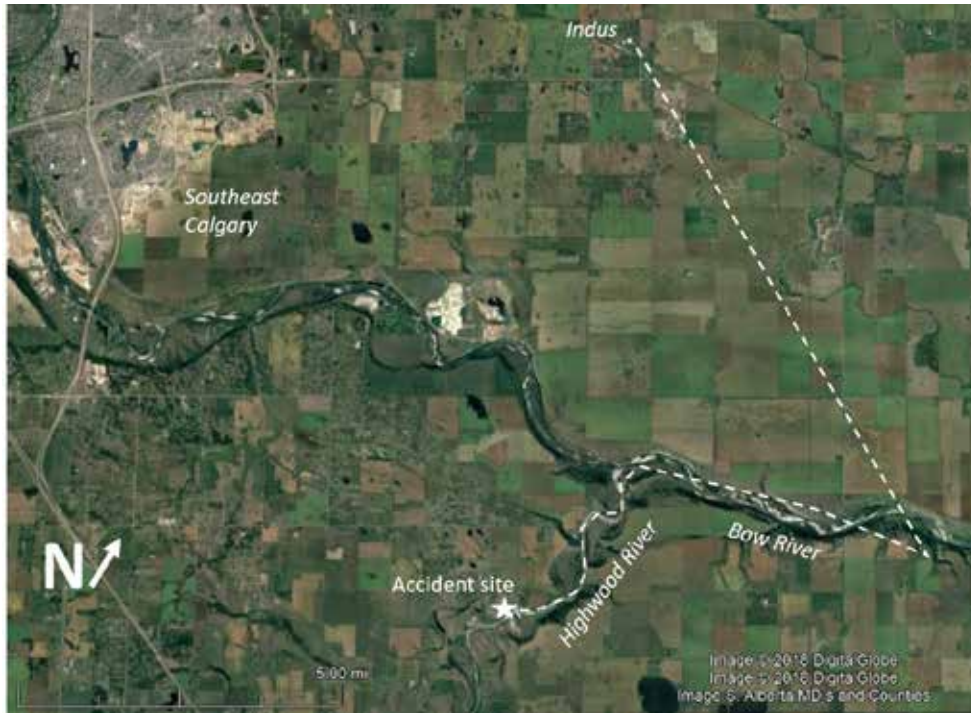
At about 1700<sup>1</sup> on 15 July 2018, the pilot departed from his residence north of Indus, Alberta, for a local flight in his amateur-built Mosquito XE helicopter (registration C-FHEZ, serial number 1004). The purpose of the flight was to visit a friend who lived south of the Bow River, Alberta, and east of the Highwood River, Alberta (Figure 1).

Figure 1. The approximate route of flight, based on data from the pilot's cellphone  
(Source: Google Earth, with TSB annotations)

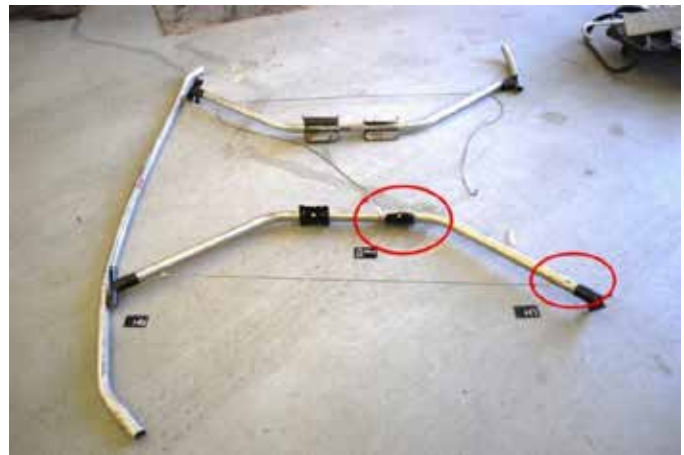
The flight control system was examined and no pre-impact failures were found. Damage to the main rotor and tail rotor systems were consistent with power being developed at the time of the accident. Examination of the helicopter's landing gear revealed that the left side of the forward cross tube struck a wire. Wire strike marks were observed across the forward cross tube (Figure 2 and Figure 3).

Figure 2. Helicopter landing gear parts recovered from the accident site (red circles denote areas with wire strike marks)

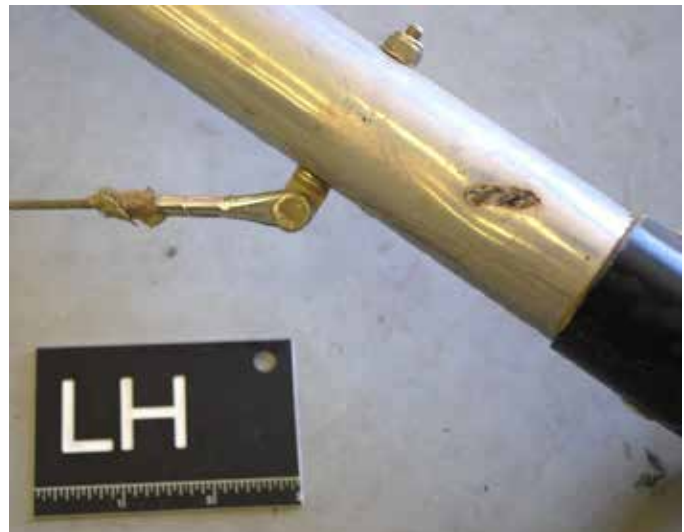
Figure 3. Close-up of lower left-hand cross-tube wire-strike mark

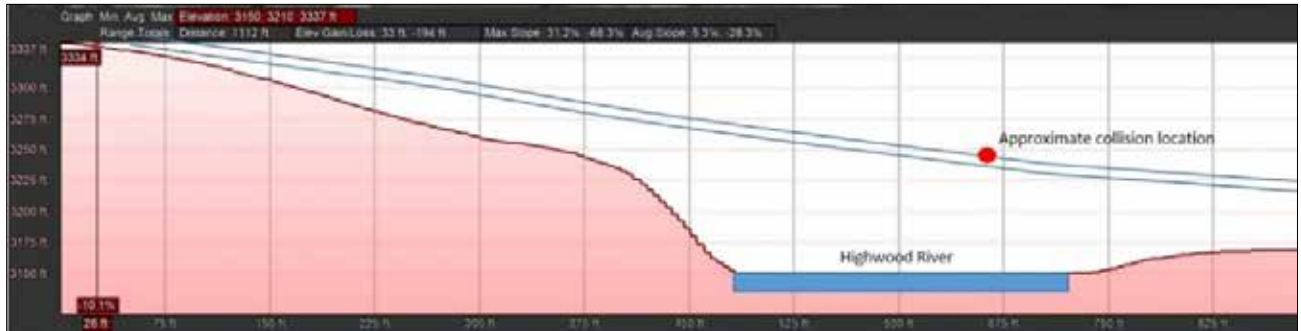
The span across the Highwood River is 1110 feet from the power pole on the north side to the power pole on the south side, which was located next to a residence. The power poles are approximately 35 feet tall. The height of the wires above the surface varied due to changes in terrain along the span. The height of the wire at the point where the helicopter struck it was approximately 80 feet (Figure 4). There were no markers on the wires and none were required by regulation.

Figure 4. Profile of terrain and location of power transmission line relative to the Highwood River, looking east toward the direction the helicopter was coming from (Source: Google Earth, with TSB annotations)
