## **AIR TRANSPORTATION SAFETY INVESTIGATION REPORT A19O0117**

### **RUNWAY INCURSION**

Air Georgian Limited  
Bombardier CRJ 200, C-GKEJ  
Toronto/Lester B. Pearson International Airport, Ontario  
09 August 2019

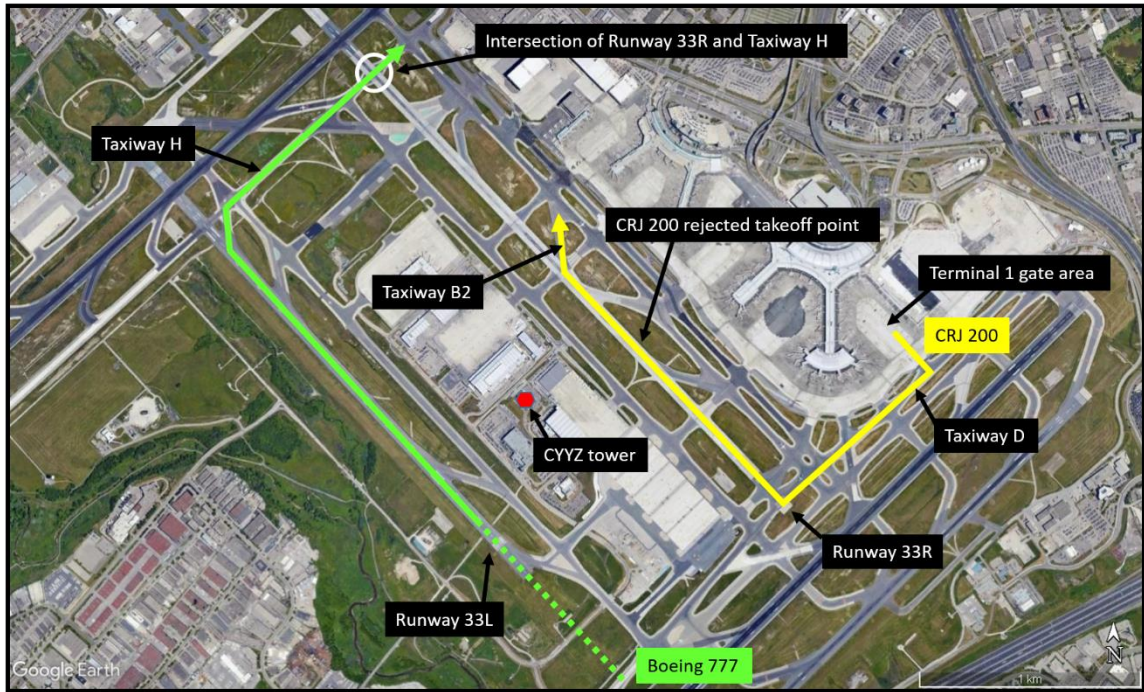
At 1243:53, the tower controller quickly assessed the situation, determined that there was no risk of collision, and immediately issued a take-off clearance to the crew of the CRJ 200, who had already initiated a rejected takeoff. The crew of the CRJ 200 made a radio call to inform the tower controller that they were rejecting the takeoff. The tower controller then instructed the CRJ 200 to exit Runway 33R on Taxiway B2 (Figure 1).

Figure 1. Depiction of the CRJ 200's route and the Boeing 777's approach path (dotted line) and taxi route (solid line) (Source: Google Earth, with TSB annotations)

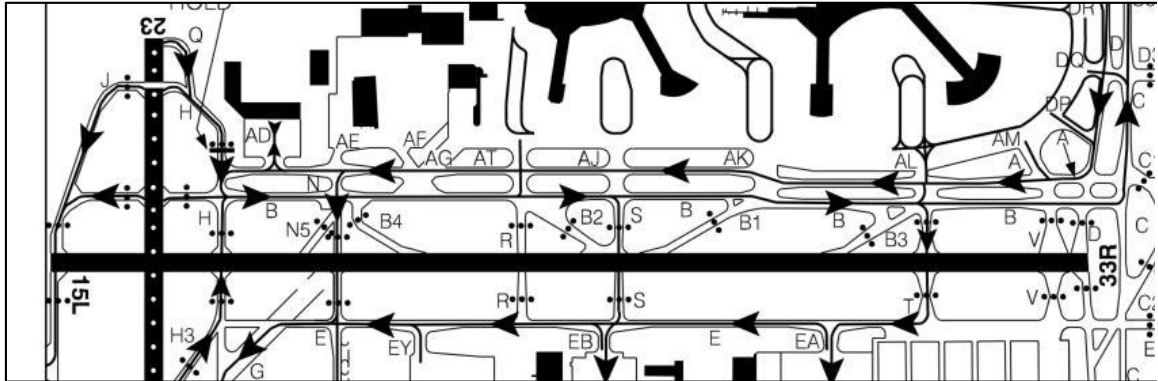
At CYYZ, Runways 15L/33R and 15R/33L are used for approximately 5% of all movements. Runway 15L/33R has 8 crossing taxiways (Figure 2) that are used to facilitate aircraft movements at CYYZ.

Figure 2. Schematic of Runway 15L/33R showing all intersecting taxiways (indicated by letters) (Source: NAV CANADA, Canada Air Pilot Vol. 4, p. 721)

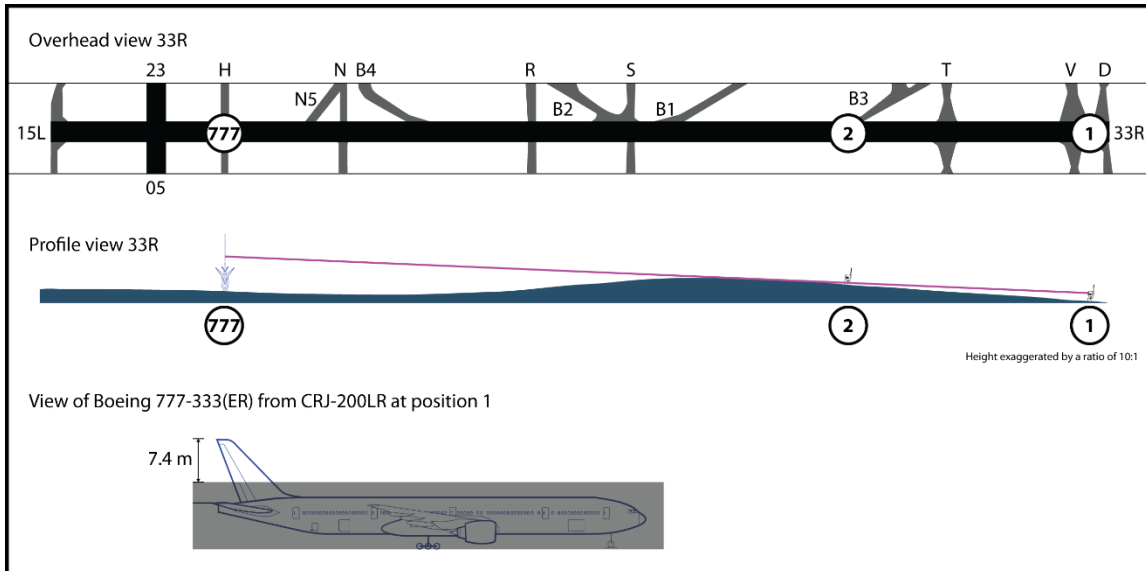
At the start of the take-off roll from the threshold of Runway 33R, the 7.4 m (24.28 feet) of the top of the Boeing 777's vertical stabilizer would have been visible approximately 8900 feet ahead (Figure 3).

Figure 3. Overhead and profile views of Runway 33R, illustrating the sightline of the CRJ 200 flight crew and their view of the Boeing 777 at the start of the take-off roll (position 1 in the figure) (Source: TSB)

Based on TSB calculations, the fuselage of the Boeing 777 would not have been visible to the CRJ 200 crew at the start of the take-off roll because of the grade profile of Runway 33R; therefore, the crew had no visual indication that it was unsafe to initiate the take-off roll on Runway 33R. The flight crew would have only been able to see the top portion of the Boeing 777's vertical stabilizer at Taxiway H, over 8900 feet away. The distance between the CRJ 200 and the Boeing 777, in addition to the speed at which the Boeing 777 was taxiing and the surrounding features on the horizon, would have made it difficult for the flight crew to identify the top portion of the vertical stabilizer.

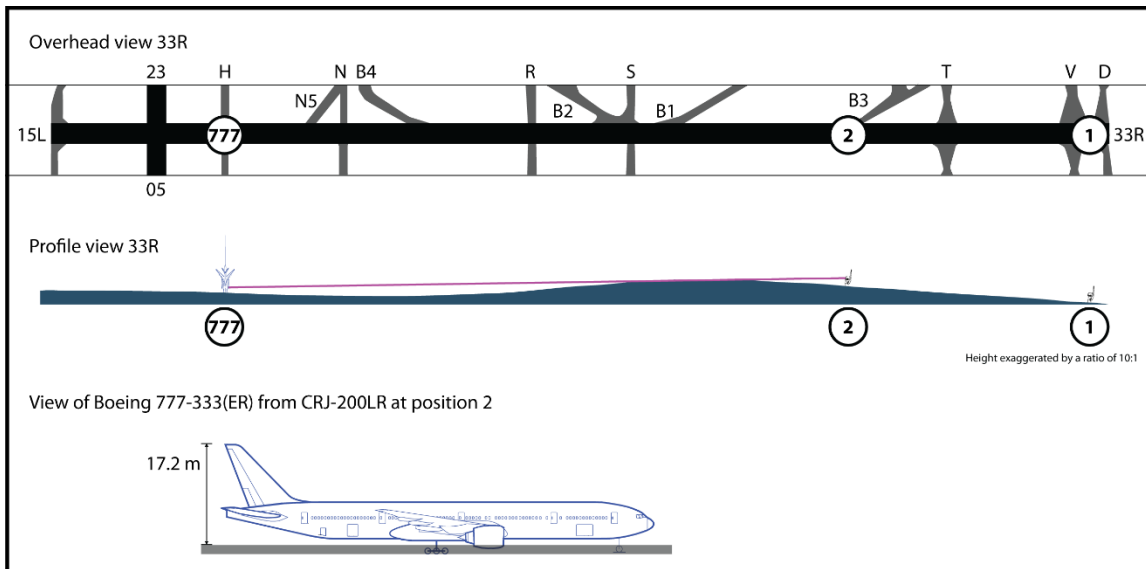
As the aircraft continued along Runway 33R and approached the crest of the hump in the runway, the entire aircraft fuselage, or the top 17.2 m (56.43 feet) of the Boeing 777, would have been visible crossing Runway 33R, at Taxiway H, approximately 6400 feet ahead (Figure 4).

Figure 4. Overhead and profile views of Runway 33R, illustrating the sightline of the CRJ 200 flight crew and their view of the Boeing 777 at the crest of the hump in the runway (position 2 in the figure) (Source: TSB)
