# Air Transportation Safety Investigation Report A19C0016

## CONTROLLED FLIGHT INTO TERRAIN

Amik Aviation Ltd.  
Cessna 208B Caravan, C-FAFV  
Little Grand Rapids Airport, Manitoba, 0.75 nm S  
04 March 2019

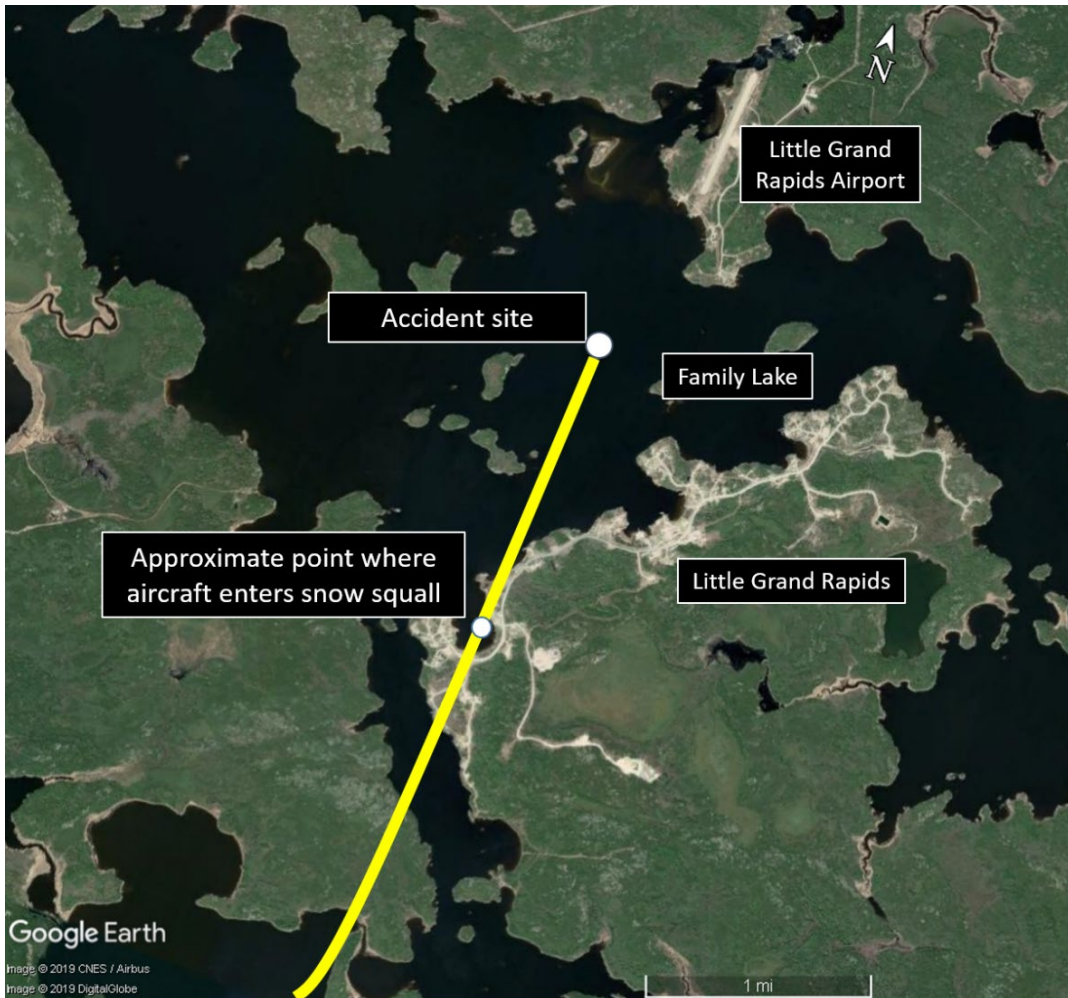
At approximately 1414, the pilot made the decision to initiate a go-around; however, as power was being applied, the aircraft collided with the frozen surface of Family Lake, 0.75 nm from the threshold of Runway 36 (Figure 1). The aircraft remained upright and slid to a stop on the snow. The pilot and

Figure 1. Estimated flight track of the occurrence aircraft (Source: Google Earth, with TSB annotations)

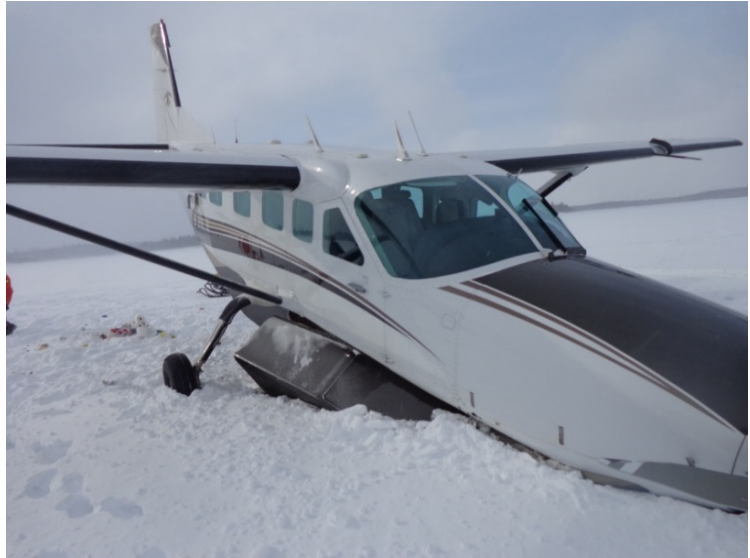
The aircraft sustained damage to the fuselage, landing gear, propeller and engine (Figure 2).

Damage to the propeller indicates that the engine was producing substantial power when the aircraft struck the snow-covered frozen surface of the lake. The floor at the front of the cabin had buckled due to forces transmitted from the nose landing gear drag brace. The engine mounts were slightly deformed.

Figure 2. Aircraft wreckage (Source: Royal Canadian Mounted Police)
