AIR TRANSPORTATION SAFETY INVESTIGATION REPORT A19O0089

LOSS OF CONTROL AND COLLISION WITH TERRAIN

Hawk Air (705833 Ontario Ltd.)
de Havilland DHC-2 Mk. I (Beaver), C-FBBG
Hawk Junction Water Aerodrome, Ontario
11 July 2019

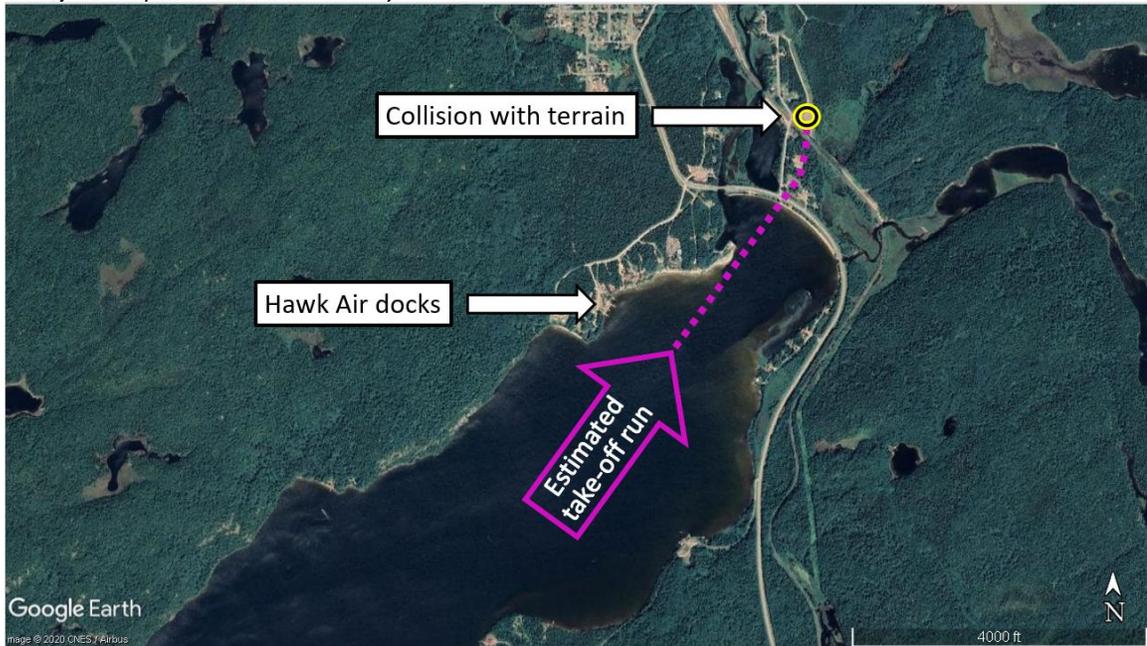
At approximately 0852, the aircraft began its take-off run. It became airborne approximately abeam the Hawk Air dock (Figure 1), and climbed to an estimated height of 300 to 400 feet above ground level (AGL). The aircraft was observed to be climbing normally before entering a sudden left bank and an extreme nose-down attitude.

Figure 1. View of occurrence site, with dashed magenta line showing estimated flight path (Source: Google Earth, with TSB annotations)

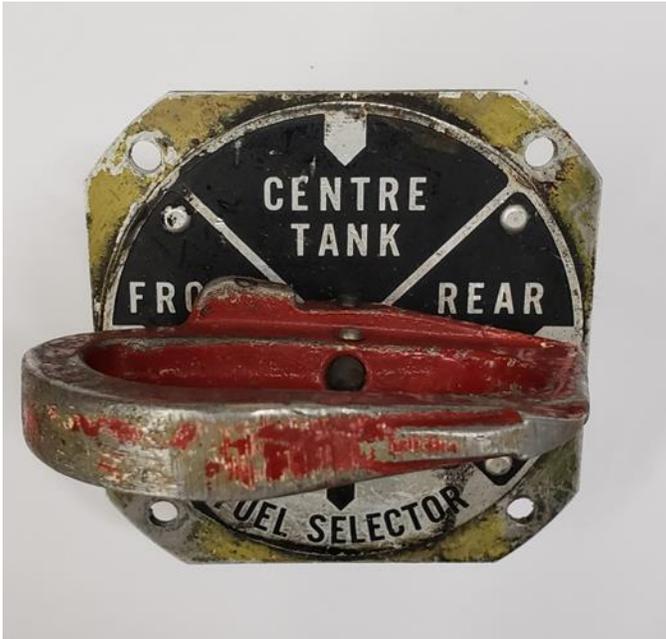
Figure 2. Fuel selector from the occurrence aircraft, with the rear tank selected (Source: TSB)

The fuel selector was found to be set to the REAR TANK position at the occurrence site, as shown in Figure 2. The cable-actuated selector valve was also found to be positioned for the rear fuel tank to be the fuel source.

During examination of the wreckage at the occurrence site, the fuel selector and cable-operated selector valve were found set to draw fuel from the rear tank, which was undamaged and contained no traces of fuel. Fuel starvation appears to be the most likely cause of the power loss experienced by the occurrence aircraft.
