AIR TRANSPORTATION SAFETY INVESTIGATION REPORT A19P0142

MAIN ROTOR BLADE FAILURE AND COLLISION WITH TERRAIN

E & B Helicopters Ltd.
Bell 206B (helicopter), C-GEBY
Campbell River, British Columbia
24 September 2019

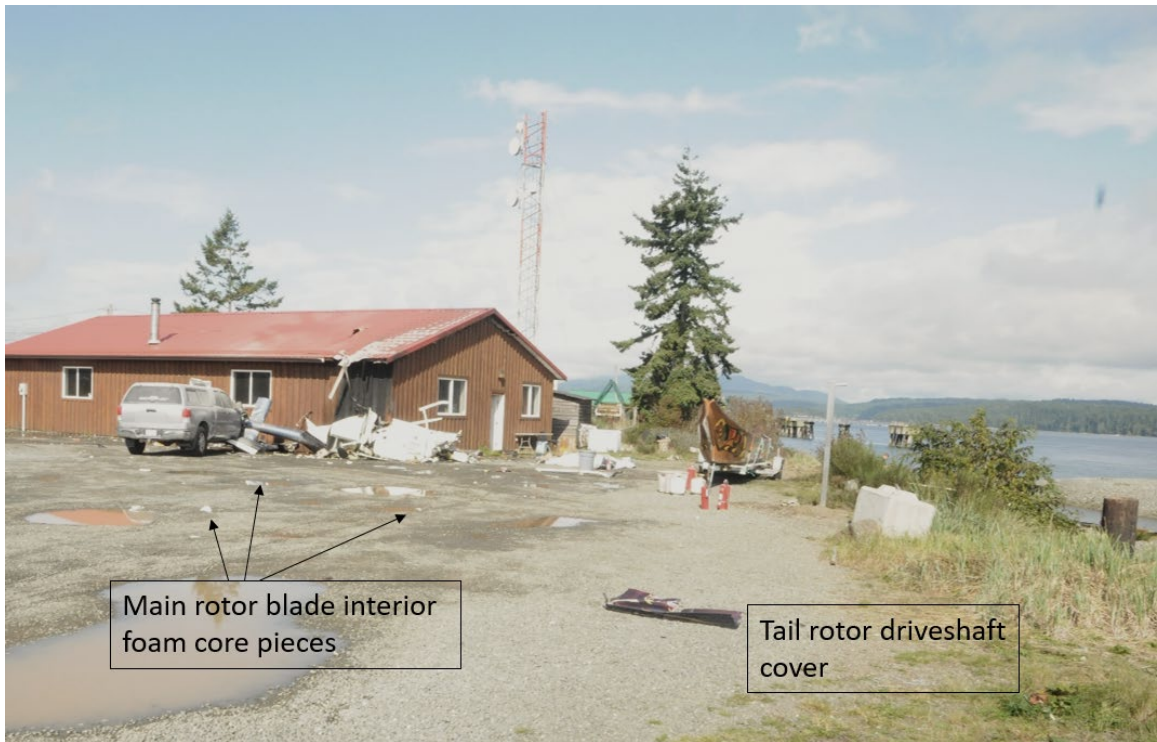
The helicopter descended vertically and, at 1103:43, it struck a building located 0.8 nautical miles east of the point of departure. The helicopter’s tail boom struck 2 trucks that were parked at the building (Figure 2). The pilot received fatal injuries. No one on the ground was injured. After the helicopter came to rest, a post-impact fire started. No emergency locator transmitter signal was detected by the search and rescue satellite system.

Figure 2. Photo of the accident site, taken 90 minutes after the accident, looking north along the direction of flight. The second truck that had been struck by the helicopter had already been moved when this photo was taken. (Source: Royal Canadian Mounted Police, with TSB annotations)

The roof and exterior walls of the building that was struck by the helicopter were damaged by the impact and post-impact fire. Two vehicles that were parked adjacent to the building were also damaged. Soil remediation was performed at the site due to fuel and oil that spilled from the helicopter.

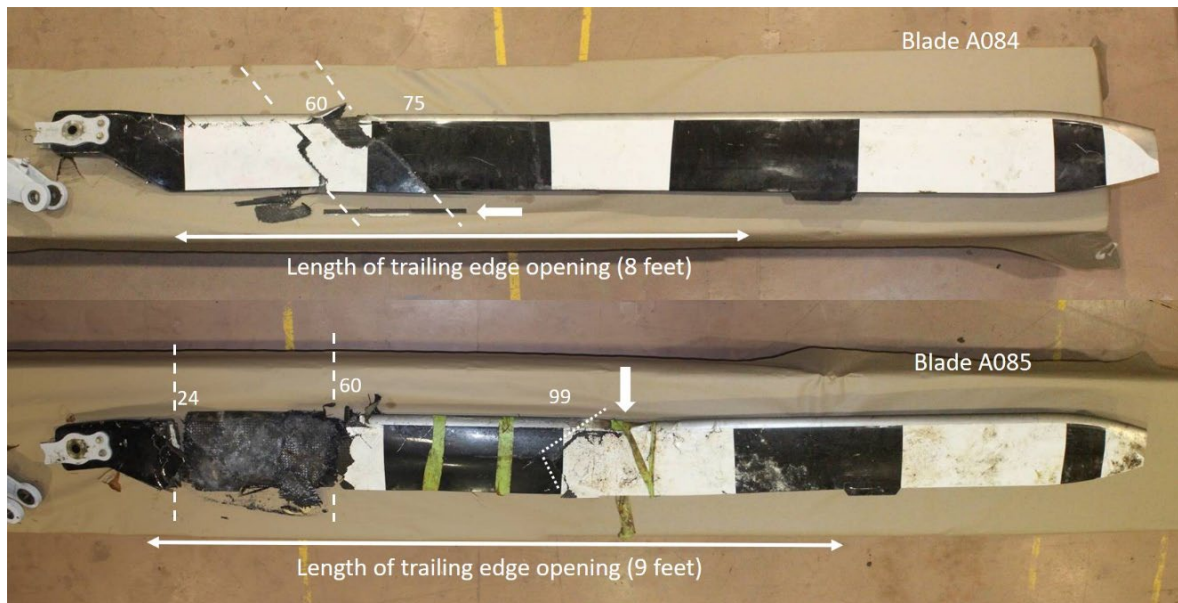
Figure 4. Overall view of both main rotor blades (serial numbers A084 [top] and A085 [bottom]) and general description of damage (Source: TSB)

On blade A084, 2 diagonal fractures (45° from the blade's edge) were observed on the upper skin (stations 60 and 75), indicated by dashed white lines in Figure 4. A relatively short section of trailing edge strip, indicated by the thick white arrow, had separated from the blade, and the trailing edge bond had fractured, leaving an 8-foot-long opening. Red paint transfer from the roof of the building struck by the helicopter was found on the lower surface of the metallic abrasion strip installed on the leading edge of the whole blade, but no dents on the blade were observed. The majority of the foam core material where the trailing edge had opened up was missing.

Blade A085 had 2 chordwise fractures near the root (stations 24 and 60), indicated by dashed white lines in Figure 4; a V-shaped partial fracture of the upper skin at station 99, indicated by dotted white lines; a trailing edge bond fracture with a 9-foot-long opening; and a dent on the leading edge, as indicated by the thick white arrow. Similar to blade A084, the majority of the foam core material where the trailing edge had opened up was missing.

The diagonal fracture lines identified during the visual examination of main rotor blade A084 are consistent with damage caused by torsional load. On both main rotor blades, the 90° change in the direction of the diagonal fracture line implies a change in the direction of torsional loads, suggesting alternating torsional loads were involved. These observations suggest that the damage on the 2 main rotor blades likely occurred in flight before the impact with the building and the ground.

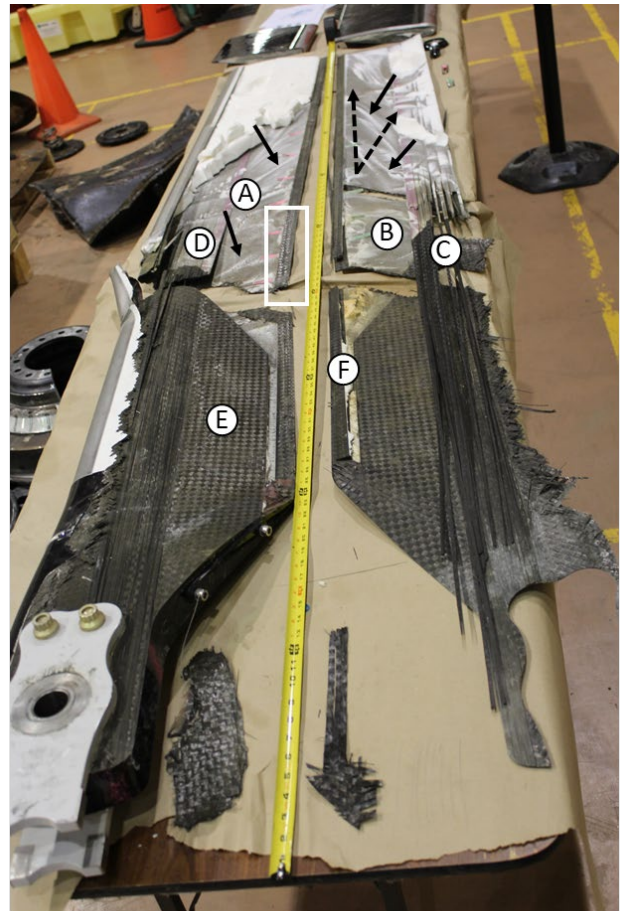
Further examination of main rotor blade A084 revealed signs of progressive failure (tidal marks) where the internal foam core adhered to the upper and lower skins (Figure 5). These tidal marks indicate that the fracture between the foam core and the skins was from inboard to outboard, starting from the main fracture at station 60 and going from trailing edge to leading edge. Main rotor blade A085 exhibited similar tidal marks where the internal foam core adhered to the upper and lower skins.

Figure 5. Main rotor blade (serial number A084) upper and lower skins sectioned by the TSB for examination (Source: TSB)

After a macroscopic and microscopic examination of main rotor blade A084, signs of rubbing were found where the upper and lower main rotor blade skins come together at the trailing edge strip, along with loose carbon filaments and matrix rolling. Matrix rollers are a unique feature associated with fatigue failure of polymer composites despite the fact that they may have different types of fibre and matrix design.²² The identification of matrix rollers in both interlaminar²³ and intralaminar²⁴ fracture surfaces suggests that fatigue failure was likely involved in the fracture of the blade.

In addition to the matrix rollers, bare fibres were observed on the rubbed fracture surface of the lower skin to trailing edge strip bond joint. This is consistent with a fibre-matrix interface failure and a resulting reduction in bonding strength.

In the separated trailing edge strip, inboard of the main fracture surface (station 60), multilayer delamination was observed. Blunt impact can result in multilayer delamination, but no associated signs of an impact in that area were noted. However, matrix rollers and a high density of composite debris were observed on the fracture end of this trailing edge strip section. This indicates that a translaminar²⁶ fracture likely occurred before the impact with the building and ground.

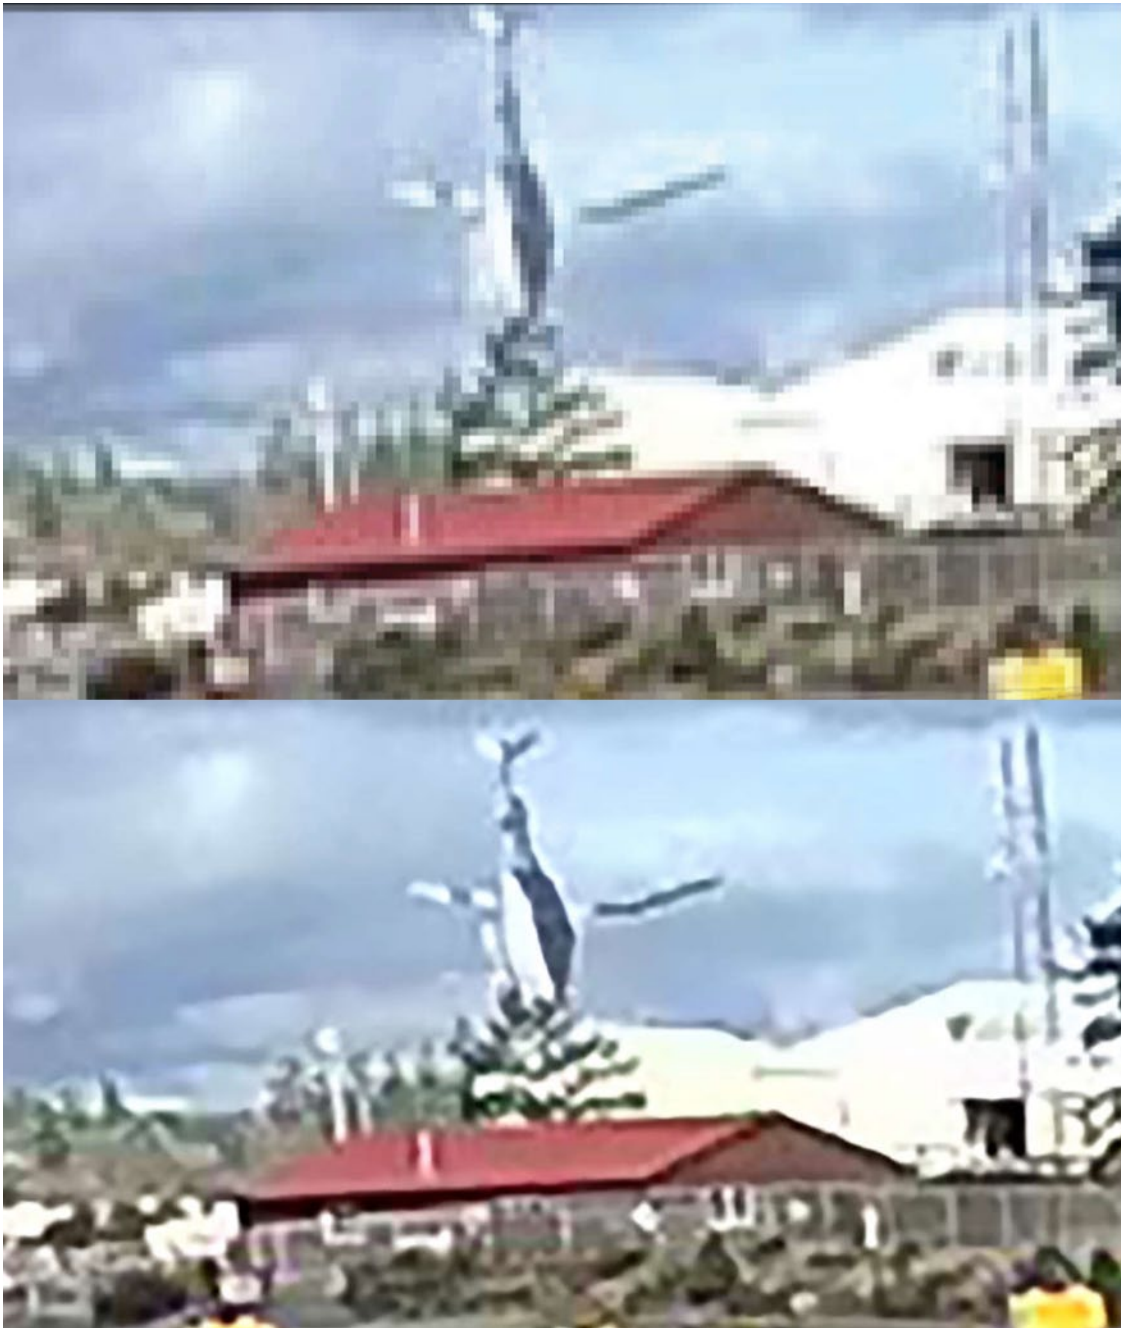
Figure 6. Original (top) and enhanced (bottom) video frame from closed-circuit television (CCTV) video showing the position and deformation of the main rotor blades (Source: Third party, with TSB enhancements)

It was noted that the rotor blade on the left side of the helicopter in Figure 6 appeared to be at an approximate angle of -46° from parallel to the roll axis; however, it could not be determined whether this was due to the main rotor head being at that angle, whether a break or bend had occurred in the rotor blade before impact leaving only the outboard section of the blade at that angle, or whether there was a combination of these 2 scenarios.

The rotor blade on the right side of the aircraft was observed to have a bend or break 1.6 m from the main rotor hub, with the outboard portion appearing to be at an upward angle of
