Transportation
Safety Board
of Canada

Air Transportation Safety Investigation Report A19W0099

MID-AIR COLLISION

Cu Nim Gliding Club
Cessna 182N, C-FPZE
and
Cu Nim Gliding Club
Schleicher ASK 21 (glider), C-FLTY
Black Diamond/Cu Nim Aerodrome, Alberta, 0.5 NM SW
26 July 2019

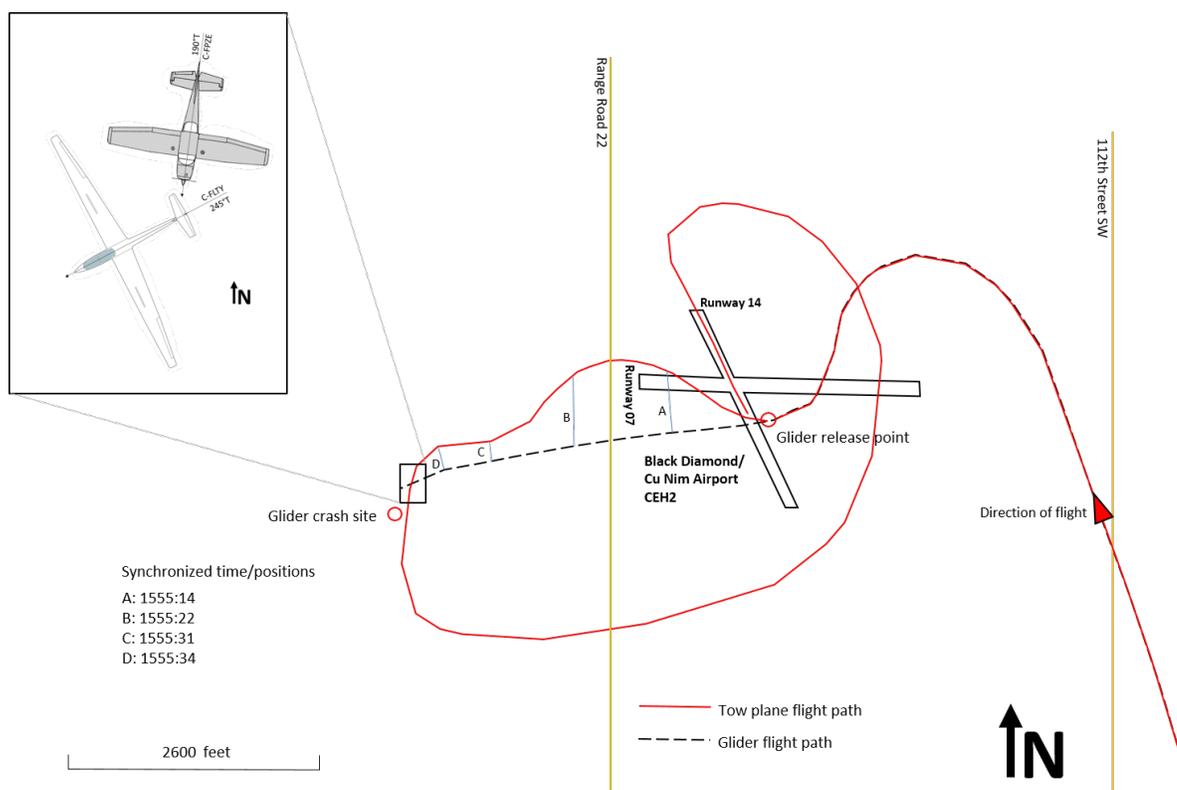
When the glider released from the tow plane, halfway through the second medium turn at an altitude of approximately 6100 feet ASL, the glider flight crew proceeded to fly more or less on a track of 270°T. By releasing in a right turn, the glider was not in a position where the tow pilot would normally expect to see it, i.e., behind and to the right of the tow plane (Figure 1).

At 1555, when the aircraft were 0.5 nautical miles (NM) southwest of the threshold of Runway 07 and at an altitude of approximately 6075 feet ASL, the tow plane's propeller struck the glider's empennage. The time between the glider release and the collision was 34 seconds.

Figure 1. Overview of the tow plane and glider's flight paths, with inset diagram showing the positions of the aircraft at the time of the collision (Source: TSB)
