AIR TRANSPORTATION SAFETY INVESTIGATION REPORT A20Q0015

CONTROLLED FLIGHT INTO TERRAIN

Service aérien gouvernemental of Quebec
Bell 206L-4 (helicopter), C-GSQA
Lac Saint-Jean, Quebec
22 January 2020

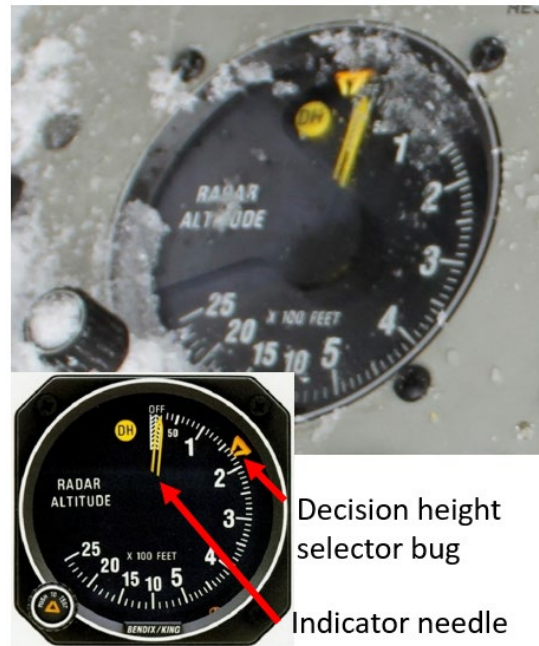
A decision height selector bug allows the pilot to choose a minimum height (Figure 2). If the aircraft descends below the selected minimum height, a light illuminates and an alarm sounds to notify the pilot. The decision height selector bug on the radio altimeter found at the accident site was set to 0 feet.

Figure 2. Radio altimeter on the occurrence aircraft (Sources: TSB [main image] and manufacturer's brochure [inset image])

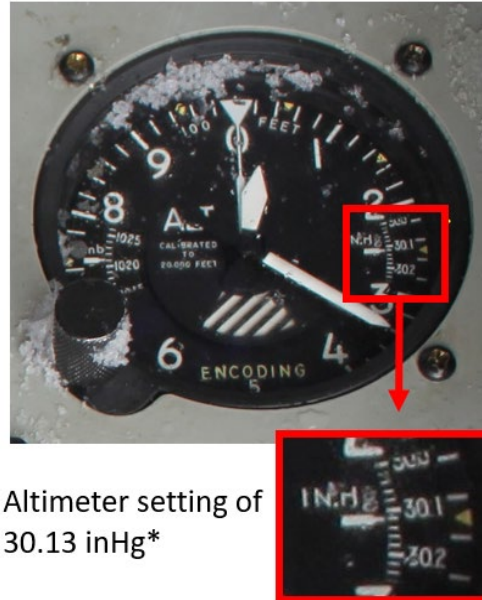
Tests performed on the conventional altimeter at the TSB Engineering Laboratory in Ottawa, Ontario, showed that the margin of error for the altitude indication was 20 feet or less for simulated altitudes below 500 feet, which is within the allowable margin of error for the instrument according to *Canadian Aviation Regulations* (CARs) Standard 571.⁴

Figure 3. Conventional altimeter on the occurrence aircraft (Source: TSB)

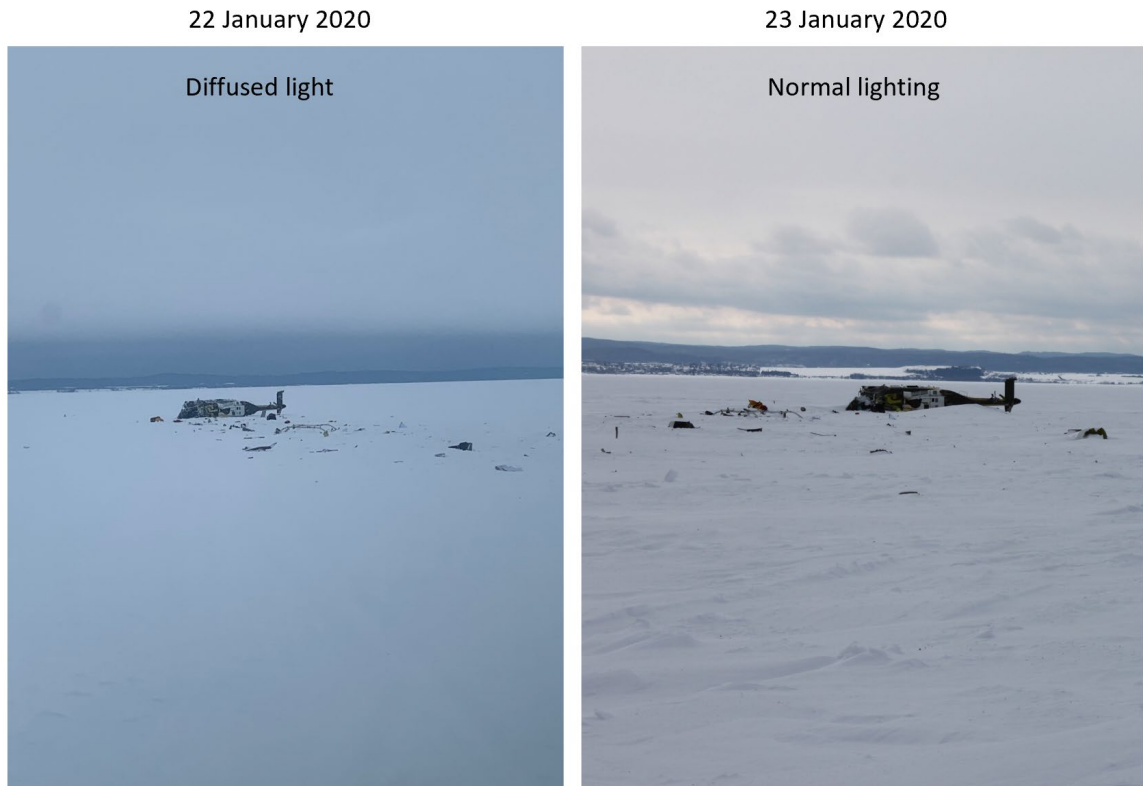
Figure 4. Photos of the accident site taken on the day of the accident and the next day (Sources: Sûreté du Québec [22 January] and TSB [23 January])

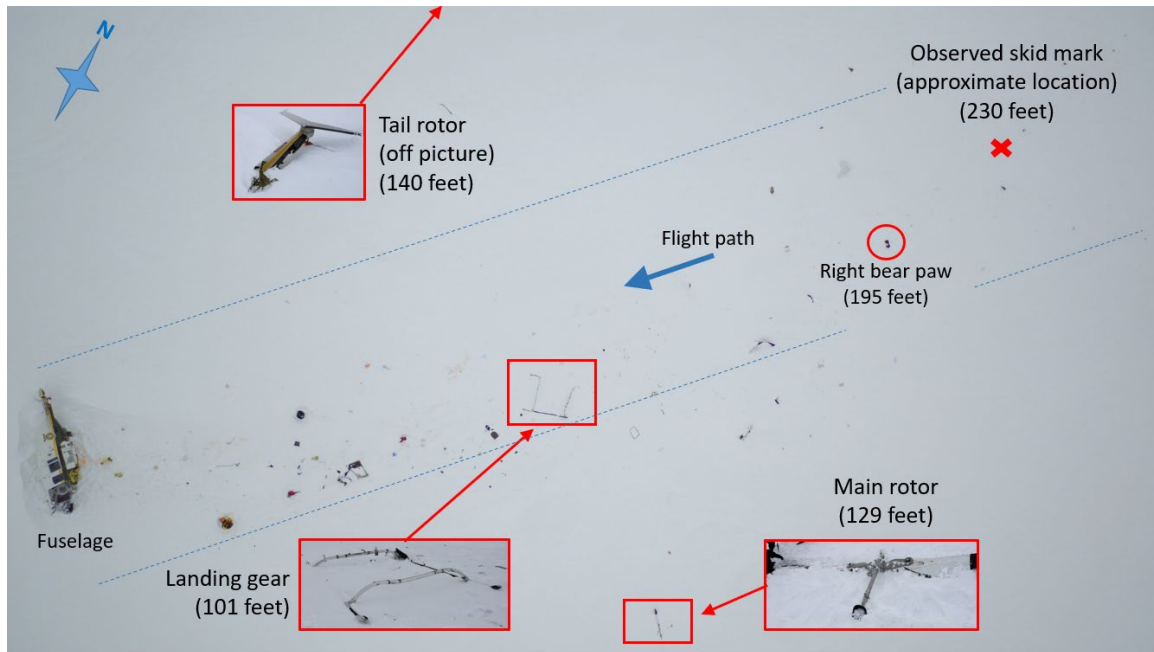
Only the tip of the tail and its rotor, along with the mast and main rotor, were found far from the wreckage trail (Figure 6). On impact, a helicopter's main rotor blades may be projected over a great distance in all directions¹⁵ due, in part, to the kinetic energy and gyroscopic inertia produced by the rotation of the blades.

Figure 6. Aerial view of the accident site showing the distribution of debris and distance from the fuselage (Source: Sûreté du Québec, with TSB annotations)

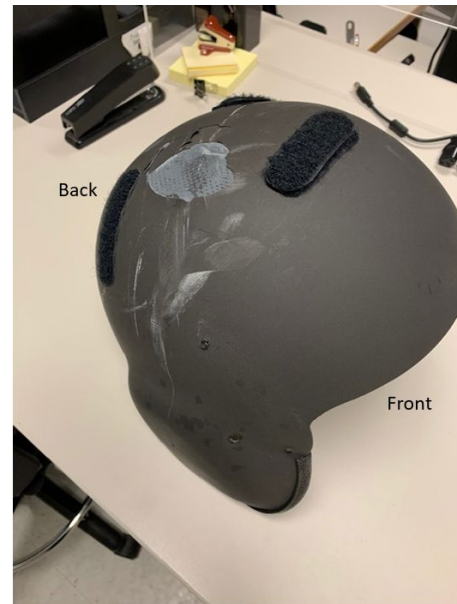
Marks found on the top of the helmet shell indicate that a major shock occurred in that area (Figure 7). The TSB has previously highlighted the importance of wearing a helmet to prevent fatal injuries or to reduce the effects of non-fatal head injuries received in an accident.¹⁸ These effects may vary from confusion to complete loss of consciousness.

Figure 7. Impact marks on top of the pilot's helmet (Source: SAG, with TSB annotations)

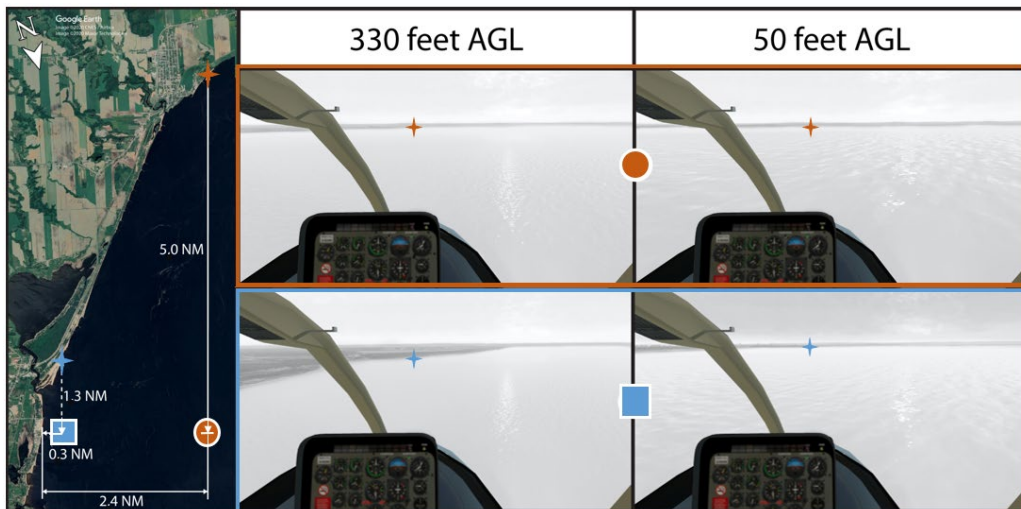
Figure 8 illustrates a simulated view of the shoreline from the cockpit at 2 different altitudes—330 feet AGL and 50 feet AGL—when there is no contrast at the surface. The top 2 images represent the view from the accident location (2.4 NM from the shoreline), and the bottom 2 images represent the view from a distance closer to the shoreline (0.3 NM), for comparison purposes.

Figure 8. Simulated view of the shoreline from the cockpit at 330 feet above ground level and 50 feet above ground level when the aircraft is 2.4 nautical miles and 0.3 nautical miles from the shoreline (Source: TSB)

When the aircraft is 2.4 NM from the shoreline, the shoreline has the same profile at both altitudes, which shows that, at these 2 altitudes, a lateral distance of 2.4 NM is too great to be able to notice a loss of altitude if the shoreline is the sole visual reference being used. However, when the aircraft is at a lateral distance of 0.3 NM, the amount of shoreline that can be seen decreases with a loss of altitude.

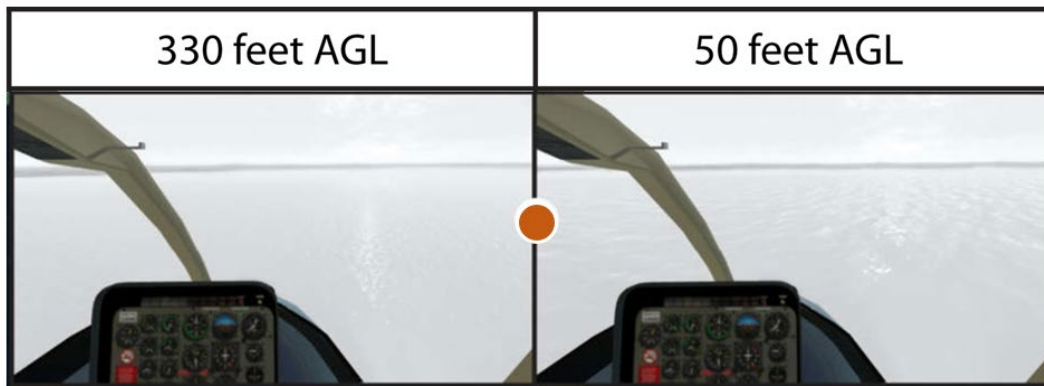
According to the simulated view of the shoreline from the cockpit at 330 and 50 feet AGL (Figure 9), without any contrast at the frozen surface of the lake, and once the islands had been passed, the appearance of the shoreline would change very little because the lateral distance would be too great to notice a loss of altitude at these heights if the shoreline was the only visual reference used.

Figure 9. Simulated view of the shoreline from the cockpit at 330 feet above ground level and 50 feet above ground level when the aircraft is 2.4 nautical miles from the shoreline (Source: TSB)
