# AIR TRANSPORTATION SAFETY INVESTIGATION REPORT A21P0069

## **LOSS OF CONTROL AT LIFTOFF AND OVERTURN**

Atleo River Air Service Ltd.  
Cessna A185F, C-GYJX  
Tofino Harbour Water Aerodrome, British Columbia  
26 July 2021

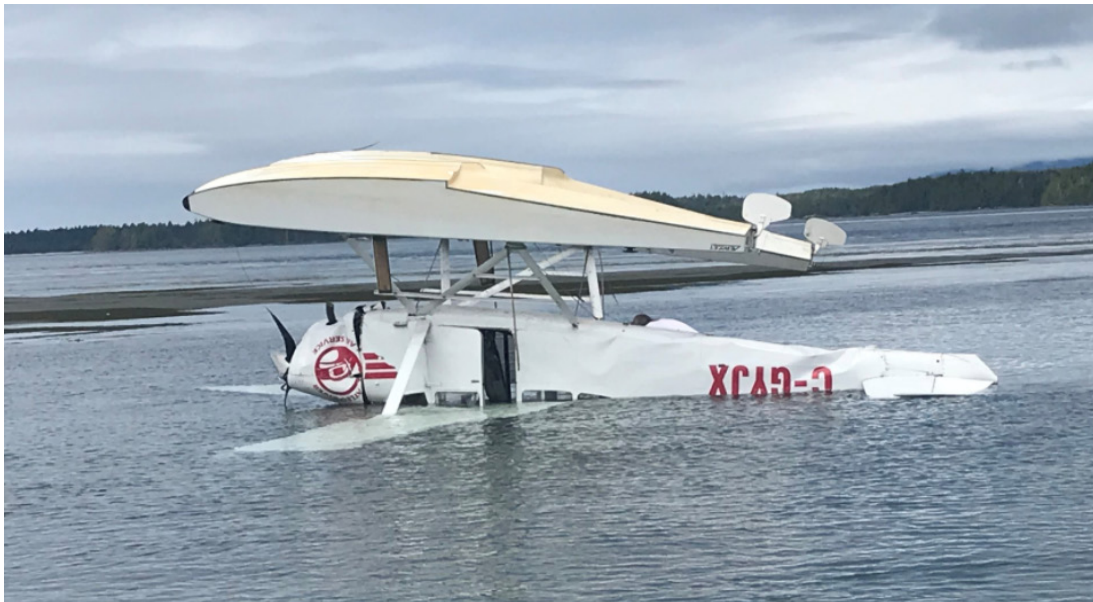
The pilot pushed the control column forward and increased flap setting from 20° to 30°. Approximately 5 seconds later, the aircraft abruptly yawed and rolled to the left while simultaneously losing altitude. The floats contacted the water, followed immediately by the left wing tip. The aircraft bounced back to the right, and the right wing tip contacted the water, causing the aircraft to yaw to the right and to skid on the surface of the water. The left float dug into the water, and the aircraft cartwheeled once before coming to rest inverted on the sandbar in approximately 1 foot of water at 1138:10 (Figure 1).

Figure 1. Occurrence aircraft resting inverted on the sandbar approximately 3100 feet northwest of the company dock (Source: Royal Canadian Mounted Police)

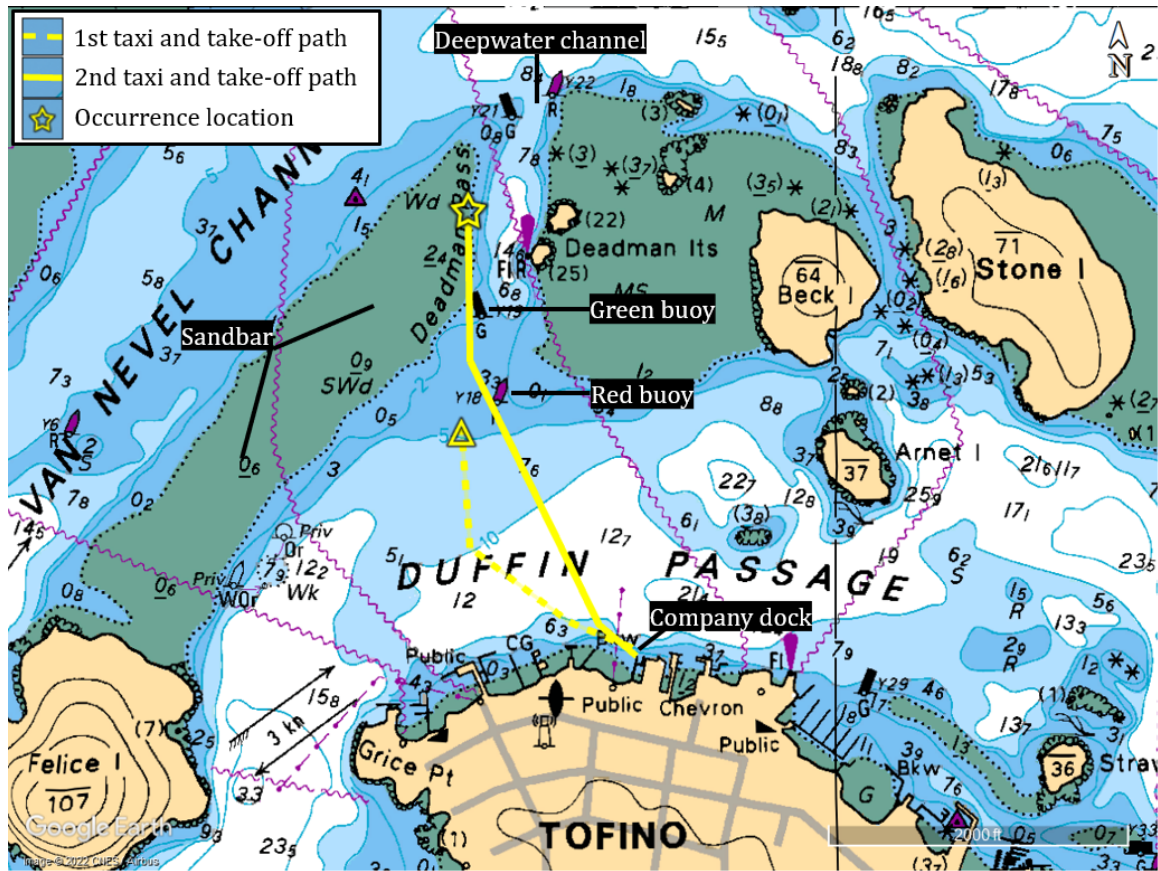
The occurrence flight was the pilot’s second takeoff of the day from CAB4 in the occurrence aircraft. The pilot’s first takeoff was completed approximately 2 hours prior and was in a similar north-northwest direction with similar wind conditions (Figure 2).

Figure 2. Approximate aircraft take-off paths superimposed on the hydrographic chart for CAB4 with indications of depths in metres at the lowest normal tide and identified markers and hazards (Source: Google Earth and Canadian Hydrographic Service Chart 3685, with TSB annotations)

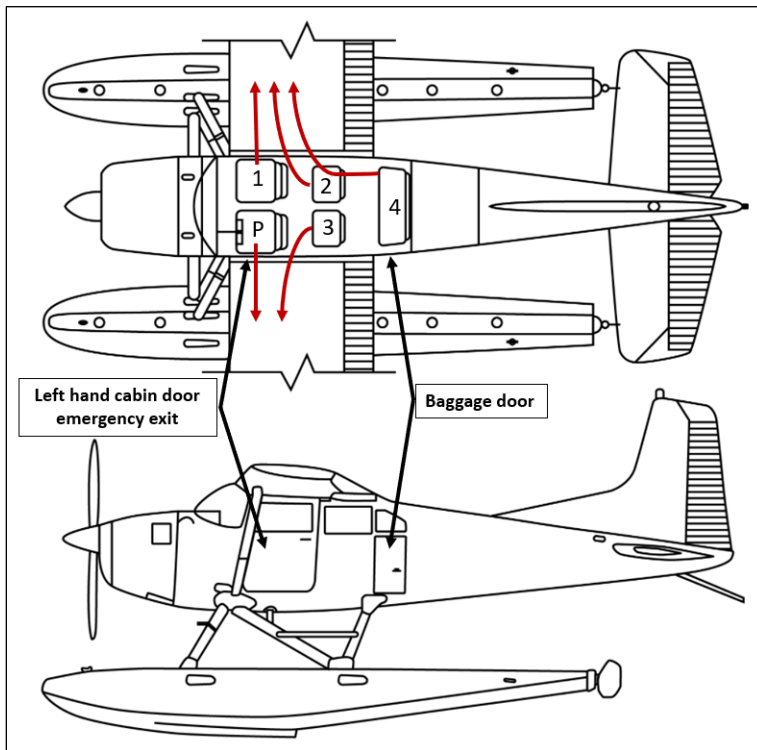
The 2 designated emergency exits for the aircraft are the right and left cabin doors as outlined in the passenger briefing card. The aircraft also has a small baggage door (approximately 22 inches high by 15 inches wide) located to the left of the aft seat. The baggage door is not designed or designated as an emergency exit, and the aft passenger is expected to move through the middle seats (Figure 3) and pass any occupants on those seats to exit the aircraft.

Figure 3. Occurrence aircraft seating configuration and direction of egress for the aircraft occupants (Source: TSB Aviation Investigation Report A11Q0136)
