AIR TRANSPORTATION SAFETY INVESTIGATION REPORT A23C0096

INCORRECT TYPE OF FUEL

2080061 Ontario Inc. (dba SkyCare Air Ambulance)
Piper PA-31-350, C-GQXD
Pickle Lake Airport, Ontario
14 October 2023

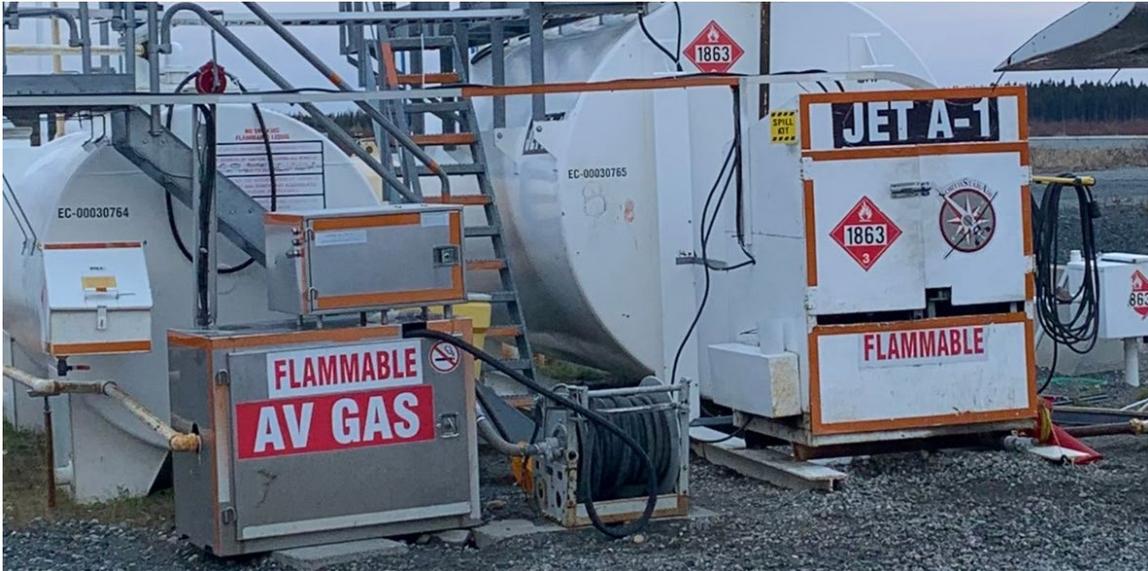
Figure 1. Fuel storage tanks at Pickle Lake Airport (Source: North Star Air Ltd., with permission)

At CYPL, fuel is stored in above-ground fixed storage tanks (Figure 1), which are placarded according to the type of fuel. Aircraft must taxi or be towed to the designated refuelling area.

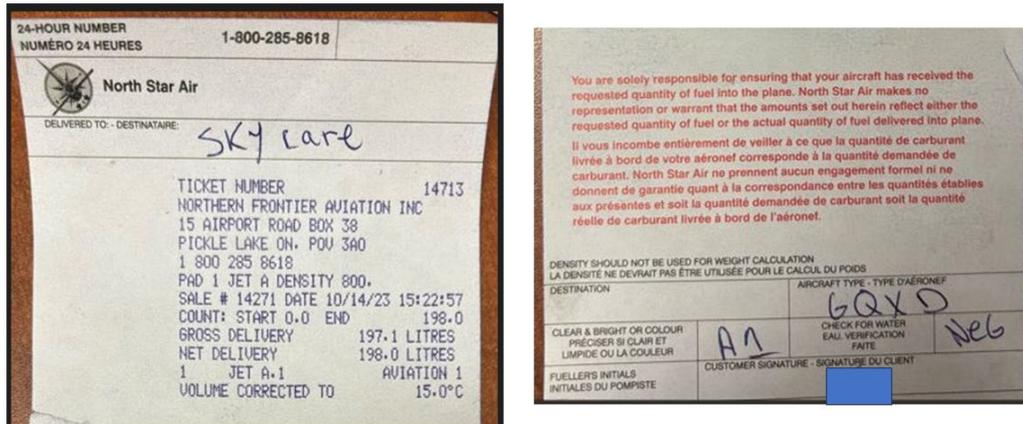
Figure 2. Fuel receipt (Source: North Star Air Ltd., with permission. Personal information hidden.)

At approximately 1500, the occurrence aircraft taxied to the refuelling pad, where it had been refuelled over the course of the previous 4 days. The captain then left the refuelling area to work on flight planning while the FO stayed with the aircraft. The FO requested that the refuelling agent add fuel to the aircraft, and the refuelling agent proceeded to refuel the aircraft with Jet A-1. Video footage obtained from North Star Air shows the refuelling agent and the FO communicating before, during, and after the refuelling event, though it does not show the whole aircraft or the refuelling process. Once fuelling was completed, the refuelling agent handed the FO a fuel receipt (Figure 2), and the FO signed it and retained a copy. The FO then handed the receipt to the captain, who did not review it. At approximately 1700, the refuelled aircraft departed CYPL for Winnipeg/St. Andrews Airport (CYAV), Manitoba, with the flight crew on board.

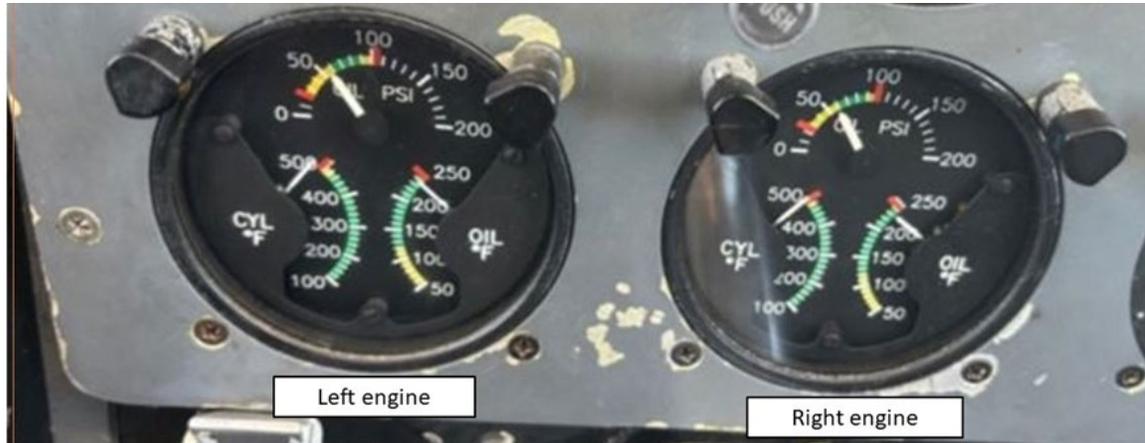
In the climb through 200 feet above ground level, the flight crew noticed that cylinder head temperatures for both engines were above 500 °F, oil temperatures were approximately 250 °F, and oil pressures indicated 50 to 60 psi (Figure 3).

Figure 3. Photo taken by the first officer at 1711, while the aircraft was at an altitude of approximately 2000 feet above sea level, showing the cylinder head temperature, oil temperature, and oil pressure for both engines (Source: First officer, with permission. TSB annotations added.)

[r]eciprocating engines that burn jet fuel at high-power settings may suffer detonations, rapid loss of power, and high Cylinder Head Temperatures (CHT). A complete engine failure can quickly follow these conditions.⁶

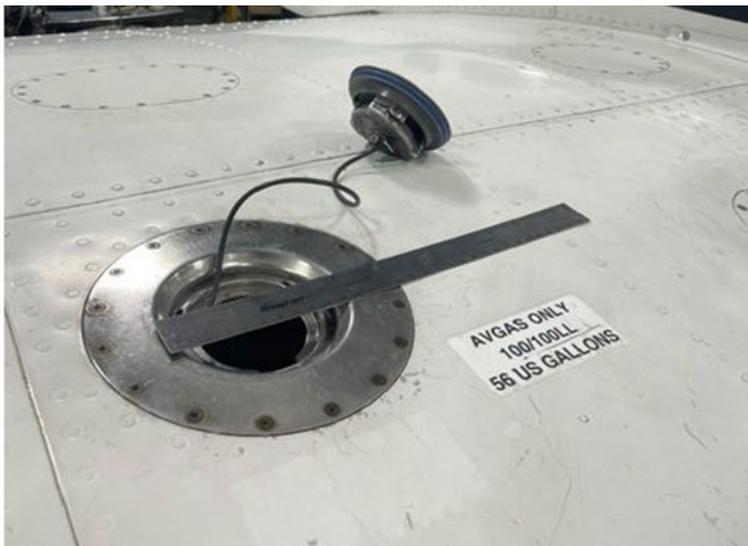
The occurrence aircraft's fuel filler opening had a placard (Figure 4) that indicated the type and grade of fuel and conformed to the FAA's certification regulations, which state, in part:

Figure 4. Fuel placard by the right-wing inboard tank filler opening on the occurrence aircraft (Source: SkyCare Air Ambulance)

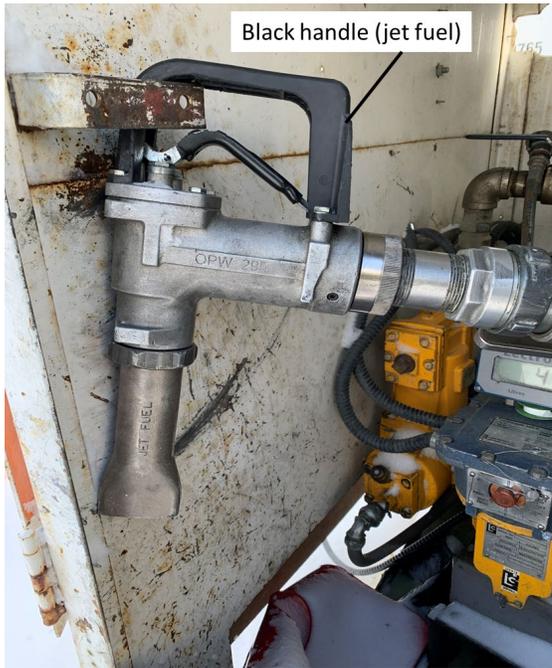
A physical defence against the incorrect selection of fuel type exists in the form of the Jet A-1 flared spout (67 to 70 mm in width), which, as mentioned in the CSA Standard, is identified with a black handle¹¹ (Figure 5). This spout will not normally fit into the AVGAS fuel filler opening.

Figure 5. Spout for jet fuel, identified by black handle (Source: North Star Air Ltd., with TSB annotations)

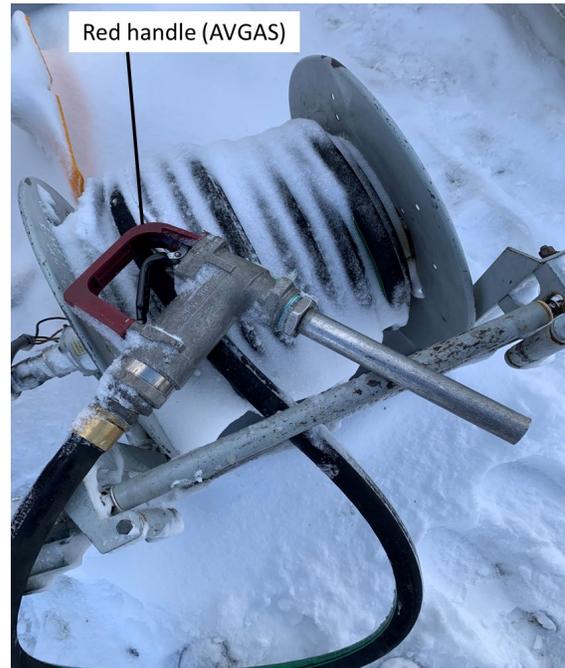
However, for various reasons, the use of the Jet A-1 flared spout is impossible, or impractical, on some turbine-powered aircraft. Aircraft that were manufactured before 1993, when the airworthiness standards were amended to include fuel filler opening requirements,¹² or that have been modified by the installation of turbine engines may have fuel filler openings that do not meet the dimension requirements and, therefore, require a reduced-diameter spout (maximum external diameter of 49 mm) (Figure 6). The airworthiness standards for rotorcraft do not specify the size of fuel filler openings.¹³

Figure 6. Spout for aviation gasoline, identified by red handle (Source: North Star Air Ltd., with TSB annotations)

As a result, fuelling equipment commonly includes a reduced-diameter spout identified with a red handle (AVGAS). The spout can be removed and installed on the jet fuel handle for use with non-standard fuel filler openings. However, when a reduced-diameter spout is available to accommodate non-standard fuel filler openings, there is an increased risk that Jet A-1 fuel will be dispensed into an aircraft that requires AVGAS. Another defence available, in addition to the black and red handles, is a coloured wraparound hose sleeve (figures 7 and 8) that can be installed near the nozzle to identify the type of fuel when the refuelling agent is at the aircraft refuelling point.

The fuel nozzle for the Jet A-1 hose at CYPL had been fitted with the reduced-diameter (1 inch) spout before the occurrence aircraft requested fuel, given that there was frequent helicopter activity that required its use. North Star Air does not have a documented procedure for removing or replacing the reduced-diameter nozzles after use. North Star Air had a flared spout available (2.6 inches), but it was not installed. The wraparound hose sleeves were not in use at CYPL.
