Marine Occurrence Report

Grounding

Sight-seeing Boat "TAN 1"
Grande Batture, East of the Wharf at
Les Escoumins, Quebec
11 August 1993

Report Number M93L0003

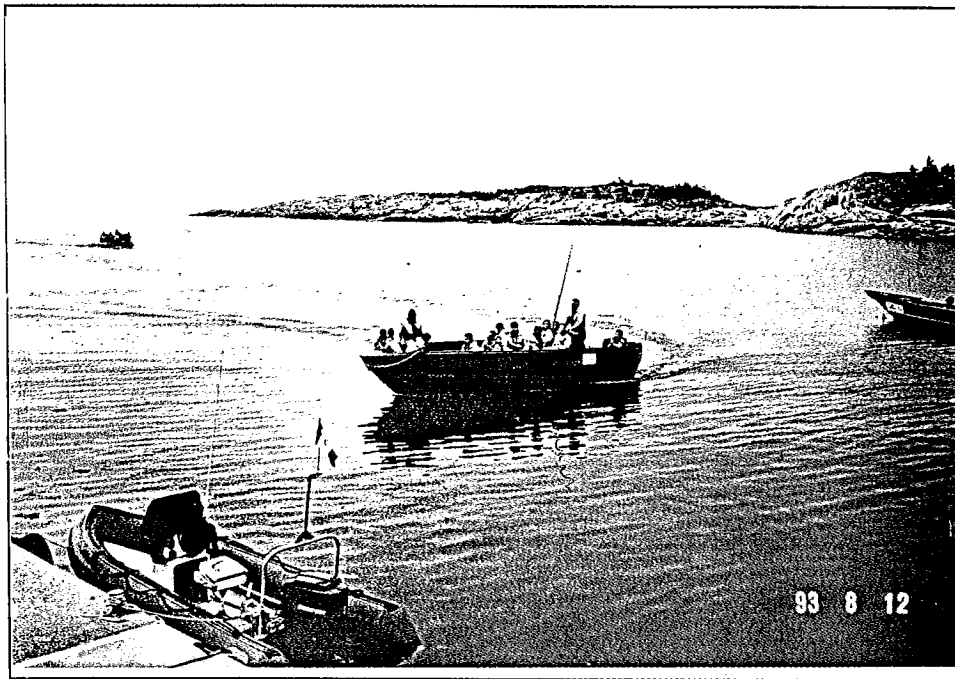
The "TAN 1" arriving at about 1600 on 12 August 1993, the day after the occurrence.

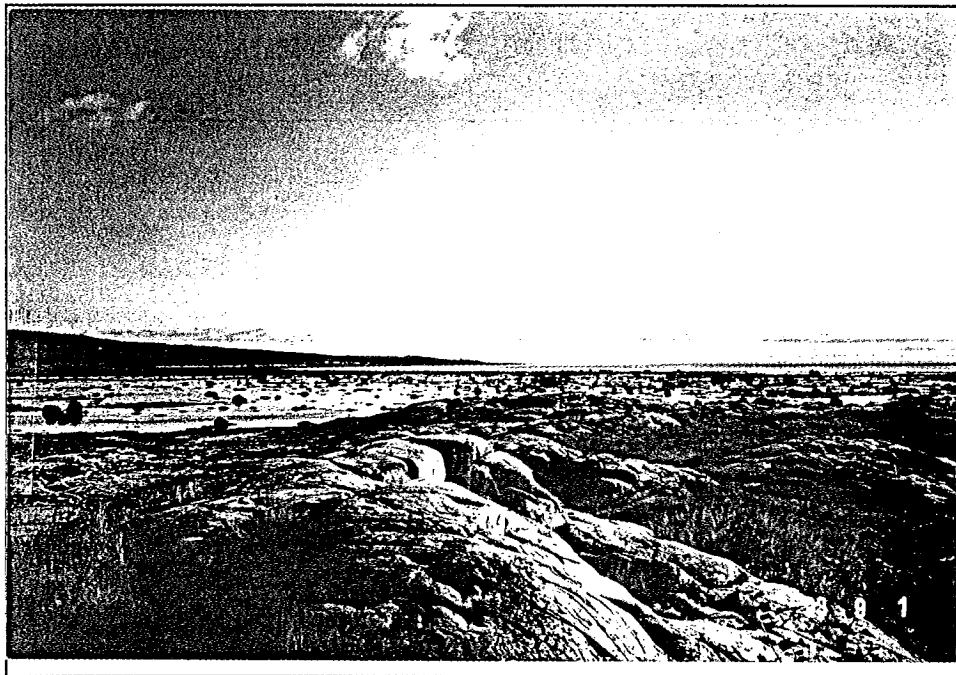
The Grande Batture, lying between Pointe de la Croix and the Îles Penchées, dries off completely at low tide. The bottom consists of sand and mud studded with large rocks that are covered and uncovered with the tides.

The Grande Batture near Les Escoumins completely dried off at low tide.
