MARINE INVESTIGATION REPORT

M01C0054

STRIKING AND SUBSEQUENT FIRE ON BOARD

BRIDGE 11, WELLAND CANAL

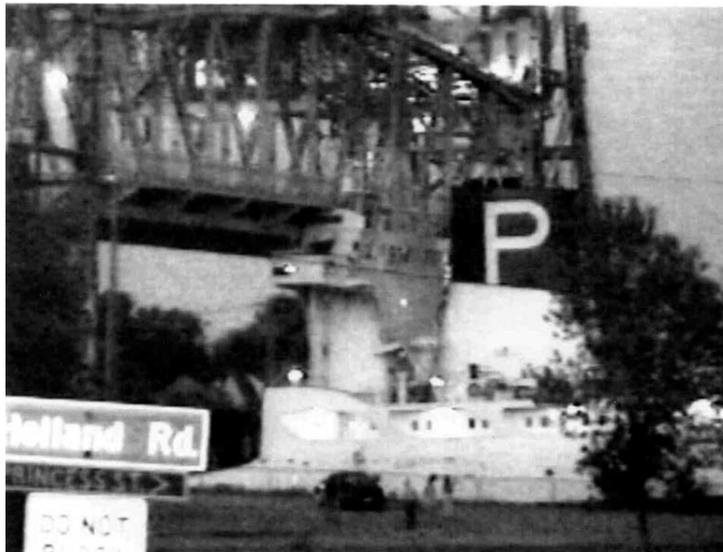
The master and third officer left the wheelhouse by the starboard navigation bridge wing. As they proceeded down the external bridge access ladder, the span of the bridge struck the vessel in way of the wheelhouse front windows, subsequently destroying the vessel's wheelhouse and funnel (see Photo 1).

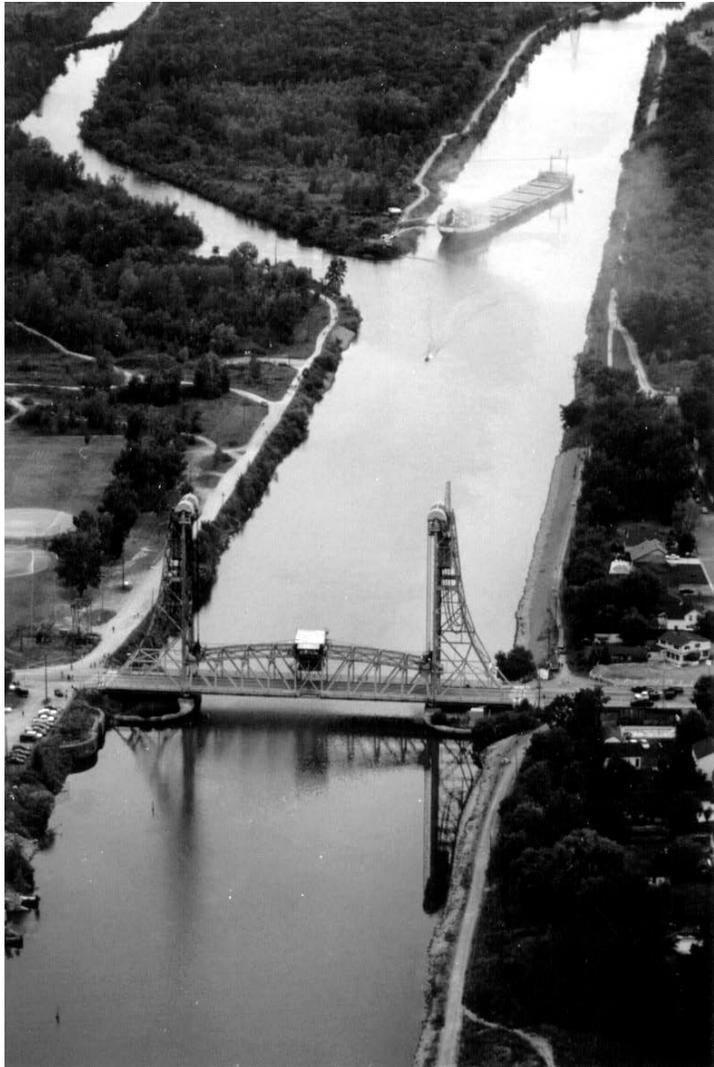
The vessel drifted downbound from Bridge 11. A fire broke out in way of the main engine casing and spread to the accommodation structure. The starboard anchor was dropped. However, the vessel's starboard bow made contact with the east bank of the canal. The vessel then drifted to the west side of the canal and went aground approximately 800 m from Bridge 11 (see Photo 2).

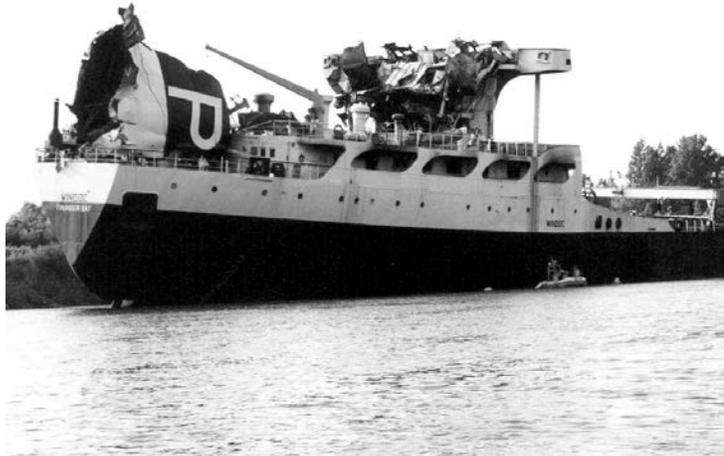
The wheelhouse, main mast, engine room vents, and funnel were destroyed by contact with the lift span of the bridge. The incinerator fuel oil tank, located in the funnel casing, was ruptured, spilling fuel into the engine room and onto the boat deck.

Accommodation on the various decks was destroyed by fire, heat, and smoke. The engine room casing and main engine were damaged by fire, heat and water. The bilge shell plating in way of starboard ballast tank No. 1 was creased and fractured. The aft bulkhead and bilge floors were distorted and torn adrift. The vessel was declared a constructive total loss. No damage to the cargo was reported (see Photo 4).

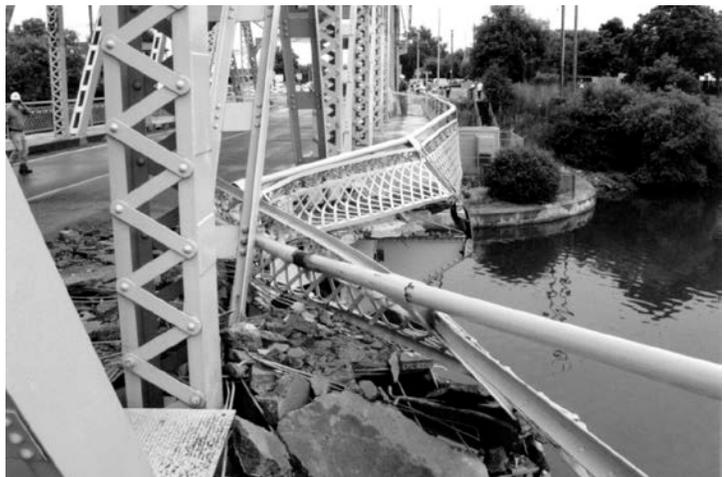
The bridge sustained structural damage to the centre of the vertical-lift span (see Photo 5). There was also damage at the extremities of the span as a result of lateral movement caused by the striking.

Other than minor adjustments on the wire ropes which operate the bridge, there was no damage, mechanical or electrical, to the bridge's systems.

Repairs to the bridge were carried out while the vertical-lift span was in the fully-raised position to permit vessel traffic to transit the canal. Upon inspection by SLSMC engineers, the bridge reopened to vehicular traffic on 16 November 2001.

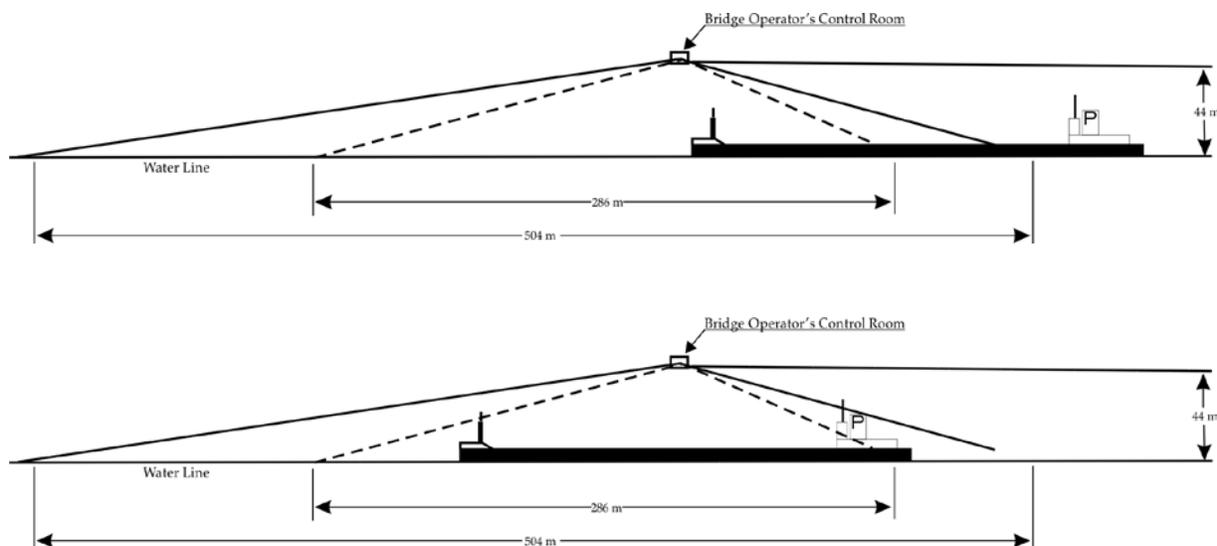
The span was being lowered when it struck the vessel in way of the wheelhouse front windows, at a height of approximately 18.6 m above water level. It took between 49 and 65 seconds to lower the span 18 m. With the vessel travelling at a speed of approximately five knots, its bow would have been under or just clear of the bridge when the bridge operator began to lower the span. The approaching vessel's aft superstructure would have been visible to the bridge operator (whether seated or standing) through the south-facing control room window (see Figures 1 and 2, Photos 6 and 7).

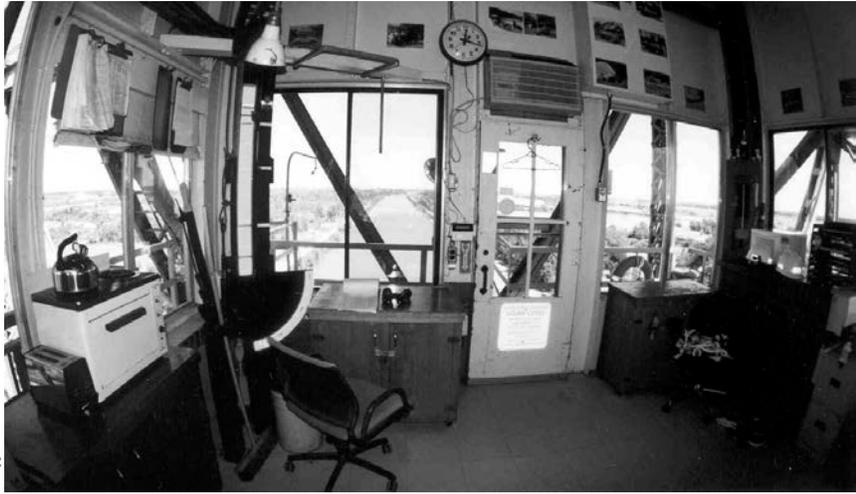
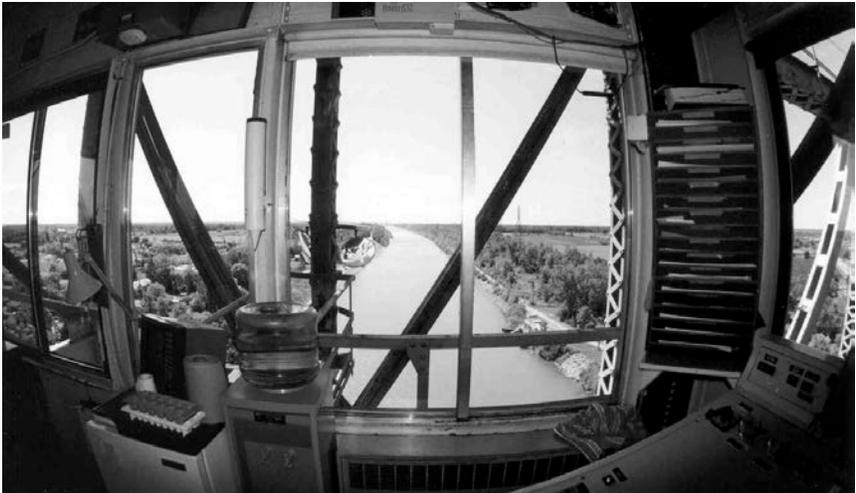
The SLSMC's operations manual for Bridge 11 states that the bridge may be lowered when it is observed that the stern of the vessel is clear of the bridge.⁷ The bridge operator described having seen the stern of the vessel through the north windows of the control room (i.e. looking downstream the canal) where the door is located.
