MARINE INVESTIGATION REPORT

M11W0063

FIRE AND SINKING
SMALL FISHING VESSEL *NEPTUNE II*
BROKEN ISLANDS, JOHNSTONE STRAIT,
BRITISH COLUMBIA
09 MAY 2011

Report Number M11W0063

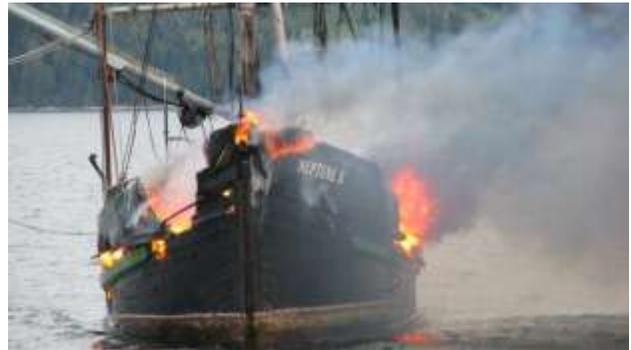
While the crew was fighting the fire, the vessel was under power, making way, and turning slowly to starboard. As a result, the vessel was repeatedly enveloped by smoke from its continuously changing direction, forcing the crew to circle the deck to stay out of the smoke (Photos 1 and 2).

Photo 2. Fire fully engaged

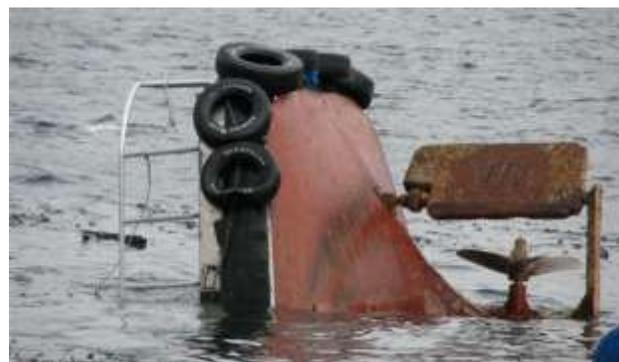
Photo 3. *Neptune II* sinking

At 0758, the CCGS *Point Race* arrived on scene. By this time, the vessel was fully engulfed. The vessel eventually sank at 0938

in position 50°28'12" N, 126°09'36" W (Photo 3). (Appendix B)

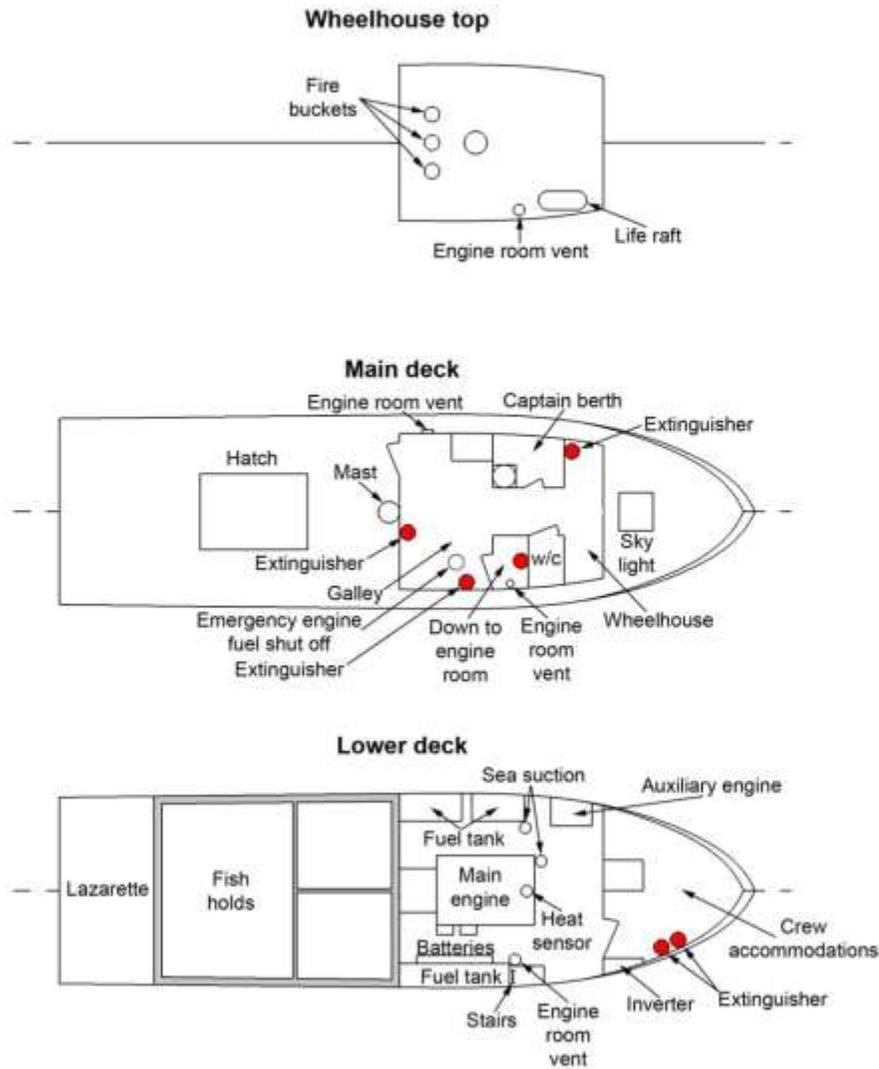
Appendix A – General arrangement of the Neptune II (diagram not to scale)

The hull below the main deck was subdivided by 4 transverse bulkheads that enclosed (from forward) the crew accommodation, the engine room, the fish hold and the lazarette (See Appendix A).
