MARINE INVESTIGATION REPORT

M11W0091

STRIKING OF A BRIDGE

TUG *F.W. WRIGHT* AND BARGE *EMPIRE 40*
FRASER RIVER
QUEENSBOROUGH RAILWAY BRIDGE, BRITISH
COLUMBIA
28 JUNE 2011

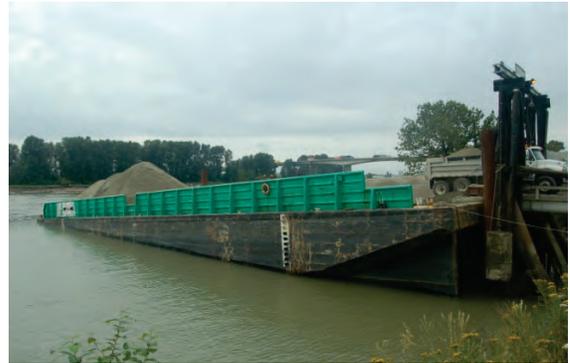
Photo 2. Barge *Empire 40*

There was no reported damage to the *F.W. Wright*. The *Empire 40* sustained damage to its top bow rail, where it collided with the bridge's swing span.

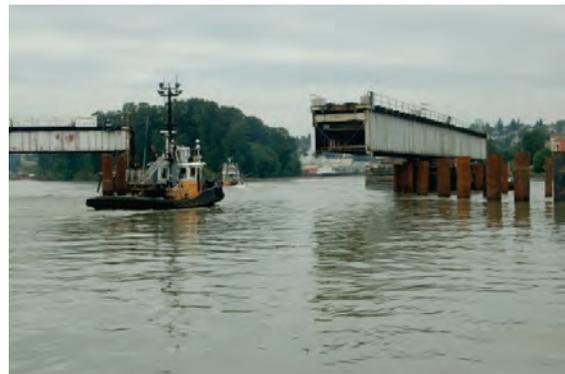
Photo 3. Queensborough Railway Bridge

The bridge consists of a centre swing span that is fitted atop a circular concrete pier (Photo 3).

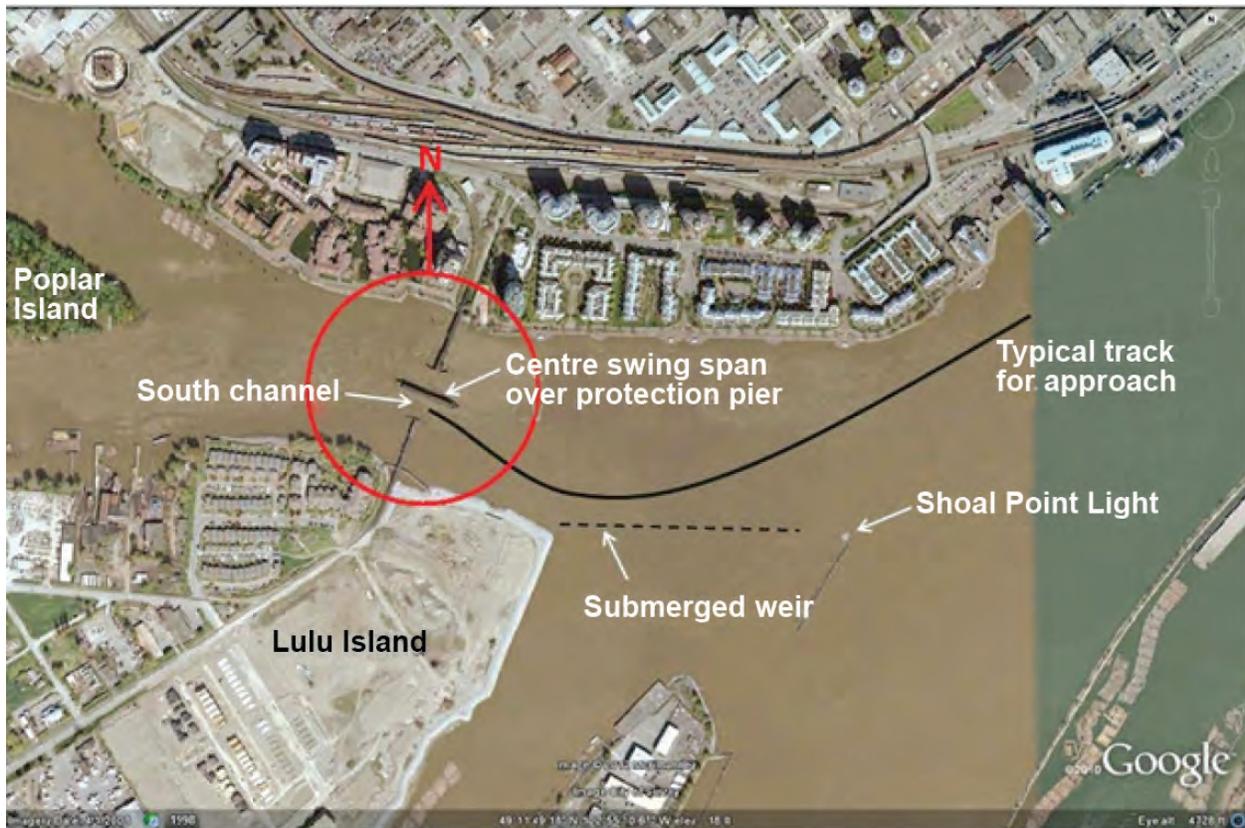
The concrete is protected by treated wood piling, timber and a wood-sheathed protection pier. When the bridge is swung open, the north channel is 26 m wide and the south channel is 29 m wide. Due to the extensive silting of the north channel over time, all upriver and downriver vessels transit through the bridge via the south channel.² The protection pier extends both upriver and downriver approximately 40 m from the center of the concrete pier and is tapered at both ends. The tapered ends are fitted with formed steel protection plates. There are lights fitted at the tapered ends: green indicates that the swing span is open and red indicates that the span is closed. The north and south rail line approaches to the swing span are protected, upriver and downriver, with cement pilings and 12 m-long wing walls (Photo 4 and Appendix A).

Photo 4. Queensborough Railway Bridge approach

Once clear of the bridges at New Westminster, the standard downriver approach to the Queensborough Railway Bridge is for the tug and tow to favour the western shore of the Fraser River. The approach would require the tug to steer towards the northeast tip of Lulu Island, approximately 230 m east of the Queensborough Railway Bridge. As the tug and tow near the northeast tip, the deflection of water caused by a submerged weir between the tip and Shoal Point, put in place years ago to limit silting, sets the tow to the north as it nears the bridge. This is counteracted by steering for the south-side opening (see Photo 4 for typical track).

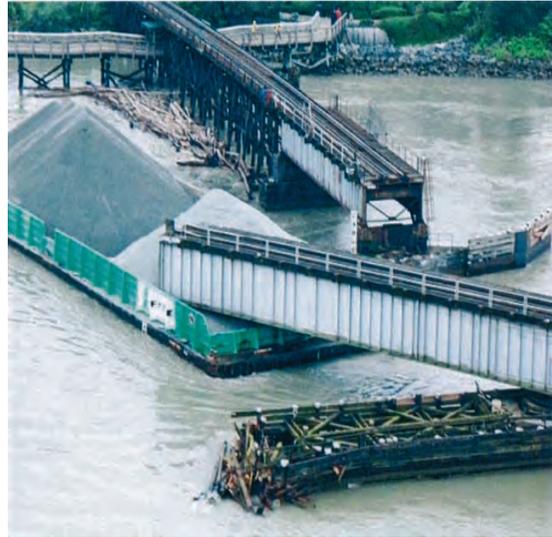
There was extensive damage to the protection pier and to the swing bridge gear mechanism (Photo 5). The leading 20 to 25 m of the protection pier for the swing span, as well as some portions of the protection pier pilings on the south side of the south channel, were extensively damaged as a result of the striking. The bridge's open swing span initially collided with the barge, before driving itself 10 m deep into the first pile of gravel, eventually stopping the barge. The current then caught the stern of the barge and swung it to port, stripping and damaging the gear mechanism of the swing span section. As it moved south, the barge took part of the swing span that was embedded in the gravel pile with it, thereby separating the span from its adjoining section.

Photo 5. Barge *Empire 40* and Queensborough Railway Bridge after striking

The barge then damaged the southeast wing wall before coming to rest on the cement protection piling of the south rail approach.
